TMS320DM6441

Digital Media System-on-Chip

Silicon Revisions 2.3, 2.1, 1.3, 1.2, and 1.1

Silicon Errata

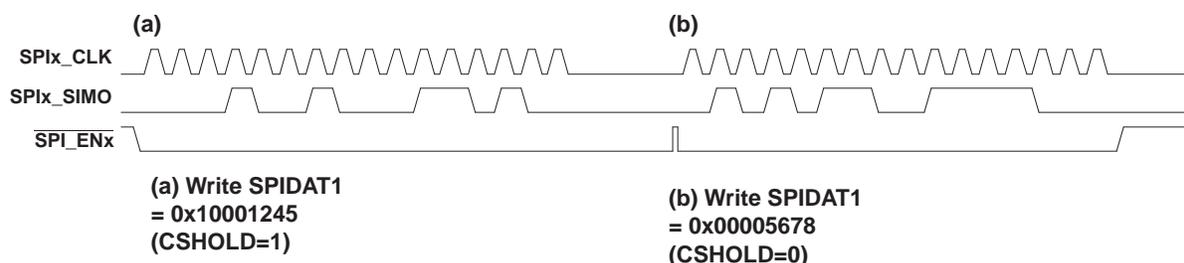
Figure 3. Actual CSHOLD Behavior—32-Bit Writes to SPIDAT1

Instead, what actually occurs is that $\overline{\text{SPI_ENx}}$ is momentarily de-asserted at the beginning of the second write, as illustrated in Figure 3.

Workaround(s): For each word in the sequence of words during which $\overline{\text{SPI_ENx}}$ should be held low, write to the SPIDAT1 register with the CSHOLD bit set to '1'. Follow this by a write to only the CSHOLD field of SPIDAT1, setting CSHOLD = 0 to de-assert $\overline{\text{SPI_ENx}}$. See Figure 5 for an illustration.

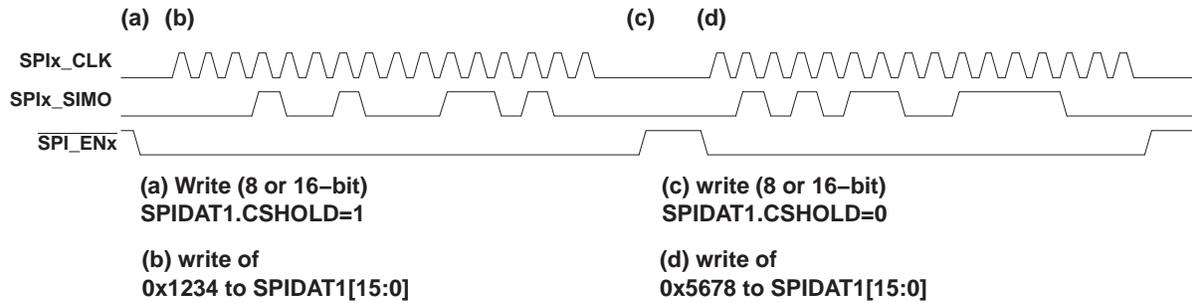
Figure 4. Actual CSHOLD Behavior—Halfword Writes to SPIDAT1

Both Figure 2 and Figure 3 assume that SPIDAT1 is written using a single 32-bit write instruction. If SPIDAT1 is instead written using an 8-bit or 16-bit instruction to write to the CSHOLD field, followed by a 16-bit write to the transmit shift register field of SPIDAT1, then what actually occurs is illustrated in Figure 4. This is the same case illustrated in Figure 3 except that the de-assertion of $\overline{\text{SPI_ENx}}$ lasts for the duration between writing a '0' to the CSHOLD field and writing new data to the transmit shift register.

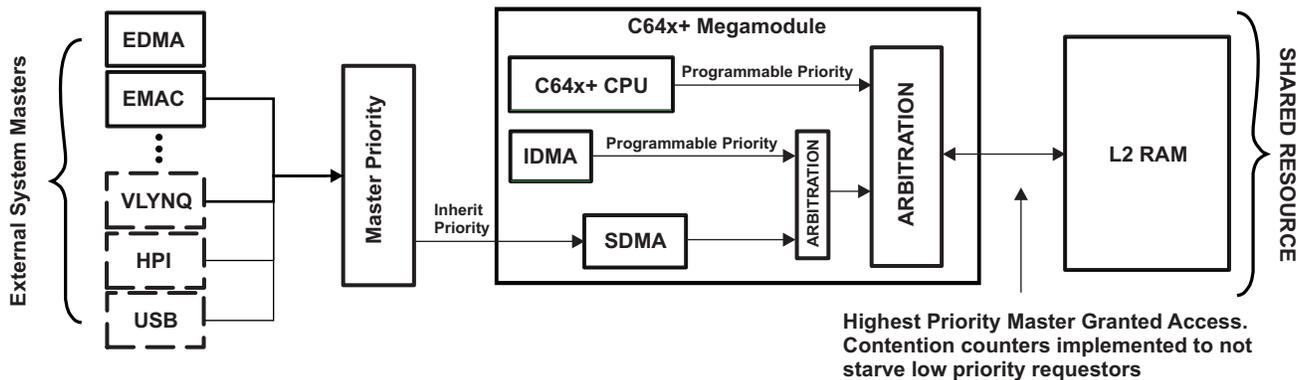
Figure 8. Priority Arbitration Scheme for L2 RAM

Ideally, the BWM arbitration will grant equal L2 bandwidth between equal priority DMA and CPU requests. Instead, when requests arrive at the BWM such that the CPU priority is *lower than or equal to* the DMA priority, the bandwidth is always granted in favor of the CPU over the DMA. In the case of successive CPU requests, it is possible for the CPU to block all DMA requests until the CPU traffic subsides. [Figure 8](#) shows a high-level diagram of the arbitration scheme used for L2 RAM requests.

When the SDMA has finished sending all of its commands to the L2 controller, the C64x+ Megamodule drops the effective transfer priority to seven. The L2 Controller uses this effective priority to arbitrate the SDMA command with the CPU.

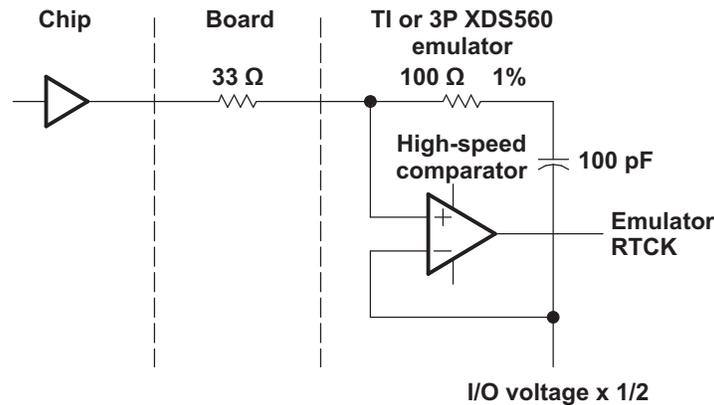
Figure 10. Typical Emulation Interface Circuit

Figure 10 illustrates the typical hardware interface between the TMS320DM644x DSP and the current TI or third-party debug controller pod. This combination of debug controller pod and DSP may not work reliably for two reasons:

- The RTCK and TDO buffers have approximately 100 Ω output impedance and rise and fall time of 5 ns and 4 ns respectively to minimize EMI and switching noise.
- The emulation pod is designed for a low impedance high drive output buffer with less than 3-ns rise/fall time. The debug controller pod expects the chip to drive the AC termination inside the emulation pod shown in Figure 10.

The 100 Ω chip buffer impedance, combined with 33 Ω series termination on the target board creates a voltage divider at the debug controller pod terminal with a RC time constant on the order of 10 ns. The slow 10 ns rise time causes the debug controller pod input to oscillate as the signal passes through the switching threshold. In addition, at faster debug controller pod operating frequencies (max TCK = 34 MHz), the RTCK and TDO signals are not able to swing to the full range (0 V - 1.8 V), instead these signals swing between 0.4 V and 1.45 V.
