DM385/DM388 DaVinci™ Digital Media Processor Silicon Revisions 1.1, 1.0

Silicon Errata

Literature Number: SPRZ387B
April 2013–Revised December 2013

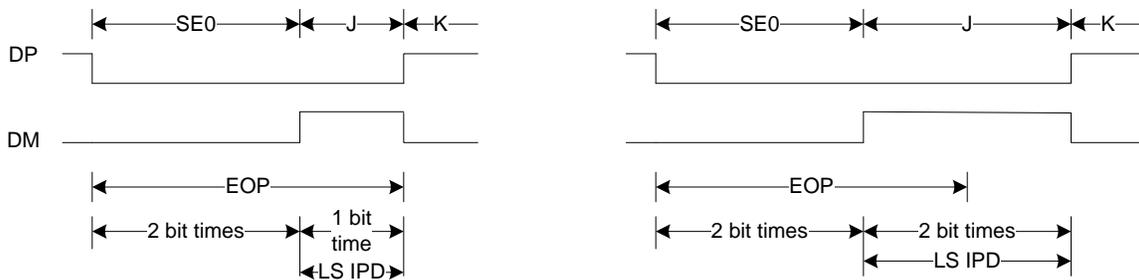
The problem is due to the length of the IPD between the Receiver-to-Transmitter (Rx-to-Tx) transactions. The Host IPD between Rx-to-Tx transactions for LS transactions should range from 2 to 6.5 LS bit times. It has been verified that the controller's LS IPD for Rx-to-Tx is only 1. This is shown in the following figure.

IPDs are measured from the SE0-to-J transition at the end of EOP to the J-to-K transition that starts the next packet.

IPD=1 and does NOT meet the IPD minimum standard

IPD=2 and DOES meet the IPD minimum standard
