OMAP-L132 C6000™ DSP+ARM® Processor Silicon Revisions 2.3, 2.1

Silicon Errata

Literature Number: SPRZ317G
August 2011–Revised March 2014

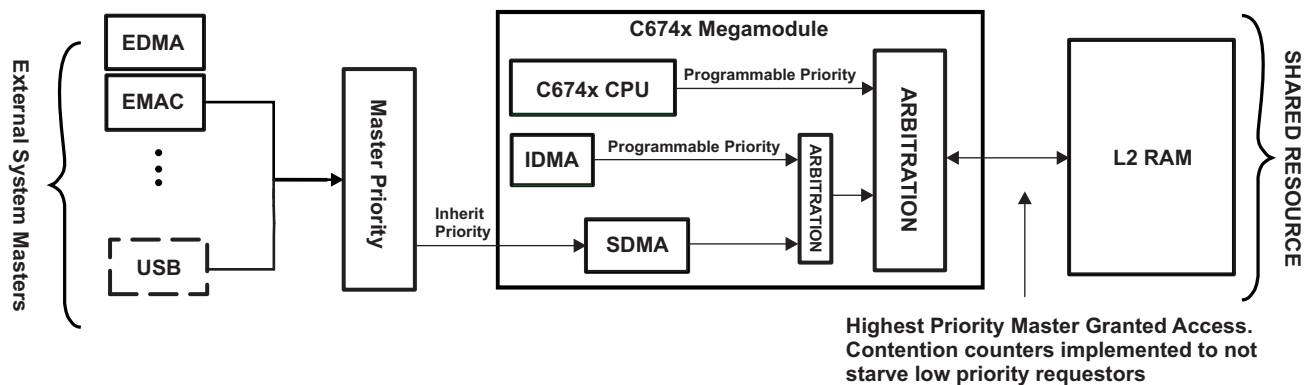
Figure 3. Priority Arbitration Scheme for L2 RAM

Ideally, the BWM arbitration will grant equal L2 bandwidth between equal priority DMA and CPU requests. Instead, when equal priority DMA and CPU requests arrive at the BWM, bandwidth is always granted in favor of the CPU over DMA. In the case of successive CPU requests, it is possible for the CPU to block all DMA requests until CPU traffic subsides. Additionally, some command logic in the BWM uses priority level 7, which can also result in SDMA stalls when the CPU is also programmed to priority level 7. [Figure 3](#) shows a high level diagram of the arbitration scheme used for L2 RAM requests.

Workaround(s) Configure DMA and CPU requests to different priority levels. There is no penalty for setting the IDMA and SDMA priorities equal to each other.

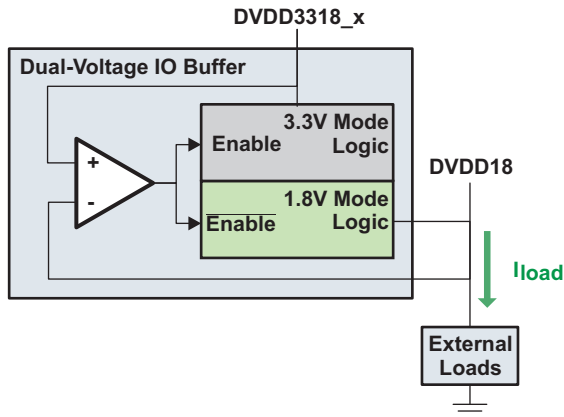
Figure 7. Behavior of the IO buffer during Zone F

As the DVDD3318_x supply ramps, but is not yet one V_T above the DVDD18 supply, the comparator enables the 1.8V mode logic section and disables the 3.3V mode logic section. No unexpected current flows between the two sections.

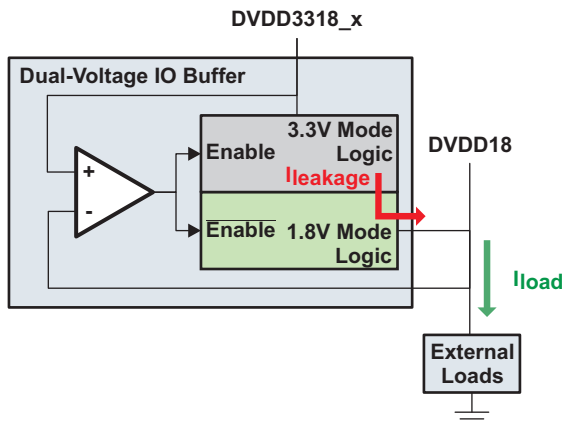
Figure 8. Error State of the IO buffer during Zone G

As DVDD3318_x exceeds DVDD18+V_T, some of the circuitry across the boundary of the two voltage domains will turn on and causes a leakage current (in red) to flow between the two voltage domains. This current pulls up the DVDD18 supply unless the power source providing that supply can oppose it or unless the load current is strong enough to counteract it.

If DVDD18 continues to rise as DVDD3318_x ramps, the comparator never sees enough difference between the two supplies to switch to 3.3V mode.

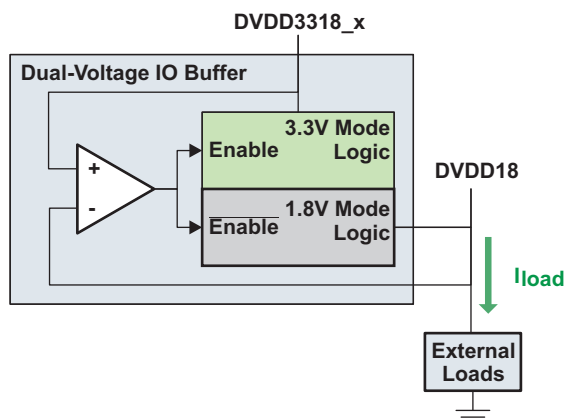
If the load current is high enough or the DVDD18 power supply can oppose the leakage current, then the DVDD18 voltage stays low enough for:

- the comparator to recognize 3.3V mode
- the 1.8V mode logic is turned off
- the leakage stops

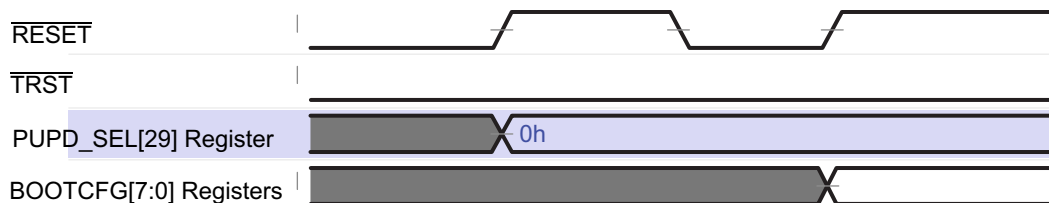
Figure 10. Initialization of PUPD_SEL[29] and BOOTCFG[7:0] Registers with Weak or No External Pull Resistors on BOOT[7:0] Pins

Internal pullups being enabled on the BOOT[7:0] pins may result in boot failures. If weak external pulldown resistors are used on the PCB to select the boot mode, they may not be able to overpower the internal pullups. This can result in the wrong boot mode being latched in the BOOTCFG[7:0] register when coming out of Reset.

Figure 10 shows the behavior of the PUPD_SEL[29] register before and after reset. Assuming weak or no external pull resistors are on the BOOT[7:0] pins, the BOOTCFG register will latch the unknown values after the device initially comes out of Reset. Note that, TRST *must* always be low in order to issue a POR and latch the boot pin values -- the boot pins are not latched after a Warm Reset.
