ABSTRACT

This document describes the known exceptions to the functional specifications (advisories).

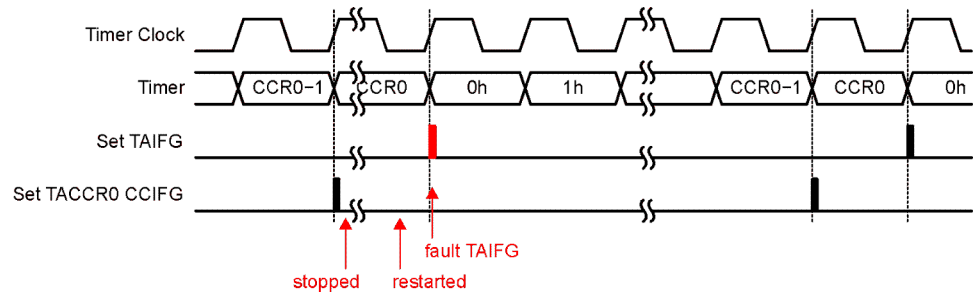
TA21 *TA Module*

Function TAIFG Flag is erroneously set after Timer A restarts in Up Mode

Description In Up Mode, the TAIFG flag should only be set when the timer counts from TACCR0 to zero. However, if the Timer A is stopped at TAR = TACCR0, then cleared (TAR=0) by setting the TACLK bit, and finally restarted in Up Mode, the next rising edge of the TACLK will erroneously set the TAIFG flag.

Workaround None.

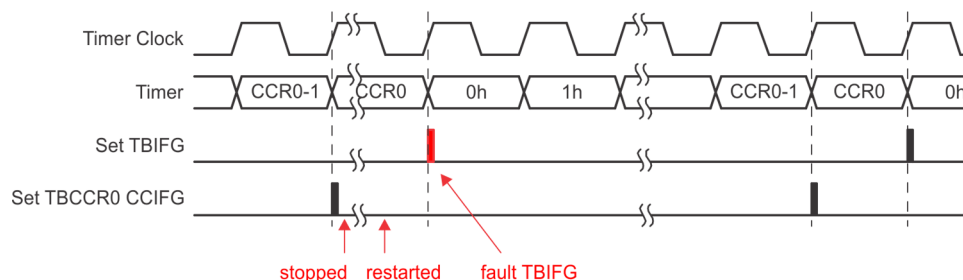
TB24 *TB Module*

Function TBIFG Flag is erroneously set after Timer B restarts in Up Mode

Description In Up Mode, the TBIFG flag should only be set when the timer resets from TBCCR0 to zero. However, if the Timer B is stopped at TBR = TBCCR0, then cleared (TBR=0) by setting the TBCLR bit, and finally restarted in Up Mode, the next rising edge of the TBCLK will erroneously set the TBIFG flag.

Workaround None.
