## ABSTRACT

This document describes the known exceptions to the functional specifications (advisories).

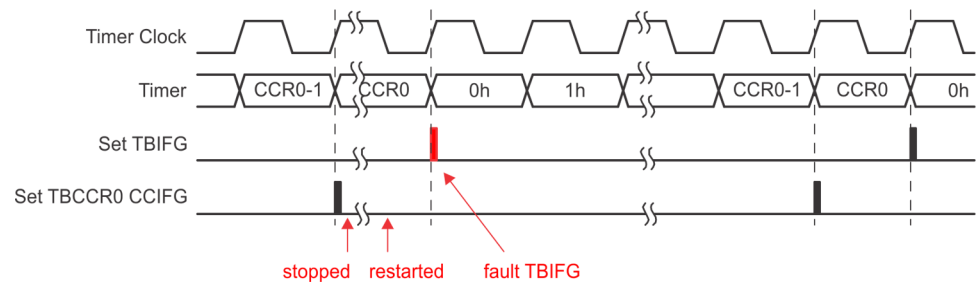
**TB24**

TBIFG Flag is erroneously set after Timer B restarts in Up Mode

In Up Mode, the TBIFG flag should only be set when the timer resets from TBCCR0 to zero. However, if the Timer B is stopped at TBR = TBCCR0, then cleared (TBR=0) by setting the TBCLR bit, and finally restarted in Up Mode, the next rising edge of the TBCLK will erroneously set the TBIFG flag.

None.
