MSP430F46191 Device Erratasheet

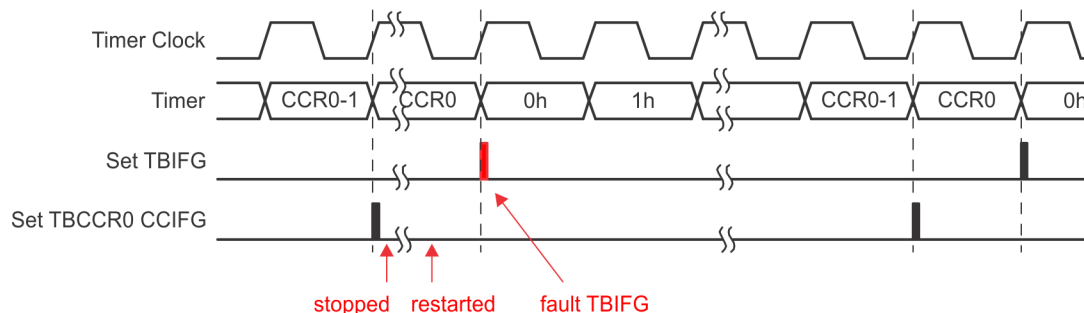
TB24 *TIMER_B Module*
Category Functional

Function TBIFG Flag is erroneously set after Timer B restarts in Up Mode

Description In Up Mode, the TBIFG flag should only be set when the timer resets from TBCCR0 to zero. However, if the Timer B is stopped at TBR = TBCCR0, then cleared (TBR=0) by setting the TBCLR bit, and finally restarted in Up Mode, the next rising edge of the TBCLK will erroneously set the TBIFG flag.

Workaround None.
