Errata
MSP430F47163 Microcontroller

This document describes the known exceptions to the functional specifications (advisories).

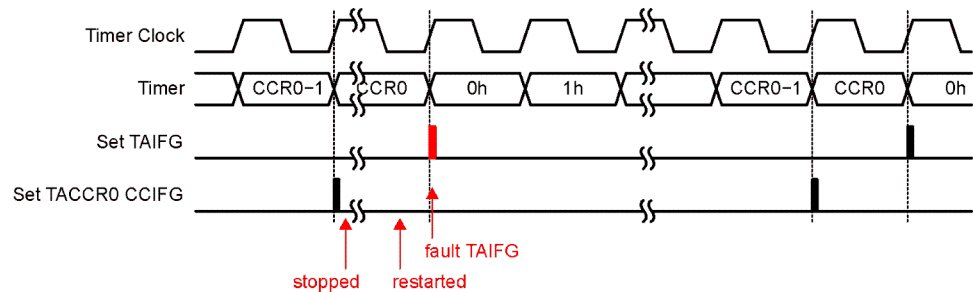
TA21 *TA Module*

Function TAIFG Flag is erroneously set after Timer A restarts in Up Mode

Description In Up Mode, the TAIFG flag should only be set when the timer counts from TACCR0 to zero. However, if the Timer A is stopped at TAR = TACCR0, then cleared (TAR=0) by setting the TACLr bit, and finally restarted in Up Mode, the next rising edge of the TACLK will erroneously set the TAIFG flag.

Workaround None.

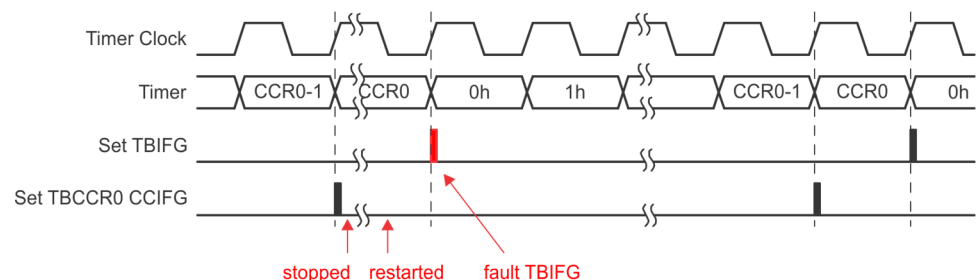
TB24
TB Module
Category

TBIFG Flag is erroneously set after Timer B restarts in Up Mode

In Up Mode, the TBIFG flag should only be set when the timer resets from TBCCR0 to zero. However, if the Timer B is stopped at $TBR = TBCCR0$, then cleared ($TBR=0$) by setting the TBCLR bit, and finally restarted in Up Mode, the next rising edge of the TBCLK will erroneously set the TBIFG flag.

None.
