Errata
MSP430F47166 Microcontroller

ABSTRACT

This document describes the known exceptions to the functional specifications (advisories).

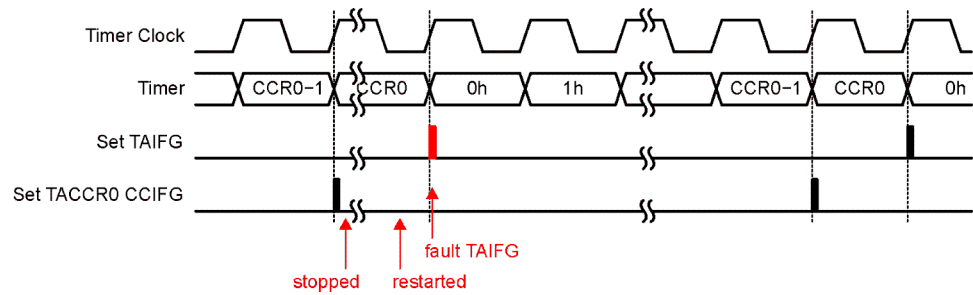
Function TAIFG Flag is erroneously set after Timer A restarts in Up Mode

Description In Up Mode, the TAIFG flag should only be set when the timer counts from TACCR0 to zero. However, if the Timer A is stopped at TAR = TACCR0, then cleared (TAR=0) by setting the TACLr bit, and finally restarted in Up Mode, the next rising edge of the TACLK will erroneously set the TAIFG flag.

Workaround None.
