MSP430F5335 Device Erratasheet

The revision of the device can be identified by the revision letter on the [Package Markings](#) or by the [HW_ID](#) located inside the TLV structure of the device

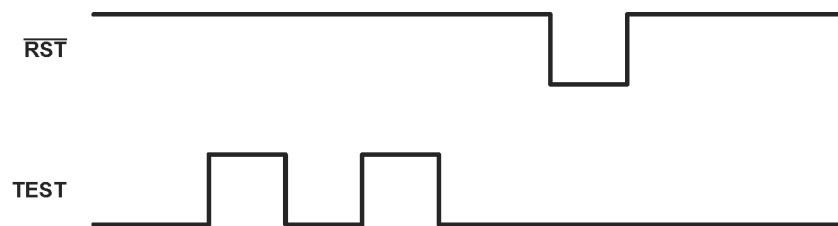
JTAG20 *JTAG Module*

Function BSL does not exit to application code

Description The methods used to exit the BSL per MSP430 Programming Via the Bootstrap Loader (SLAU319) are invalid.

Workaround To exit the BSL one of the following methods must be used.

- A Power cycle
- or
- Toggle the TEST pin twice when nRST is high and after 50us pull nRST low.

Note: This toggling of TEST pins is not subject to timing constraints. The appropriate level transitions on TEST pin, followed by a RST pulse after 50us, are sufficient to trigger an exit from BSL mode.
