Errata
MSP430F5527 Microcontroller

This document describes the known exceptions to the functional specifications (advisories).

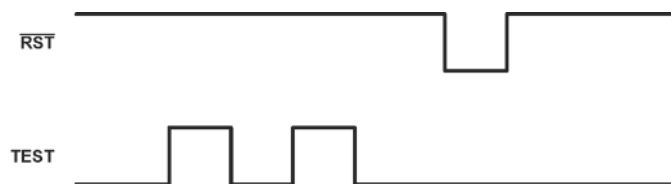
- Toggle the TEST pin twice when nRST is high and after 50us pull nRST low.

Note: This toggling of TEST pins is not subject to timing constraints. The appropriate level transitions on TEST pin, followed by a RST pulse after 50us, are sufficient to trigger an exit from BSL mode.
