Errata  
**MSP430G2113 Microcontroller**

**ABSTRACT**

This document describes the known exceptions to the functional specifications (advisories).

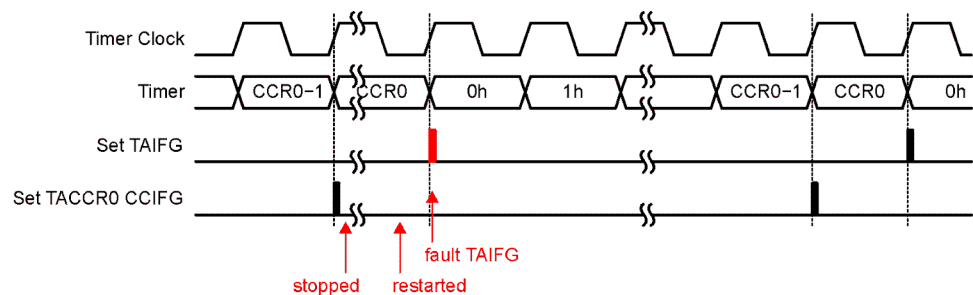
## TA21 *TA Module*

**Function** TAIFG Flag is erroneously set after Timer A restarts in Up Mode

**Description** In Up Mode, the TAIFG flag should only be set when the timer counts from TACCR0 to zero. However, if the Timer A is stopped at  $TAR = TACCR0$ , then cleared ( $TAR=0$ ) by setting the TACLr bit, and finally restarted in Up Mode, the next rising edge of the TACLK will erroneously set the TAIFG flag.

**Workaround** None.
