MSP430G2231 Device Erratasheet

1 Functional Errata Revision History

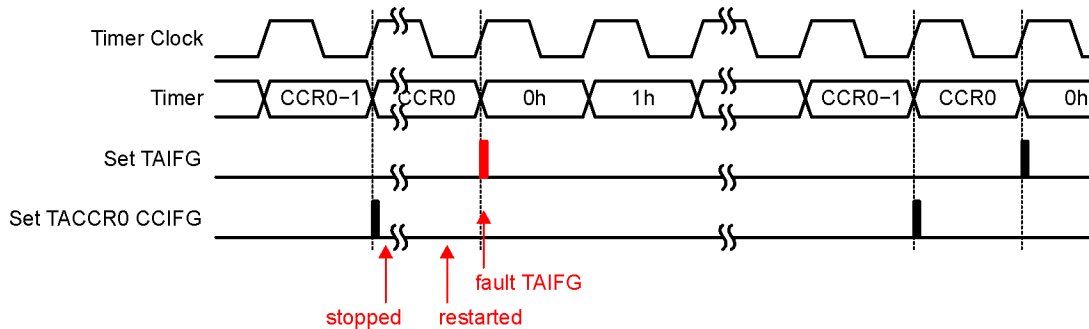
| TA21 | TIMER_A Module |

Function TAIFG Flag is erroneously set after Timer A restarts in Up Mode

Description In Up Mode, the TAIFG flag should only be set when the timer counts from TACCR0 to zero. However, if the Timer A is stopped at TAR = TACCR0, then cleared (TAR=0) by setting the TACLRL bit, and finally restarted in Up Mode, the next rising edge of the TACLK will erroneously set the TAIFG flag.

Workaround None.
