Stellaris® LM4F232H5BB Rev A1/A3/B0 Errata

Note: The Stellaris LM4F232H5BB microcontroller has been replaced by the identical Tiva™ C Series TM4C123GH6ZRB microcontroller.

This document contains known errata at the time of publication for the Stellaris LM4F232H5BB microcontroller, revisions A1, A3, and B0. Additional errata that applies to revisions A1, A3, and B0, as well as revisions following B0 can be found in *Stellaris® LM4F Microcontrollers Silicon Revisions 6 and 7 Errata (SPMZ856)*. Read both documents for a complete list of errata for your device.

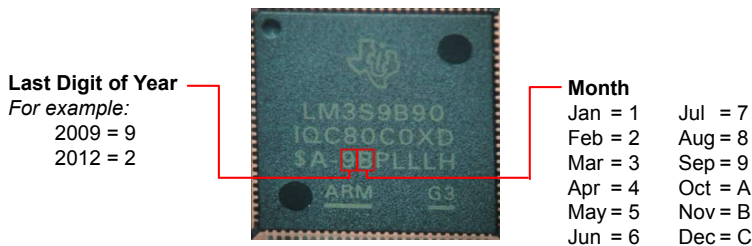
Note: To determine the date code of your part, look at the first two characters following the dash on the third line of the part markings (highlighted in red in the following figure). The first number after the dash indicates the last decimal digit of the year. The second character indicates the month. Therefore, the following example shows a date code of 9B which indicates November 2009.
