## TMS320C82 Errata Sheet

### December 31, 1997 – Version 1.0h

**SPRZ125**  
**April 1998**

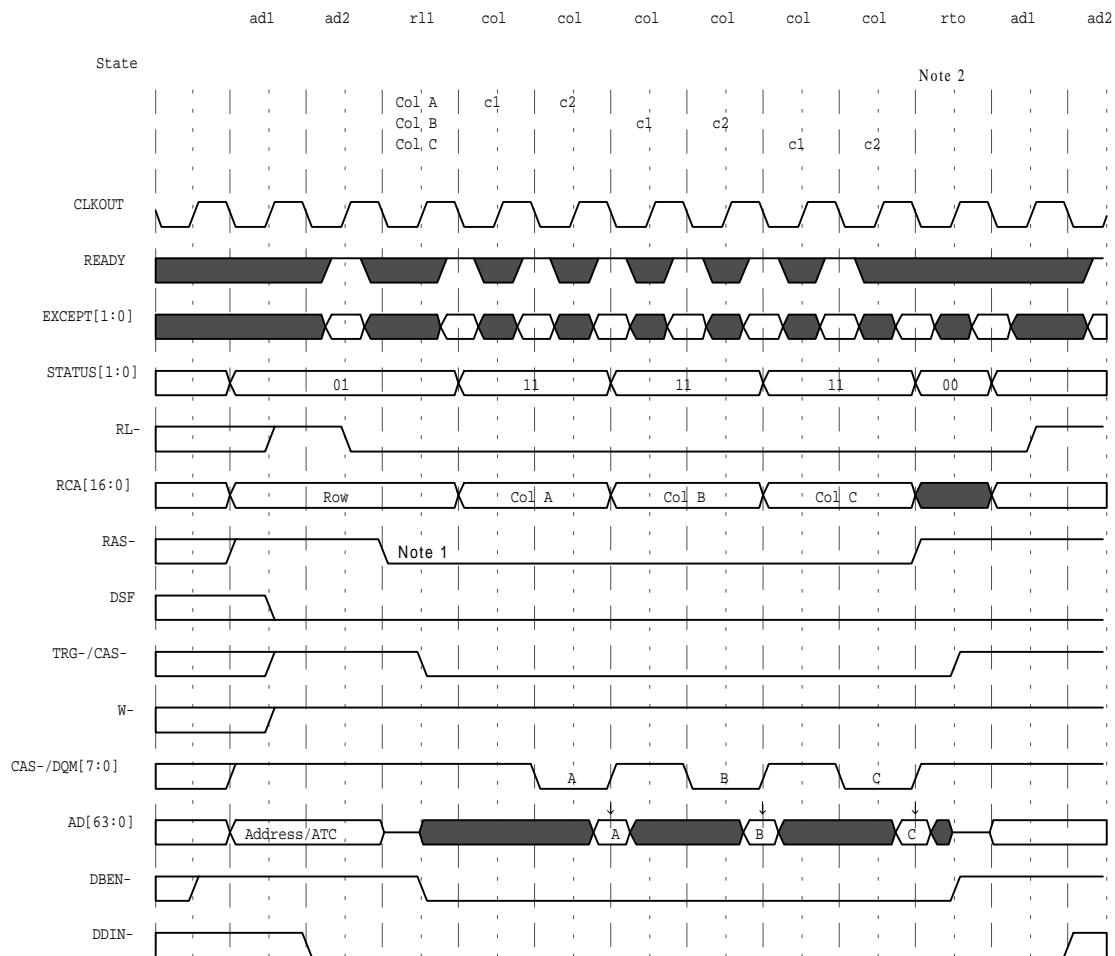
#### 2 Cyc/Col SRAM Read - Rev 1.0/1.1

The 2 cycle/column SRAM (CT = 0110) cycles are not implemented correctly. For 2 cycle/column reads, the fall of **/CAS** is delayed by ½ cycle. The following cycle diagram illustrates the operation of revision 1.0/1.1 silicon for 2 cycle/column SRAM reads.

None. As a consequence, SRAMs with faster access times may be required to interface at this cycle timing.

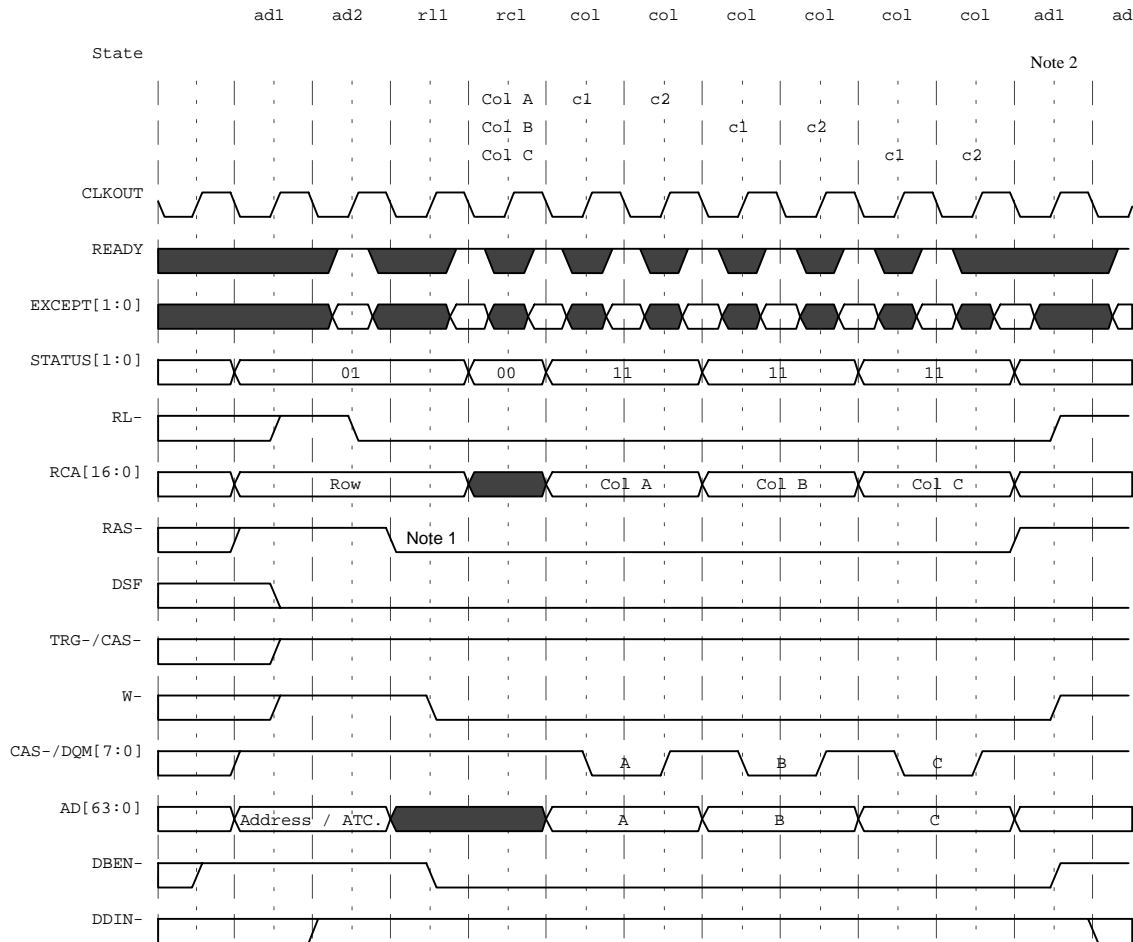
2 Cyc/Col SRAM Write - Rev 1.0/1.1

In the revision 1.0/1.1 silicon, the 2 cycle/column SRAM write cycles are implemented as shown below. Note that the fall of /CAS is delayed by 1/2 cycle.

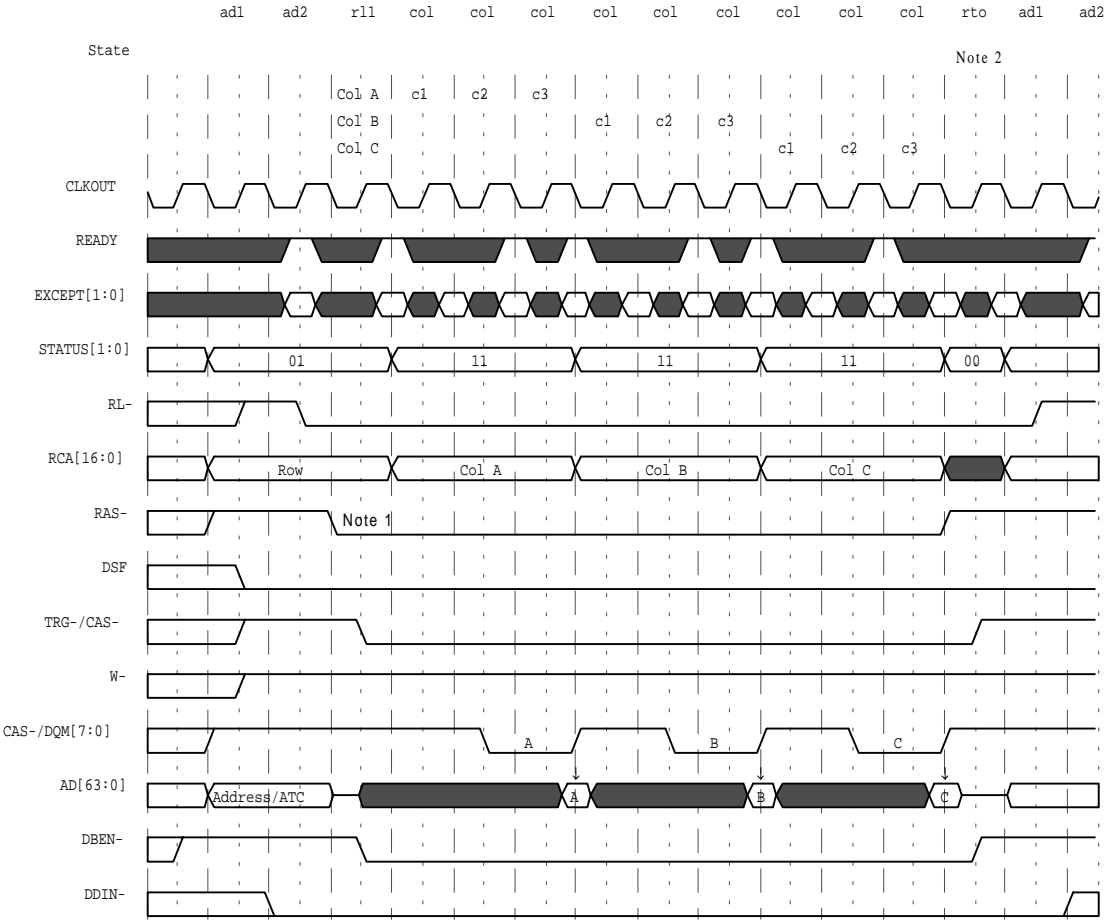
3 Cyc/Col SRAM Read - Rev 1.x

The 3 cycle/column SRAM (CT = 0111) cycles are not implemented correctly. For 3 cycle/column reads, the fall of /CAS is delayed by 1/2 cycle. The following cycle diagram illustrates the operation of revision 1.x silicon for 3 cycle/column SRAM reads.

None. For silicon revision 1.3 (see Section 1.12), a 2 cycle/column access (CT = 0110) may be used with the **WS[1:0]** field = 01 to achieve a longer /CAS low pulse width.

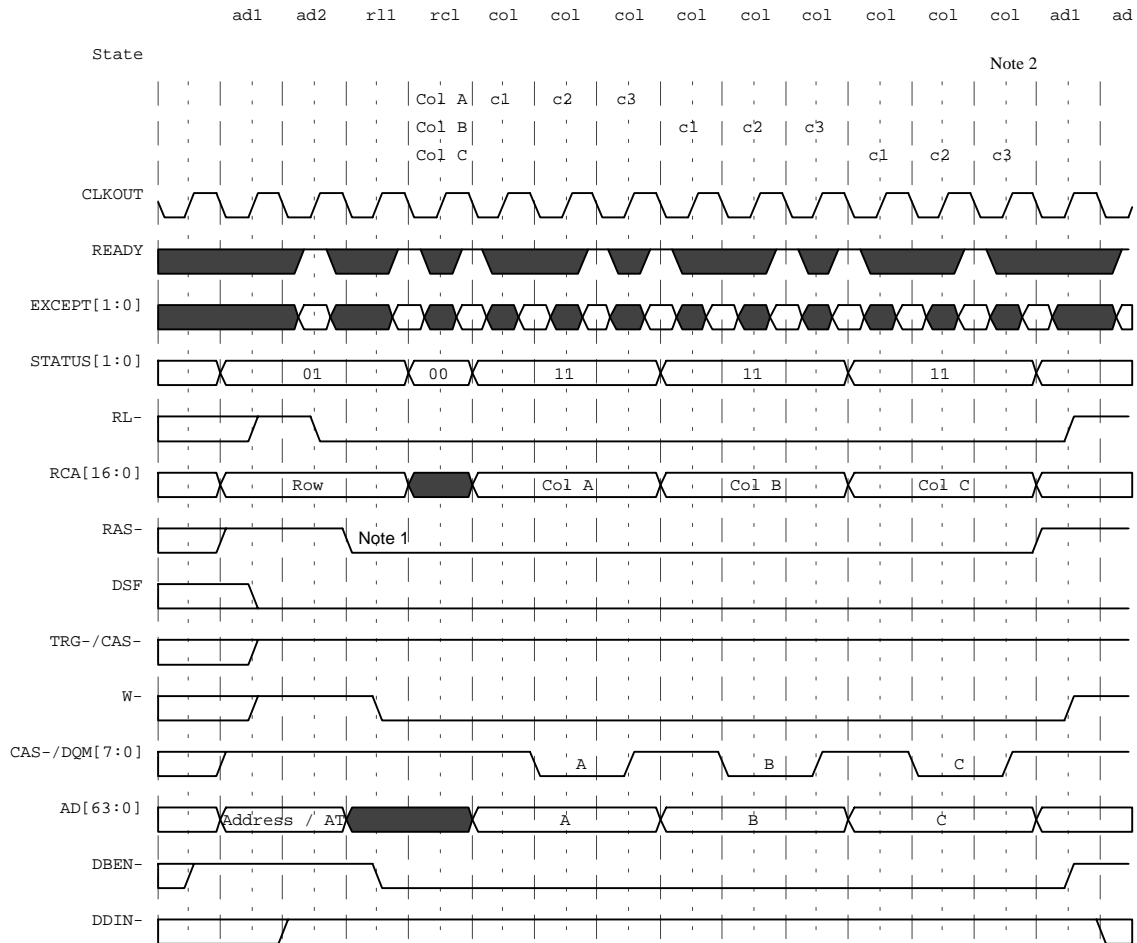
### 3 Cyc/Col SRAM Write - Rev 1.x

In revision 1.x silicon, the 3 cycle/column SRAM write cycles are implemented as shown below. Note that the fall of /CAS is delayed by ½ cycle.

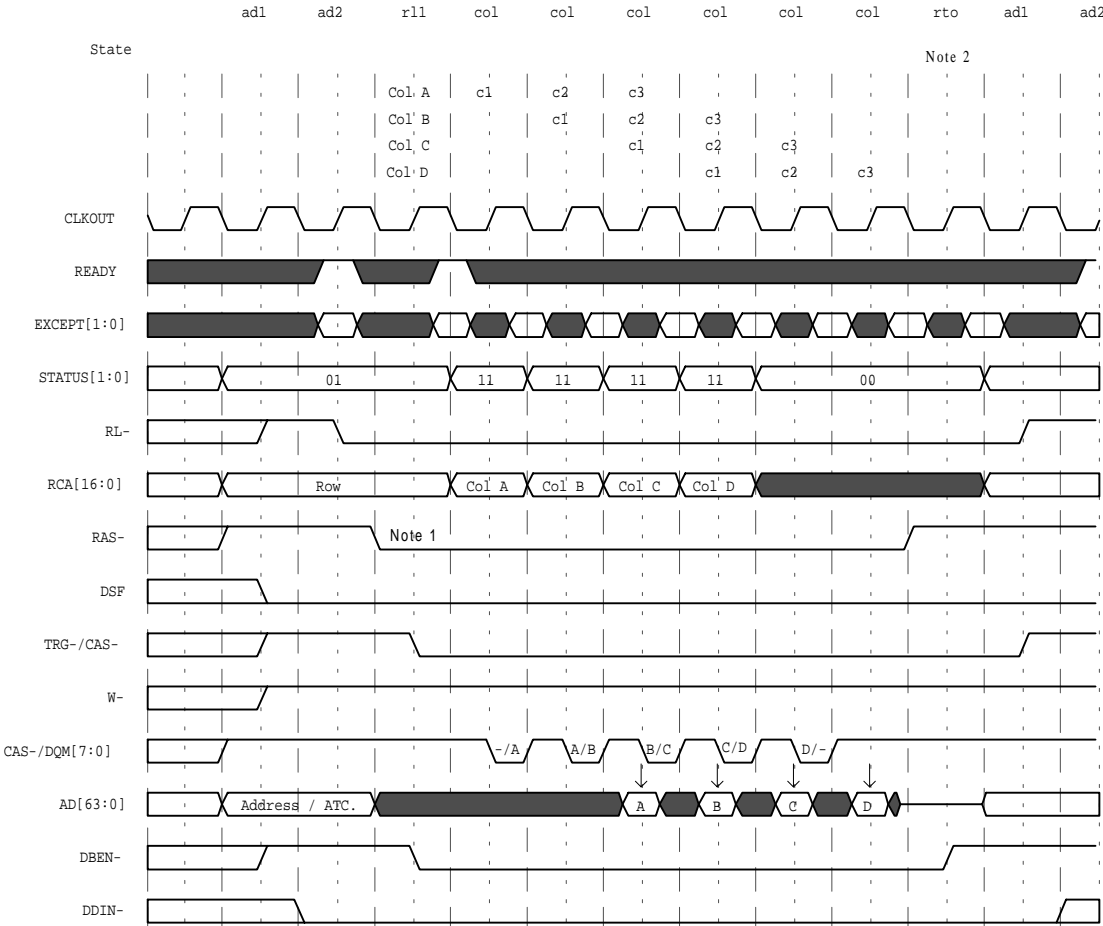
Synchronous SRAM Read - Rev 1.0/1.1

The synchronous SRAM (CT = 0100) cycles are not implemented correctly. In revision 1.0/1.1 devices, the synchronous SRAM reads are implemented as follows. Note that the /CAS signals are active (low) for only 1/2 cycle, and an additional /CAS pulse is inserted to force a drain that is not required.

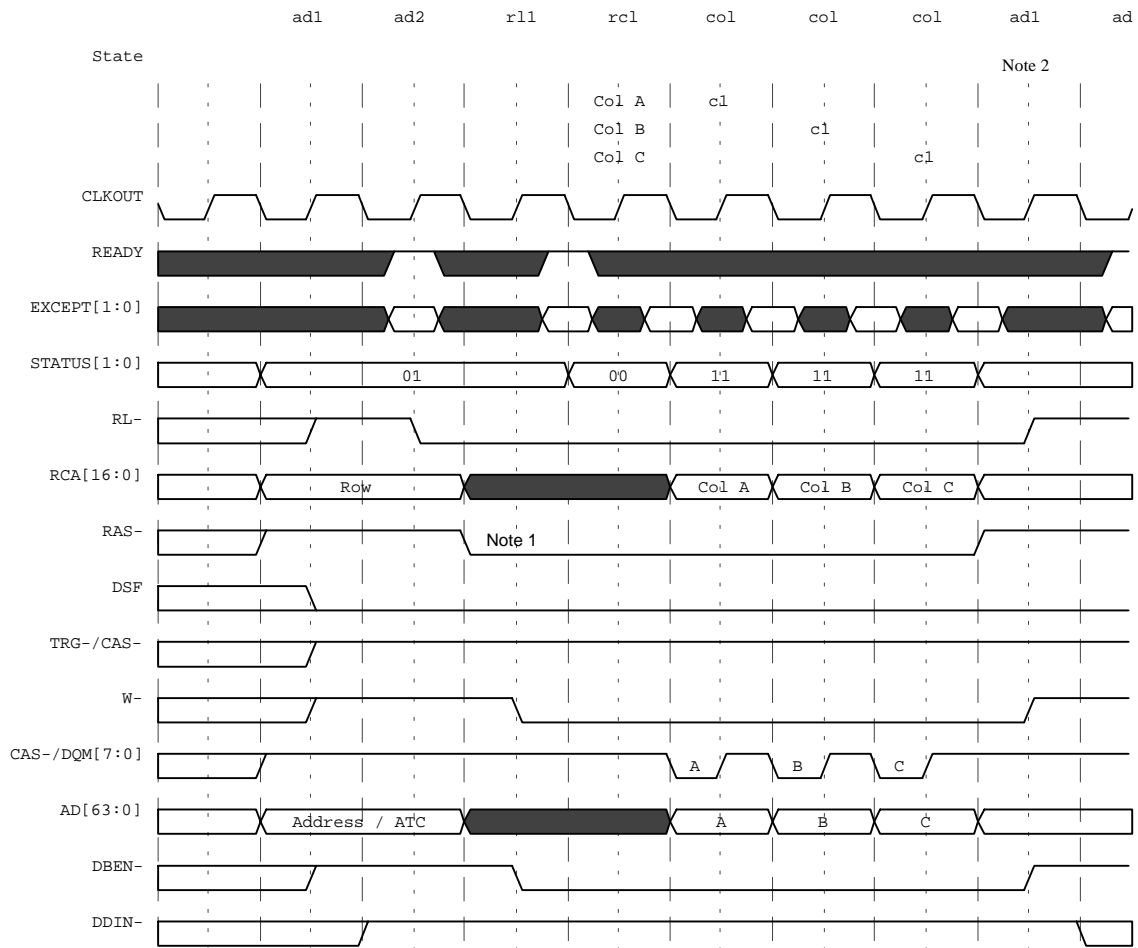
#### Synchronous SRAM Write - Rev 1.0/1.1

In revision 1.0/1.1 silicon, the synchronous SRAM write cycles are implemented as shown below. Note that /CAS is active for ½ cycle, instead of remaining low for an entire machine cycle.

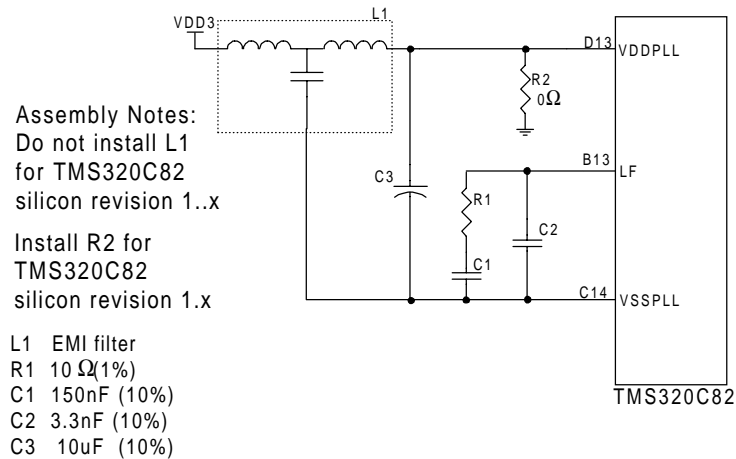
**PLL Disabling**

The on-chip phase-locked loop (PLL) of the TMS320C82 exhibits a large amount of jitter in silicon revision 1.0/1.1. The jitter can prevent reliable operation.

Disable the PLL. This can be accomplished by connecting  $V_{DDPLL}$  (D13) to system GND. The following schematic illustrates this.

When  $V_{DDPLL}$  is tied to GND, the device operates in non-PLL mode; **CLKOUT** is  $\frac{1}{2}$  the frequency of **CLKIN**. With the PLL disabled, components R1, C1, C2, and C3 are not required.

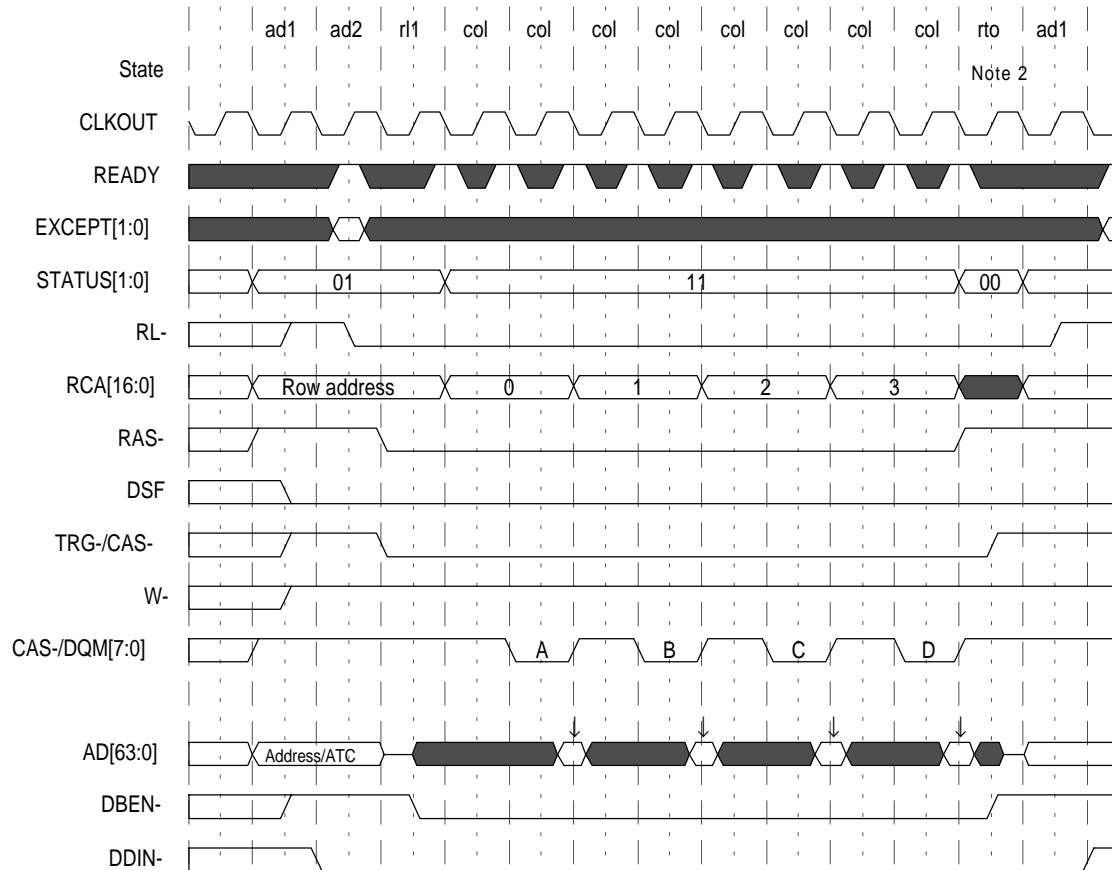
**Bank Configuration Cycle - Rev 1.0/1.1**

The memory bank configuration cycles are not implemented correctly. Similar to the 2 cycle/column SRAM reads, the fall of **/CAS** is delayed by ½ cycle. The following cycle diagram illustrates the operation of revision 1.0/1.1 silicon for memory bank configuration cycles.

Note: This diagram represents the errata timing for Rev 1.0 & Rev 1.1 Devices. For Rev 1.2 devices, the timing will appear as shown in the TMS320C82 datasheet.

None. Devices with faster access times may be needed to provide configuration data if **/CAS** is used as the output enable of said device.

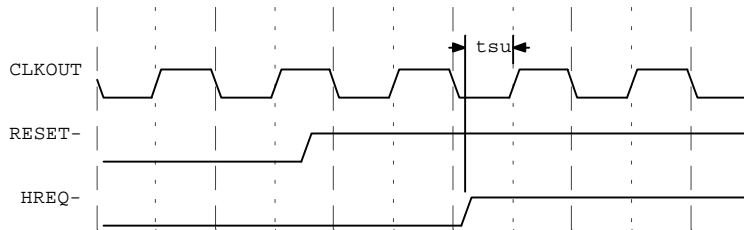
The hold time of the **/HREQ** input with respect to the rising edge of **/RESET** is 0 ns, such that the TMS320C82 may be powered up running by tying **/HREQ** directly to **/RESET**. A bug has been found in the sampling logic of **/HREQ** which will cause the device to hang if the rise of **/HREQ** is sampled low on the second **CLKOUT** cycle after the rise of **/RESET** before the refresh initialization cycles. This is illustrated below.

Figure 1.13.1 - Normal Operation

Figure 1.13.2 - Device Hangs After Reset

When the second case is encountered, the TMS320C82 will begin driving all signals normally in the high-impedance state once the host request condition is removed (**/HREQ** pulled high). The device will begin the first refresh cycle normally performed after reset but will then hang. All outputs of the TMS320C82 will continue to be driven, though no signal transitions other than **CLKOUT** will occur.

Ensure that **/HREQ** is sampled high on the second **CLKOUT** rising edge after the rise of **/RESET**. Note that tying **/HREQ** directly to **/RESET** is an acceptable workaround. For multi-C82 designs, it may be required that separate **/RESET** signals be provided for each TMS320C82 to prevent the refresh initialization cycles from conflicting with one another.
