TMS320C6201
Digital Signal Processor
Silicon Errata

SPRZ153
November 2000

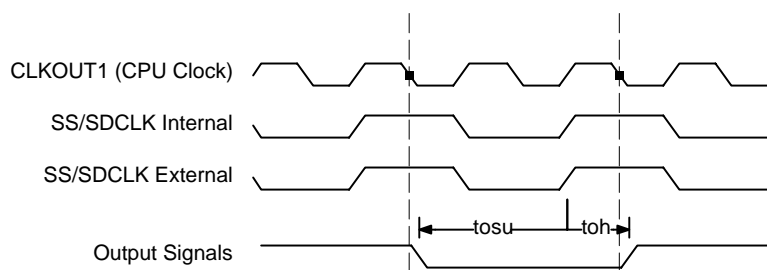
Figure 4. Write Example – Desired Behavior

The desired relationship is described in the TMS320C6201B data sheet (SPRS051) and is illustrated in Figure 4 and Figure 6. However, in the case where SDCLK/SSCLK becomes inverted (Figure 5 and Figure 7), control signals only have 1/2 CPU clock of setup to the next SDCLK/SSCLK rising rather than 3/2 CPU clock of setup. This has two negative effects to interface timing to external synchronous RAMs.

1. On writes, setup time to RAMs for control signals and write data is reduced by 1 CPU cycle.

- For prototypes, raising the core supply to 1.9 – 2.1 V corrects this problem. This is not recommended in boards shipped to customers, since the manufacturing process is not designed to be reliable outside the normal operating range. This option allows the user to verify current board designs at all valid frequency ranges.

- Reduce the operating frequency of the TMS320C6201B until SSCLK/SDCLK has the desired relationship. Typically, this occurs at 175 MHz across the range of recommended operating conditions.

- Since SSCLK and SDCLK are inverted externally relative to each other by design, these signals can be swapped on external memory interfaces to correct the problem (SSCLK to SDRAM and SDCLK to SBSRAM). This will cause invalid operation at frequencies below 175 MHz and will not work with future silicon revisions.

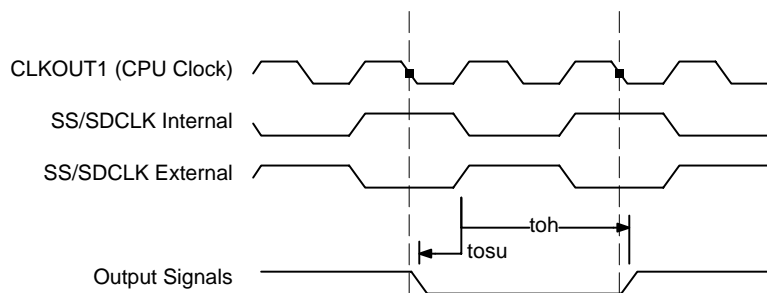
Figure 5. Write Example – Failing Behavior

A speedpath in the device causes SDCLK and SSCLK to start up 180 degrees out-of-phase (effectively inverted) from the desired waveform. Normally, EMIF outputs are delayed 1/2 CPU clock from the rising edge of SDCLK/SSCLK to give it adequate hold time while maintaining more than adequate setup times.

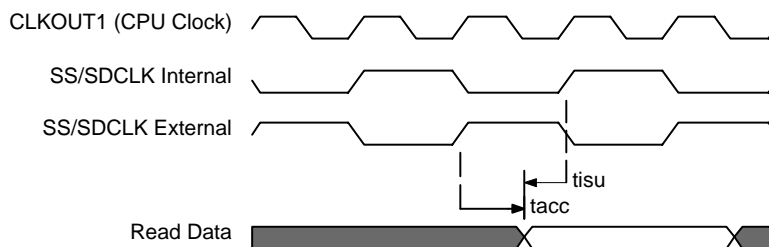
**Figure 7. Read Example – Failing Behavior**

- On SBSRAM/SDRAM reads, data will be sampled on the falling edge before the rising edge that would be expected. In this case, the input setup time for data at the C62x™ is reduced by 1 CPU cycle. Note that this case can be compounded with Case 1. The control signals could be latched one SSCLK/SDCLK cycle (2 CPU cycles) late by the memories. Thus, the setup could be reduced by up to 3 CPU cycles and be more than an entire SSCLK/SDCLK late.

CLKOUT2 is also affected by this speedpath bug and is 180 degrees out-of-phase. It behaves in the same way as SDCLK. (Internal reference number C601307)
