TMS320VC5421
Digital Signal Processor
Silicon Errata

SPRZ170C
April 2000
Revised October 2001

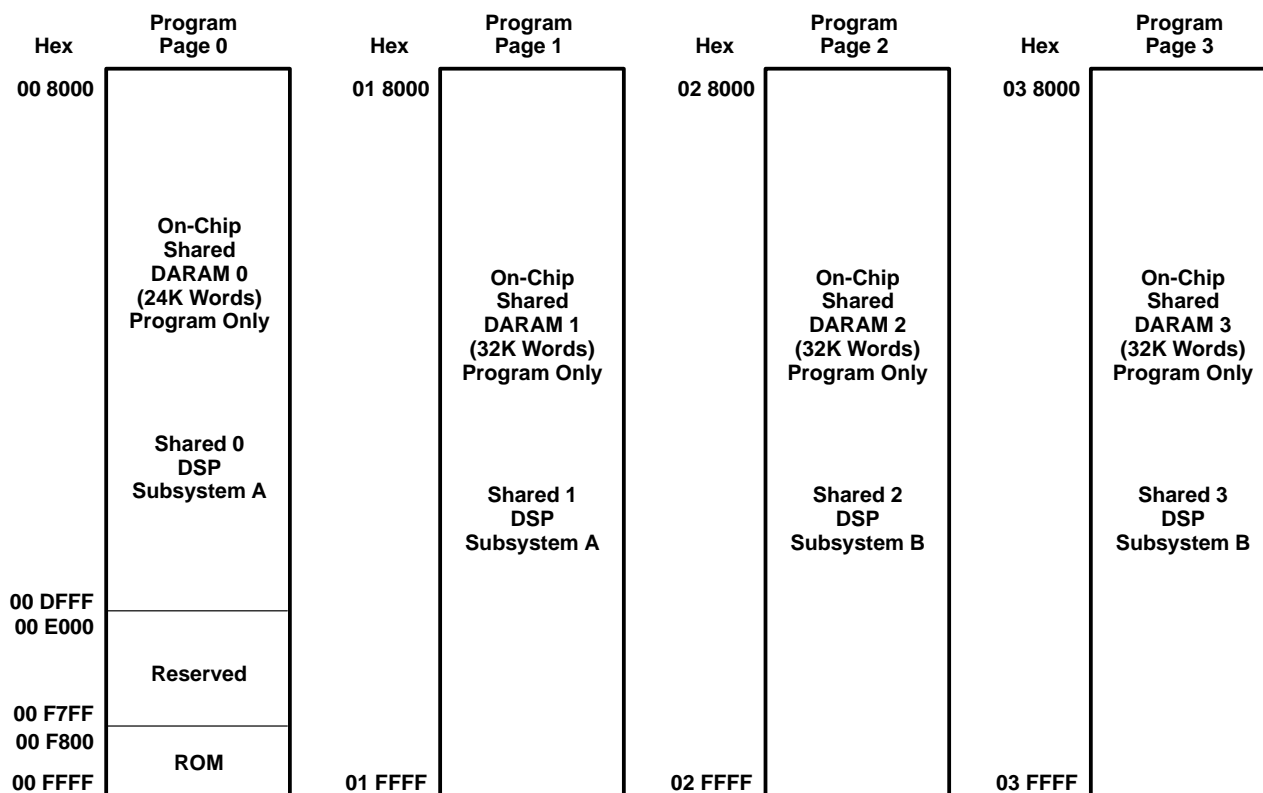
Figure 3. Shared-Memory Map

Details: When a 5421 subsystem is halted in emulation mode, the other subsystem is unable to access the shared memory associated with the halted subsystem (see Figure 3 for the shared-memory map). This also affects the use of software and hardware breakpoints in the shared memory. Note that this issue only affects the TMX320VC5421 during emulation, and there are no issues with shared memory accesses during normal functional mode.

Workaround: None. This problem is corrected in Revision A silicon.
