Errata

TMS320F2833x, TMS320F2823x DSCs Silicon Errata Silicon Revisions A, 0

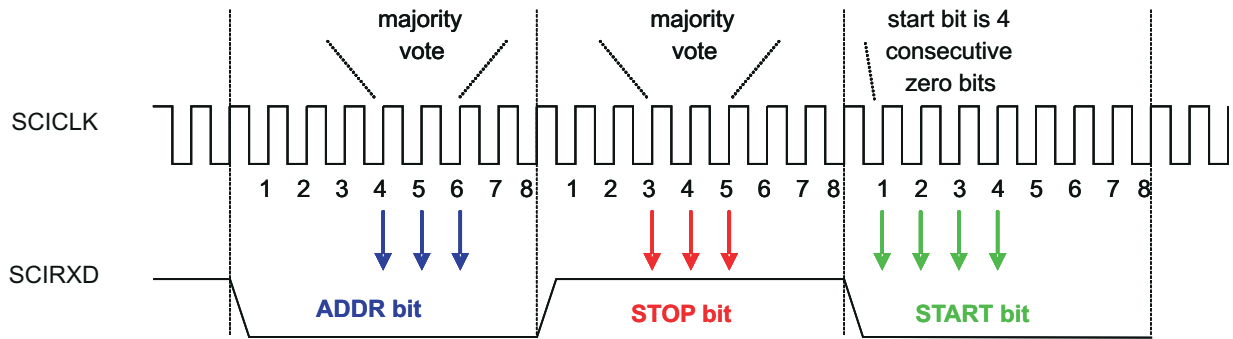
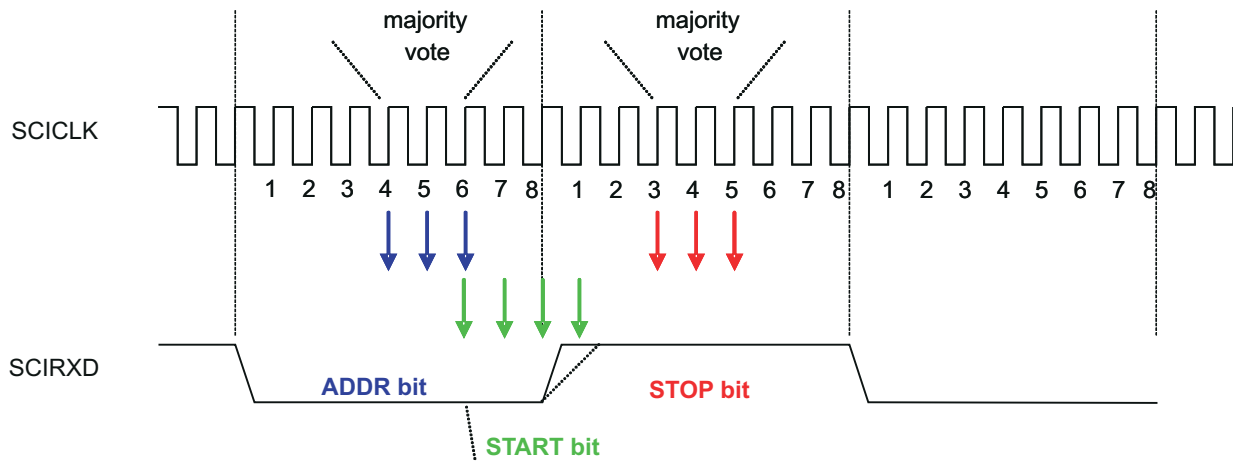
Figure 5-1. Difference Between Expected and Erroneous Operation of START Bit

Details SCI does not look for STOP bit after the ADDR bit. Instead, SCI starts looking for the start bit beginning on sub-sample 6 of the ADDR bit. Slow rise-time from ADDR to STOP bit can cause the false START bit to occur since the 4th sub-sample for the start bit may be sensed low.

Program the baud rate of the SCI to be slightly slower than the actual. This will cause the 4th sub-sample of the false START bit to be delayed in time, and therefore occur more towards the middle of the STOP bit (away from the signal transition region). The amount of baud slowing needed depends on the rise-time of the signal in the system. Alternatively, IDLE mode of the SCI module may be used, if applicable.

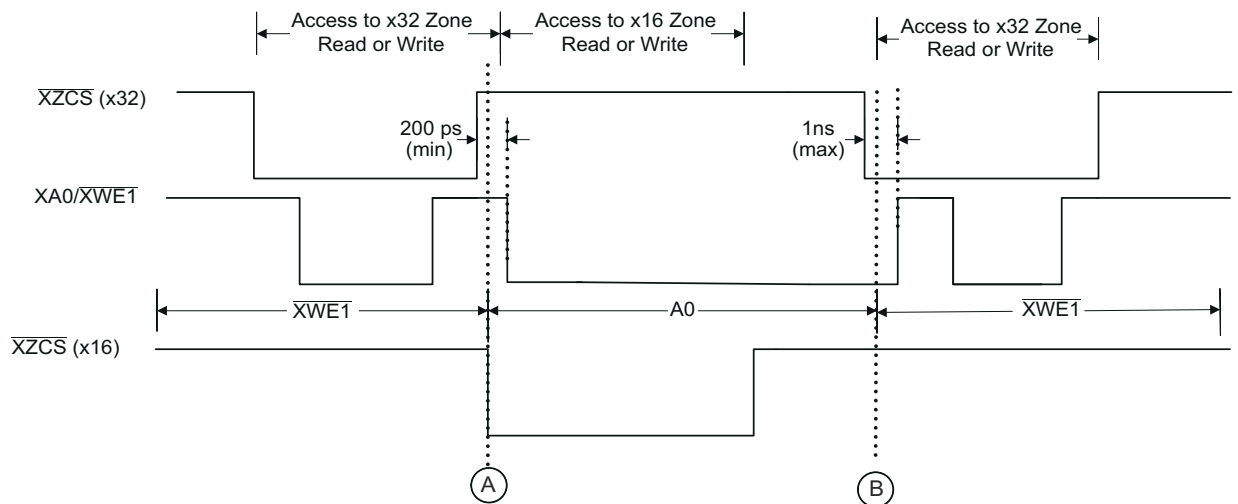
Figure 5-5. Behavior of Zone Chip Select Signals and XA0/ $\overline{XWE1}$

Figure 5-5 shows the behavior of zone chip select signals and XA0/ $\overline{XWE1}$ for back-to-back accesses between zones configured for different data bus widths.

- Design simulation data indicates the delta between \overline{XZCS} (x32) high and XA0/ $\overline{XWE1}$ low can be as small as 200 ps.
- Design simulation data indicates XA0/ $\overline{XWE1}$ can stay low for as long as 1 ns after \overline{XZCS} (x32) goes low.

When A0/ $\overline{XWE1}$ changes functionality, the x32 zone chip select signal (\overline{XZCS} x32) changes state. Depending on the board design and peripherals attached to the XINTF, it is possible that an external memory or peripheral on the x32 zone may respond to A0/ $\overline{XWE1}$ switching as a write access. If this happens, a rogue write to the x32 zone can occur.

- If all zones are configured for x16 operation, then no action is required.
- If all zones are configured for x32 operation, then XA0/ $\overline{XWE1}$ will switch from XA0 to $\overline{XWE1}$ on the first access. After the first access, the XA0/ $\overline{XWE1}$ pin will remain as $\overline{XWE1}$. To keep external devices from responding to the XA0/ $\overline{XWE1}$ change, follow these steps when configuring the XINTF module:

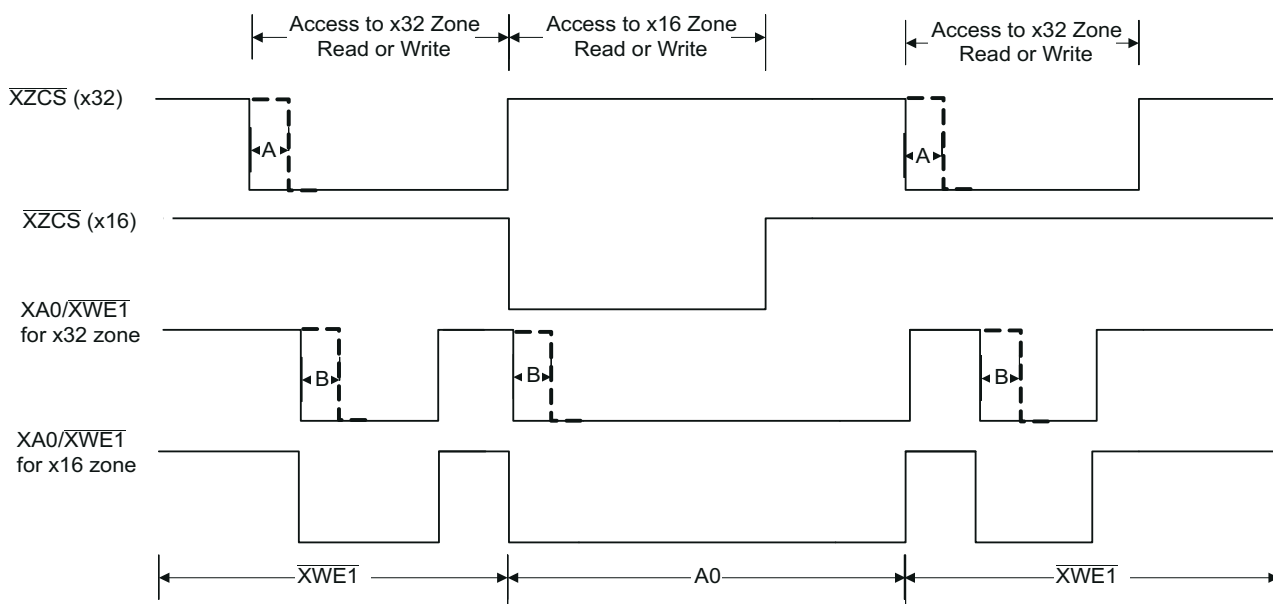
Figure 5-6. Behavior After Application of Delay

- A. Delayed falling edge of zone chip select for x32 zone.
- B. Delayed falling edge of $\overline{XWE1}$. The x16 zone will not see this delay.

The timing configuration of the x32 zone must account for the additional delay. The zone chip select delay may require additional lead time. The $\overline{XWE1}$ delay enable may require additional active write time. In addition, specify at least 1 trail cycle for writes to the x32 zone.
