AM1808 ARM Microprocessor Silicon Revisions 2.3, 2.1, 2.0, and 1.1

Silicon Errata

Literature Number: SPRZ313H
March 2010–Revised September 2014

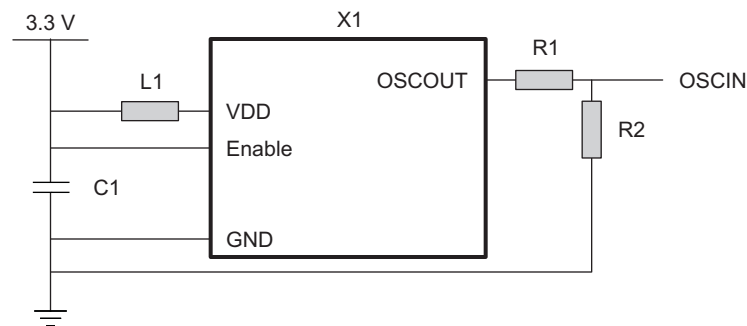
Figure 2. External 3.3V Clock Source

On all silicon revisions, certain design elements make this device susceptible to radiated noise during an ESD strike, as described in the standard IEC 61000-4-2. Exposure to the electrical noise caused by the ESD can cause soft device failures due to noise coupling on the system clock (OSCIN). ESD events within the IEC spec range do not cause permanent device damage and full functionality is recoverable with a device reset. The sensitivity to this noise issue is primarily due to the 1.2V oscillator/clock input implemented on this device. The low voltage range, coupled with slow rise and fall times, provides a lower noise margin than other TI devices with higher voltage internal oscillators (for example, 1.8V or 3.3V oscillators).

If ESD robustness is a concern, it is strongly recommended to avoid using the internal oscillator as a clock source. An external 3.3V clock source with a resistor voltage divider as in [Figure 2](#) can be used to externally generate the required 1.2V input clock. By using an external clock input with fast rise/fall times (less than 5 ns), the noise margin improves significantly, increasing ESD noise resistance.

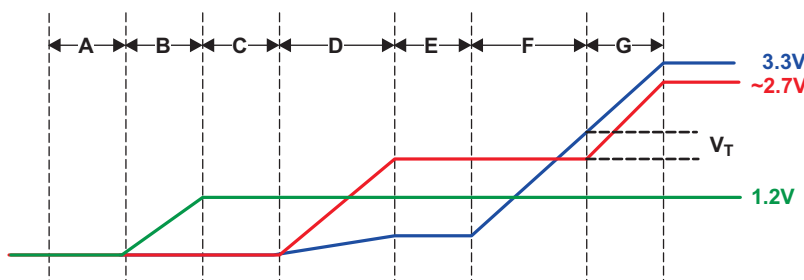
Figure 4. Faulty power-supply ramp

The behavior is the same until zone G. When the DVDD3318_x supply exceeds DVDD18 by a transistor V_T , the DVDD18 supply begins to be pulled up by the DVDD3318_x supply and follows the DVDD3318_x supply by $DVDD3318_x - V_T$. Since the DVDD18 supply is often connected to other 1.8V supplies in the design, these other supplies can be pulled up also.

The condition occurs because the dual-voltage IO buffers have voltage detection circuitry that monitors DVDD3318_x during reset and determines whether the applied supply voltage is 1.8V or 3.3V. This detection circuitry then configures the IOs to operate at the appropriate voltage. As the DVDD3318_x supply ramps, there is a small range near DVDD18 + V_T where the voltage detection circuit finds the state indeterminate and briefly turns on circuitry associated with both voltage options creating a current path between them. This current path can cause the DVDD18 supply to be pulled up. The mechanism for this behavior is explained below:

1. Design simulation has indicated that under the worst-case process/voltage/temperature conditions the maximum leakage current into the DVDD18 supply due to this phenomenon will be 140 mA (the 140 mA is a cumulative current generated by all of the dual-voltage IOs). So this error state can be prevented by ensuring that the load on the DVDD18 supply during the DVDD13318_x supply ramp exceeds 140 mA. This can be achieved by any combination of the following as long as they cumulatively produce >140 mA load on DVDD18 during the DVDD3318_x ramp period:

- (a) Maintain sufficient bulk capacitance on the DVDD18 supply such that the charging current for these capacitors provides all or part of the required >140 mA. Bulk capacitance in this context means the total capacitance seen by the DVDD18 supply (filter capacitors, bypass capacitors, etc.). Capacitor charging current is defined as $I = C \cdot (dV/dt)$. So the ramp rate of the DVDD3318_x supply and the total bulk capacitance on the DVDD18 supply can be used to calculate the current produced. This solution provides additional power supply filtering and little current leakage after the supplies are ramped (depending on the type of capacitors used).

2. Choose a regulator for the DVDD18 supply (or grouped 1.8V supplies) that is capable of actively regulating voltage up and down. Many high-efficiency switching regulators switch current into the load only when the voltage needs to be raised and rely on the load to pulldown the current. In this error condition, a regulator of this type will not be able to compensate for the leakage current described above. Synchronous buck regulators use external inductance to pulldown the regulated voltage when necessary.

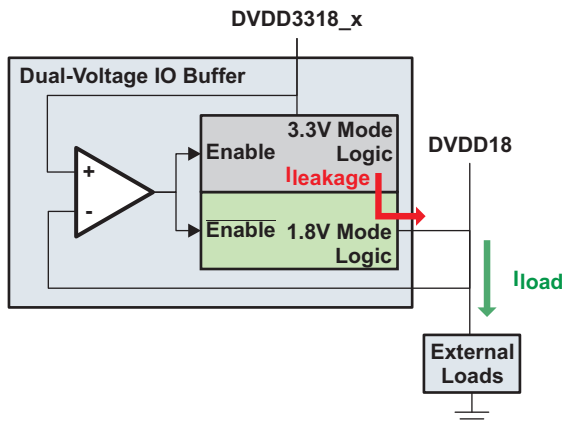
Figure 6. Error State of the IO buffer during Zone G

Error State of the IO buffer during Zone G:

As DVDD3318_x exceeds DVDD18+V_T, some of the circuitry across the boundary of the two voltage domains will turn on and causes a leakage current (in red) to flow between the two voltage domains. This current pulls up the DVDD18 supply unless the power source providing that supply can oppose it or unless the load current is strong enough to counteract it.

If DVDD18 continues to rise as DVDD3318_x ramps, the comparator never sees enough difference between the two supplies to switch to 3.3V mode.

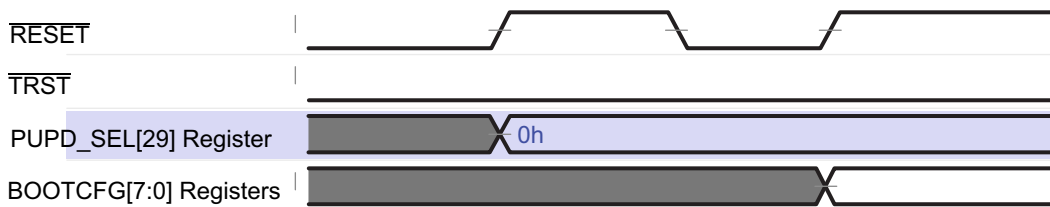
Initialization of PUPD_SEL[29] and BOOTCFG[7:0] Registers with Weak or No External Pull Resistors on BOOT[7:0] Pins

Internal pullups being enabled on the BOOT[7:0] pins may result in boot failures. If weak external pulldown resistors are used on the PCB to select the boot mode, they may not be able to overpower the internal pullups. This can result in the wrong boot mode being latched in the BOOTCFG[7:0] register when coming out of Reset.

Once the device is out of Reset, the PUPD_SEL[29] register is initialized, and the internal pulldown resistors for the BOOT[7:0] pins are all enabled. Issuing a second Power-On Reset (\overline{POR}) results in the intended boot mode being latched, since the pins are internally pulled down as expected.

[Initialization of PUPD_SEL\[29\] and BOOTCFG\[7:0\] Registers with Weak or No External Pull Resistors on BOOT\[7:0\] Pins](#) shows the behavior of the PUPD_SEL[29] register before and after reset. Assuming weak or no external pull resistors are on the BOOT[7:0] pins, the BOOTCFG register will latch the unknown values after the device initially comes out of Reset. Note that, \overline{TRST} *must* always be low in order to issue a \overline{POR} and latch the boot pin values -- the boot pins are not latched after a Warm Reset.

Section 4, *Device Operating Conditions*, of the device datasheet shows the electrical characteristics information which can be used to calculate the maximum external pull resistance required. The value is dependent on the DVDD3318_C I/O supply level.

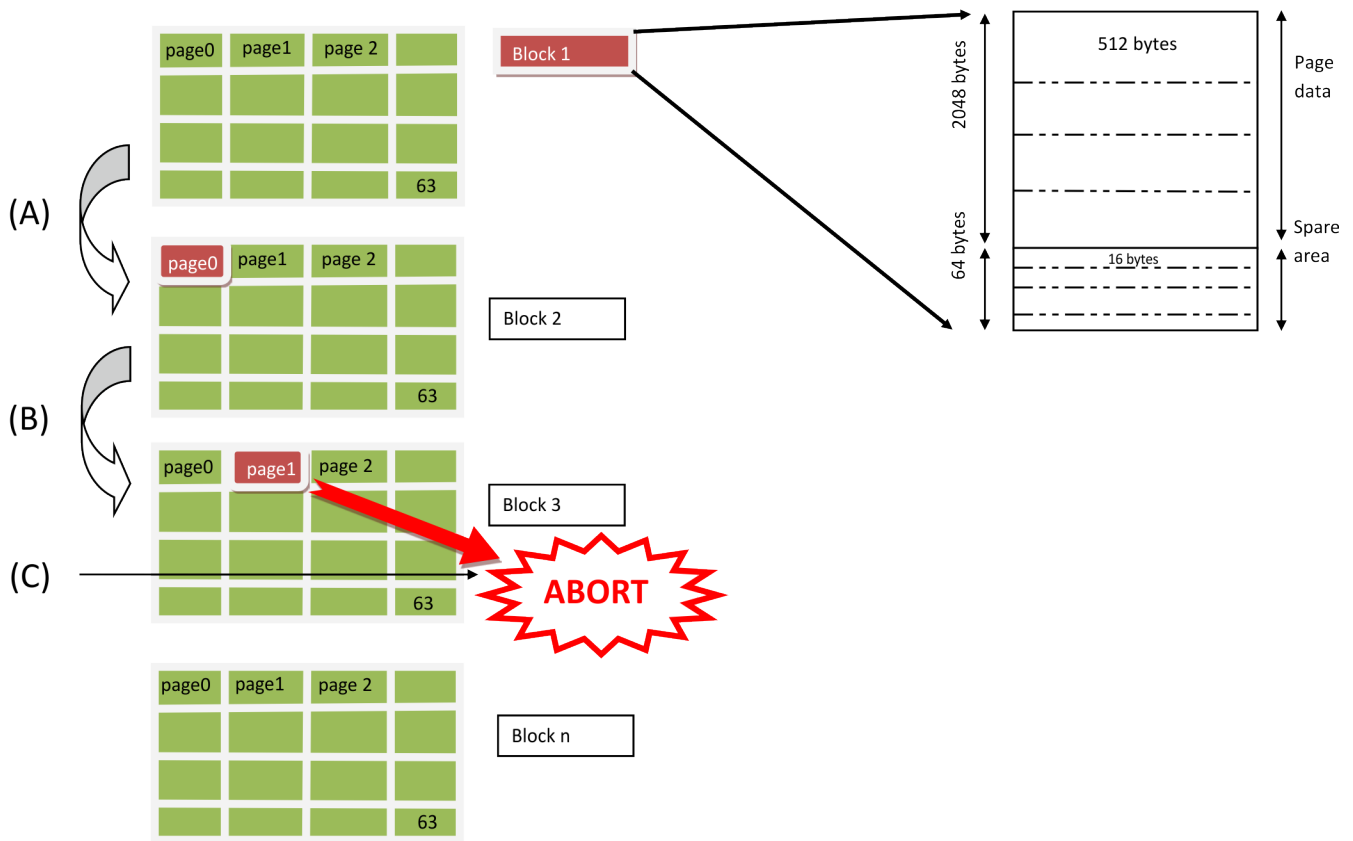
D800K008 ROM Behavior Before Application of Software Patch⁽¹⁾

However, over the life span of the NAND flash, ECC data stored in the spare area can develop errors due to bit flips. When the calculated syndrome indicates an error in the ECC data, the ECC Correct and Read functions of the RBL abort the read process even though, it is possible to correct up to 4 bit errors combined in user and ECC data. Consequently the device fails to boot.

If page0 of the good block has an ECC data error or an uncorrectable error (more than 4 bit errors combined), the RBL skips to the next block (shown as (B) in [D800K008 ROM Behavior Before Application of Software Patch^{\(1\)}](#)). This bad block check mechanism enables the device to check up to the first 32 blocks in the NAND flash for booting (the boot process will fail if all 32 blocks have uncorrectable or ECC data errors in page0). Note that the RBL does not abort on detecting an error in ECC data on page0.

Once the RBL finds a good block with a good page0, it continues to read subsequent pages in that block. If an uncorrectable or ECC error is detected in subsequent pages, the RBL will abort with a boot error (shown as (C) in [D800K008 ROM Behavior Before Application of Software Patch^{\(1\)}](#)). The workaround, described below, enables the boot process to continue for both types of errors (ECC data and uncorrectable errors).

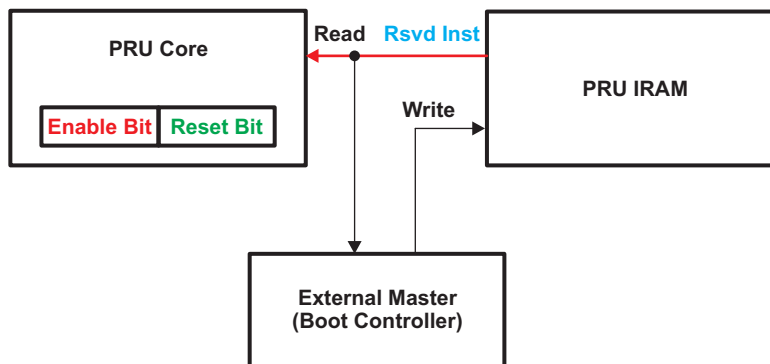
Figure 9. Boot Failure on Power-On

When the device is first powered-on, the read bus from the PRU IRAM is not initialized and will contain random values (see Figure 9). Under unpredictable circumstances, the random value on the read bus may resemble a reserved instruction which can be interpreted by the PRU when the core is reset and not enabled.

If the PRU core executes this reserved instruction, it will not be able to properly execute the first functional op-code in the PRU IRAM when the core is later enabled. In this fail state, the PRU will never acknowledge to the Boot Controller that the reset vector table was successfully initialized and the Boot Controller will be stuck in a polling loop waiting for the PRU to complete its task.

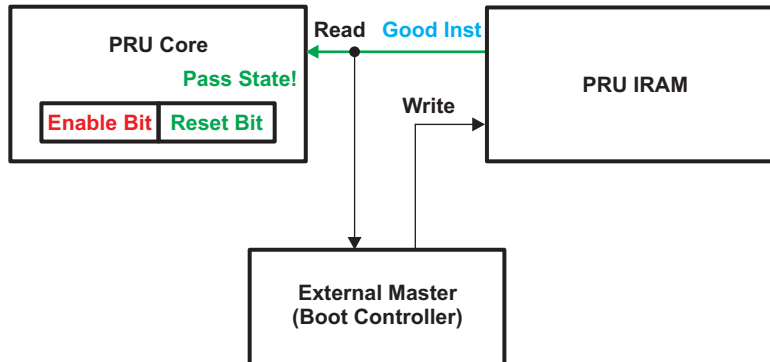
Figure 10. Secondary Reset

Although the PRU core execution is stuck, the PRU IRAM read bus is now initialized with a non-reserved instruction that was fetched from the IRAM by the PRU core (see Figure 10). If a secondary reset is provided to the device (either POR or WARM), the PRU will be able to execute its functional instructions as expected.

Note that in order to recover from this fail state with a secondary reset, the Boot Controller must be allowed to execute up to the point where the PRU has fetched a known instruction from the PRU IRAM. The approximate count of 15k clock cycles is sufficient.
