TMS320TCI6612

Communications Infrastructure KeyStone SOC

Silicon Revisions 1.0, 1.1, 1.3

Silicon Errata

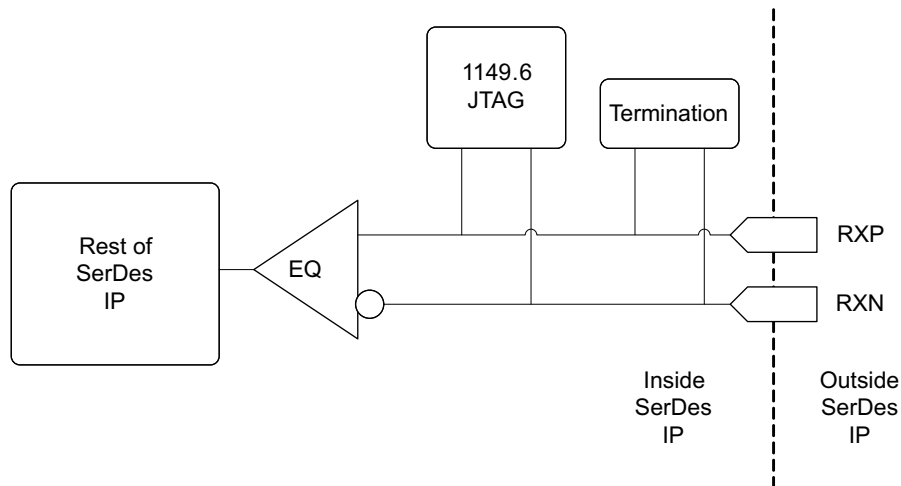
Figure 4. Simplified SerDes Receiver Block Diagram Depicting Relative Placement of Major Receiver Components

The SerDes receivers as shown in Figure 4 for AIF2, SRIO, PCIe, SGMII and Hyperlink are all designed to be AC coupled to their associated transmitters. For these AC-coupled SerDes receivers the IEEE 1149.6 scan-chain provides edge-sensitive sensing.

A problem has been identified in some cases where the AC-JTAG (IEEE 1149.6, edge-sensitive) input cells on Rincewind and Draco receivers do not reliably respond to input edge transitions from an associated transmitter. Because of this failure, the 1149.6 scan-chain users can receive faulty signal levels transitions or no transitions at all.

IEEE 1149.1, level-sensitive, input cells show no issue and normal operation of the SerDes receivers is also unaffected by this problem.

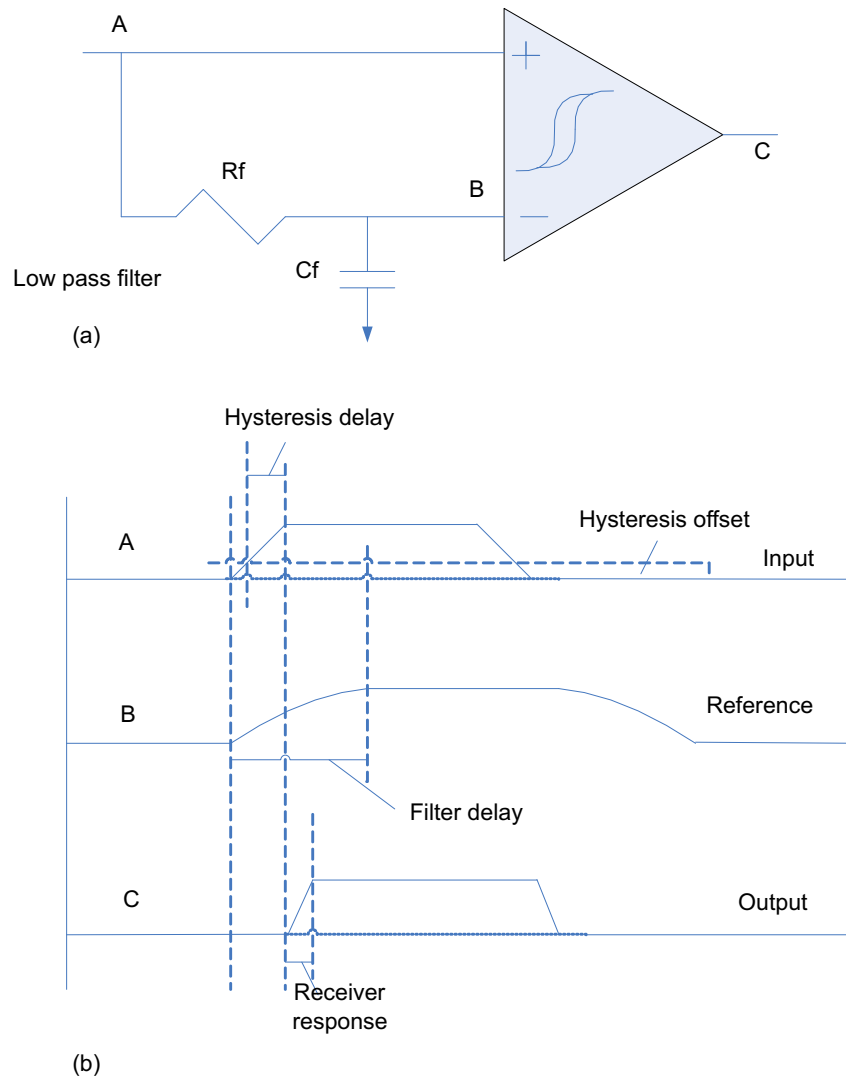
Figure 5. Self-referenced Comparator and Response (See Note Below)

The AC-JTAG input cell is based on a self-referenced, hysteretic comparator. See Figure 5. If the SerDes receiver pins are idle (no transitions are applied), the voltage of the pins will settle to the programmed, receiver common-mode voltage (0.80V nominally). From this idle state a single edge transition applied to the AC-JTAG input cell can push both terminals of the AC-JTAG comparator inputs past the VDDT (1.0V) supply voltage level.

When the comparator inputs are saturated the comparator gain is minimized and under certain PVT conditions (strong silicon, 125C junction temperature, minimum VDDT), the comparator can fail to switch to the proper state, or not respond at all.

One potential workaround has been identified. The failure mode of the AC-JTAG comparator is most pronounced by single edge transitions at low frequency as this creates the highest likelihood of the comparator inputs being saturated and switching incorrectly. More frequent transitions can result in proper switching of the comparator output.

The basic procedure is to initiate multiple edge transitions and then read the state of the RX input cell in question. However, due to the nature of the failure, the exact number would have to be determined experimentally for a given device.

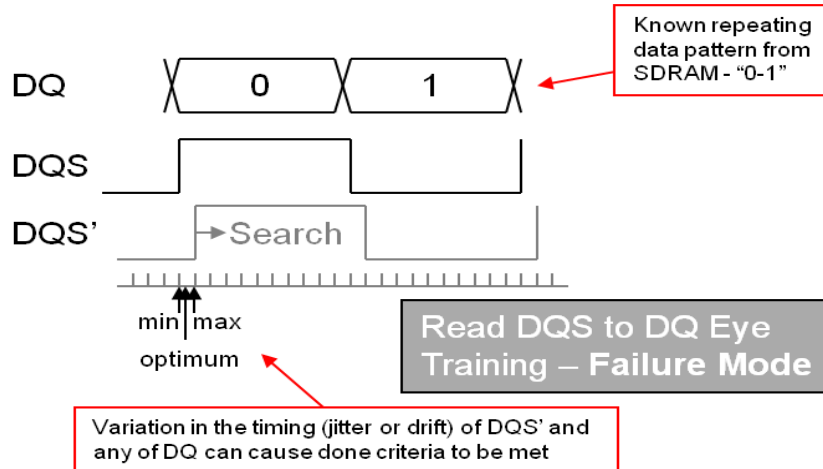
Figure 8. Read DQS to DQ Eye Training - Failure Mode

The leveling feature with the problem is the Read Data Eye Training. Depending on the jitter seen on the DQ and DQS signals, this leveling feature will fail to converge on a good data eye, resulting in corrupted DSP to DDR3 SDRAM reads.

However, if too much jitter is present on the DQ or DQS signals, the search can converge to a false edge as shown in Figure 8.

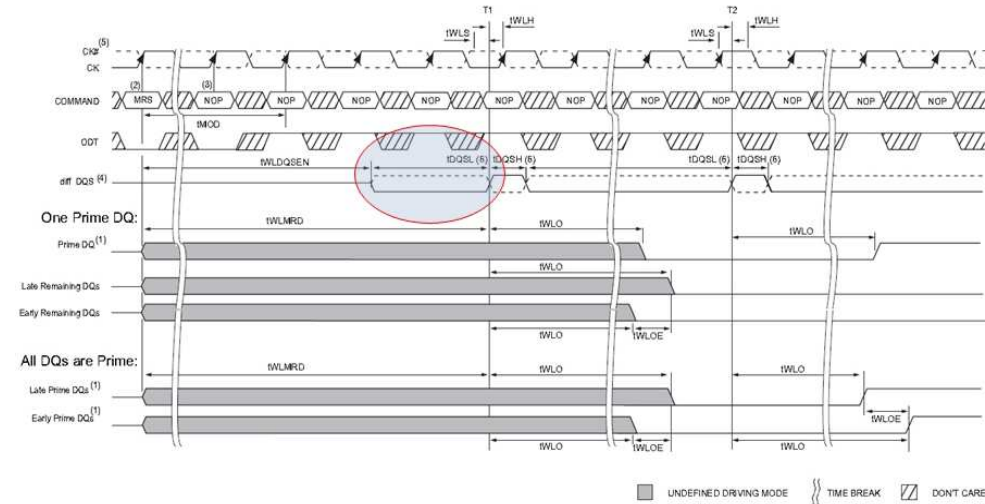
Figure 9. Timing Details of Writing Leveling Sequence

As shown in [Figure 9](#), the DDR3 JEDEC standard requires that the DQS strobe be sent with a preamble (DQS=0) for at least tDQSL during write leveling, prior to the first rising edge of the DQS strobe (DQS=1). It was observed in simulations that the first DQS strobe is sent immediately following the high impedance state of the DQS line and without a preamble. This Z->1 transition on the DQS line may allow incremental write leveling to fail. Note that this issue impacts only the incremental write leveling feature of the DDR3 Memory controller. No issue is expected with automatic write leveling.

At this time, incremental write leveling is not supported on this device and we recommend that the incremental write leveling intervals in RDWR_LVL_CTRL and RDWR_LVL_RMP_CTRL be programmed to 0 to disable this feature.

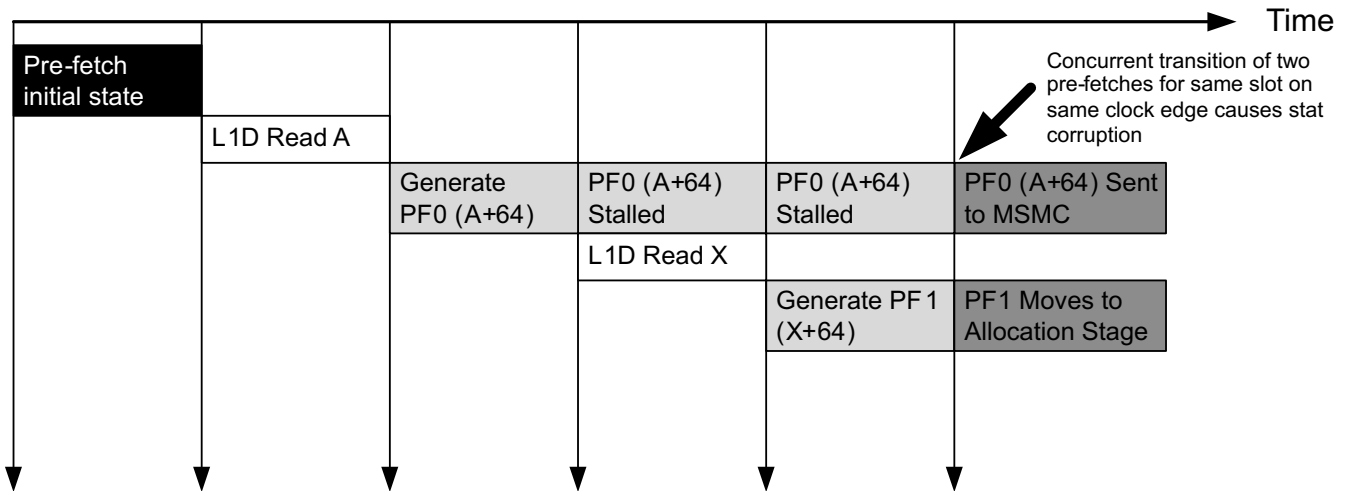
Figure 11. Sequence diagram

7. PF0 transitions to the XMC output (to MSMC) on the exact same clock edge that PF1 is transitioning to the buffer allocation pipeline stage

8. Instead of PF0 being marked stale and thrown away when returned, both PF0 and PF1 are marked valid and outstanding.
9. This leads to two valid outstanding pre-fetches for the same data buffer slot which is an invalid state and can result in unexpected behavior for a subsequent pre-fetchable data access to address X+64.
