DRA72x (SR 2.0, 1.0) and DRA71x (SR 2.1, 2.0) SoC for Automotive Infotainment

This document describes the known exceptions to the functional specifications for the device.

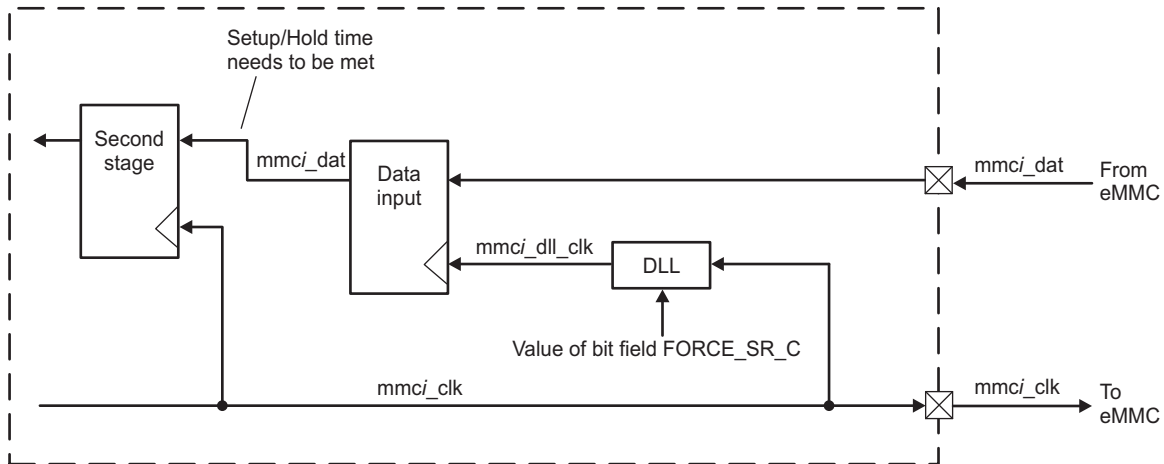
Figure 1. Simplified SoC 192-MHz Mode DLL Block Diagram

DESCRIPTION Internal to the MMC module, a second stage latch is used to recapture data captured by DLL delayed clock, *mmci_dll_clk*. The second stage latch captures with the original transmitting clock, *mmci_clk*.

mmci_dll_clk and *mmci_clk* both run at the same clock frequency. This results in a narrow range of tuning ratio elements, where the delayed *mmci_dll_clk* comes in phase with *mmci_clk*. If the clocks are in phase, the data captured by the first clock violates the setup and hold time requirements needed for the second stage latch, resulting in incorrectly read data. This is known as tuning re-timing errors.

For systems in which MMC DLL tuning algorithm* chooses a ratio less than 40, which is sufficiently far from the lowest re-timing error ratio element, no workaround is necessary.

WORKAROUND A DLL tuning algorithm has been implemented that can avoid the tuning re-timing errors. More details on this can be found in App Note [SPRACA9](#). The following notes summarize the updated algorithm:

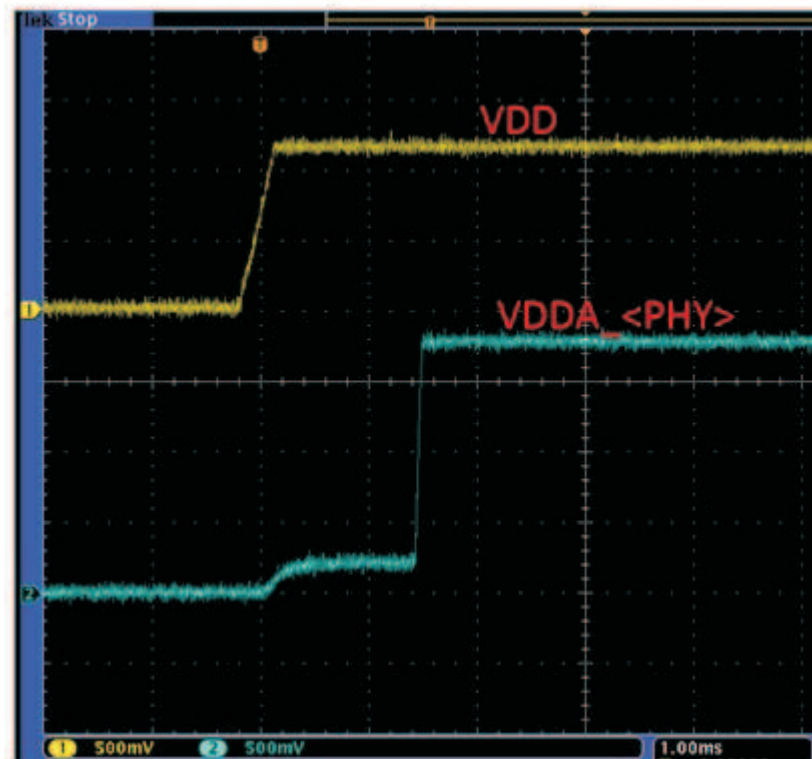
Figure 3. Leakage Voltage

The device-specific Data Manual requires Core AVS rail (VDD) to power up before the 1.8 V high speed analog PHY domain(s). When this sequence is followed, the high speed analog PHY domain will have a small step-up to a voltage plateau (< 0.5 V) that aligns to the beginning of the VDD ramp-up, and is maintained until the ramp-up of high speed analog PHY rail, as shown in [Figure 1](#). Note the leakage value will differ from system to system, but will be less than 500 mV. The leakage voltage in the provided capture is approximately 250 mV.

The reverse is true on the power down sequence. The high speed analog PHY domain(s) are required to be powered down prior to Core AVS rail (VDD), and such sequence may cause a small plateau to exist during the period.

The root cause of the plateau is related to the parasitic diodes in logic blocks which have multiple power sources. This leakage path is not a reliability concern for this device.
