***TDA2Ex SoC for Advanced Driver Assistance Systems
(ADAS)
23mm (ABC) Package (SR2.0, SR1.0)
17mm (CBD) Package (SR2.1, SR2.0)***

1 Introduction

This document describes the known exceptions to the functional specifications for the device.

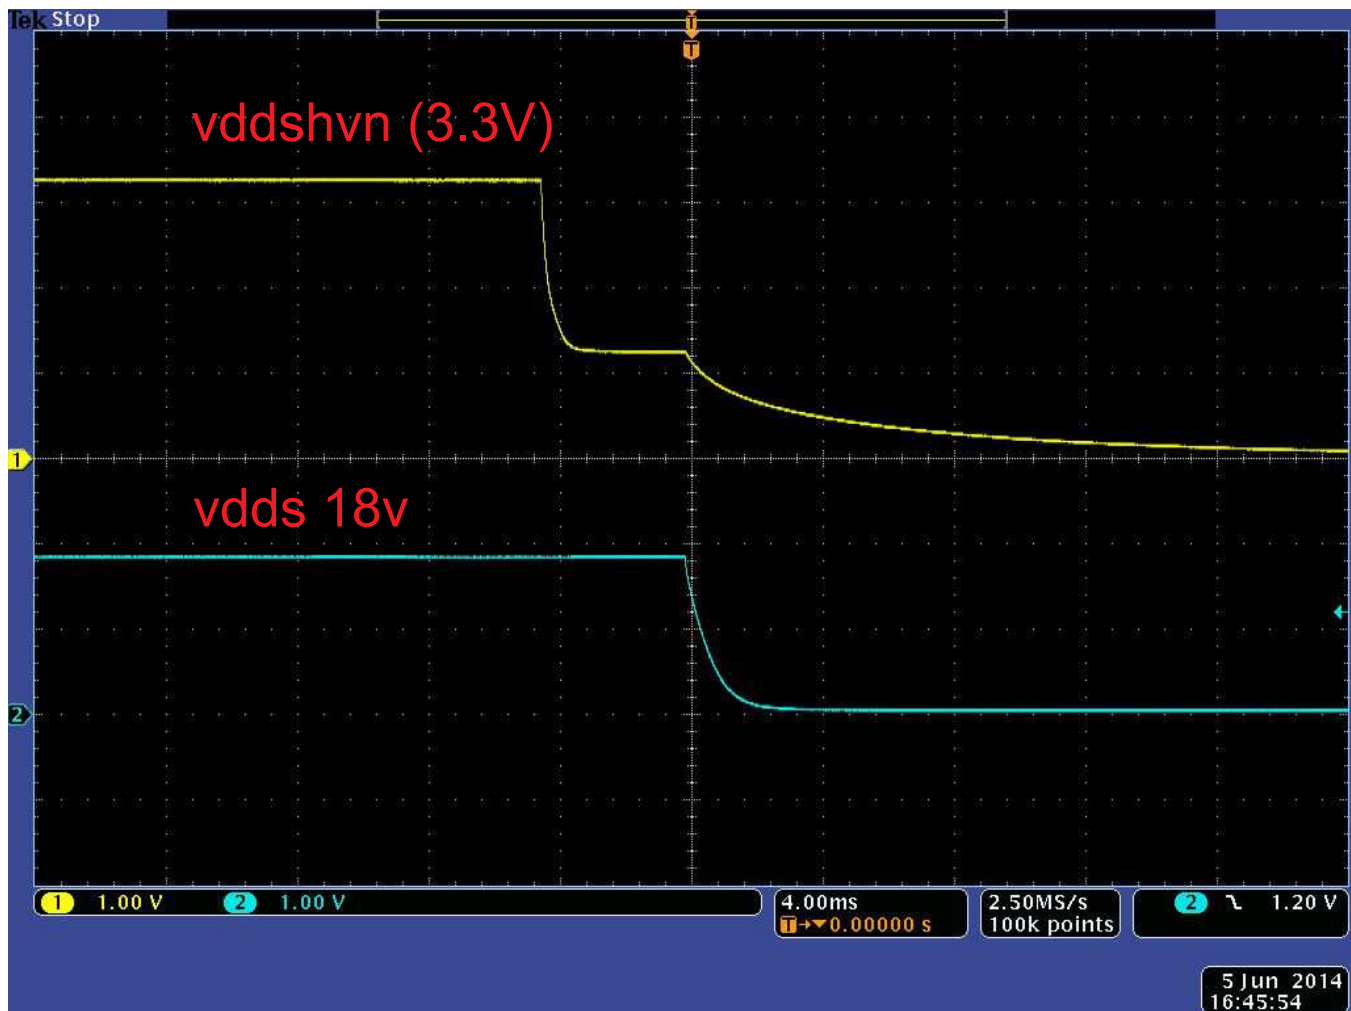
Figure 2. PAB_RevA

A subset of the SOC's LVC MOS IOs (refer to DM for details) have a pull-up resistor that is active by default, including during reset and power-down. The SOC's IOs that have internal or external pull-ups will stay at Plateau Level (<1.5V) during the power-down. If other ICs on the board that are interfaced to the SOC's LVC MOS signals use a separate supply then it's possible that the other IC's signals can be pulled to the Plateau Level while its power supply is off.

The root cause of the plateau is related to the LVC MOS IO buffer Dual Voltage detection circuitry. The LVC MOS Dual Voltage IO includes voltage comparator circuitry to determine if the IO is in 3.3V mode or 1.8V mode. During powerdown of vddshvn domains, a current path in the internal bias transistors results in the vddshvn rail being held to an intermediate voltage level (<1.5 V). This path can consume at most 500 uA per IO - worst case estimate is ~150 mA (based on 280 IOs) from the vdds18v supply

during power down. This path is not a reliability concern for the device.

In general, TI recommends using the same supply source for connected components. E.g., a single LDO should drive vddshvn and the related 3.3V external components.

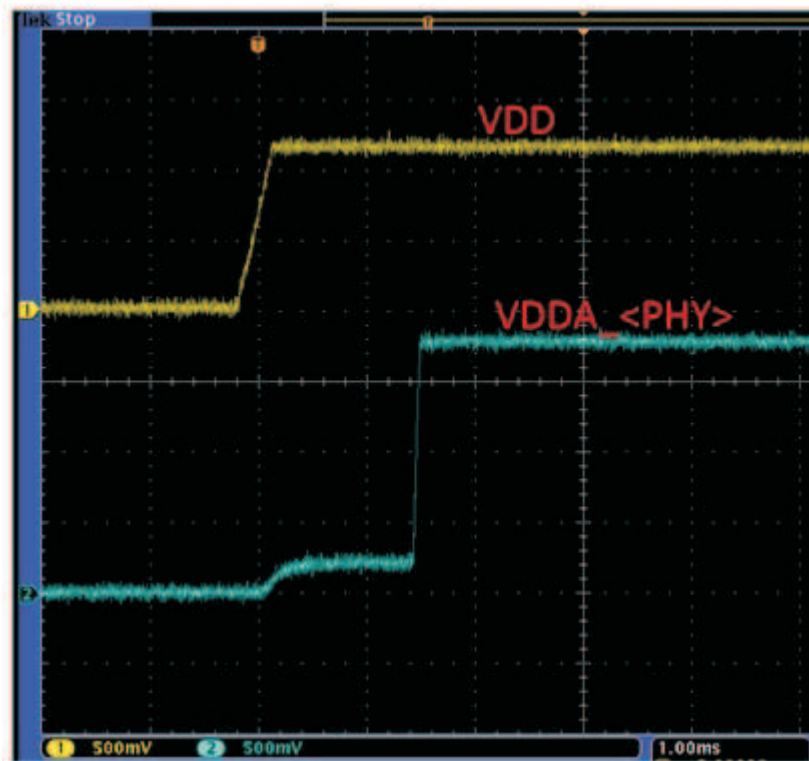
Figure 3. Leakage Voltage

The device-specific Data Manual requires Core AVS rail (VDD) to power up before the 1.8 V high speed analog PHY domain(s). When this sequence is followed, the high speed analog PHY domain will have a small step-up to a voltage plateau (< 0.5 V) that aligns to the beginning of the VDD ramp-up, and is maintained until the ramp-up of high speed analog PHY rail, as shown in [Figure 1](#). Note the leakage value will differ from system to system, but will be less than 500 mV. The leakage voltage in the provided capture is approximately 250 mV.

The reverse is true on the power down sequence. The high speed analog PHY domain(s) are required to be powered down prior to Core AVS rail (VDD), and such sequence may cause a small plateau to exist during the period.

The root cause of the plateau is related to the parasitic diodes in logic blocks which have multiple power sources. This leakage path is not a reliability concern for this device.

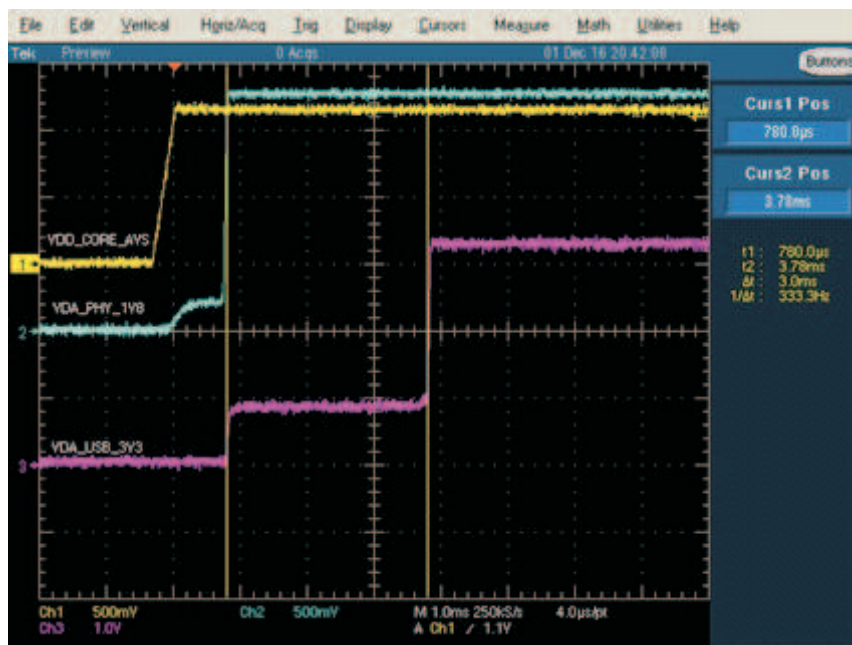
Figure 4. Original Power-Up Sequence

DESCRIPTION An unintended leakage current path between VDDA_PCIE (1.8 V) and VDDA33V_USB1 (3.3 V) due to ESD protection diode connection across the signal to I/O supply pads exists. This path can allow current to flow from VDDA_PCIE to VDDA33V_USB1. The current flows whenever the voltage level on VDDA_PCIE exceeds VDDA33V_USB by more than a diode drop during certain power-up and power-down sequences.

This leakage current causes the un-energized VDDA33V_USB1 to rise to a ~1 V plateau (see Figure 4) due to the power resource’s “off impedance” seen between the VDDA33V_USB1 power rail to ground. When the minimum “off impedance” is $\geq 100 \Omega$, the SoC leakage current is small and sustainable with no SoC reliability impacts.

Note: Figure 4 shows in VDA_PHY_1V8 rail a plateau approximately 250 mV documented in i931, VDD to VDDA_"PHY" Current Path.

GUIDELINES TI recommended Power Delivery Networks (PDNs) could have multiple different PMIC LDO power resources connected to the VDDA33V_USB1 rail. The LP8733/32 PMICs have a minimum OFF resistance equal to 150Ω so a PDN using these PMICs would not exceed safe leakage current level and could continue to use the original SoC power sequences. However, the TPS65917/919 PMICs have a minimum OFF resistance equal to 30Ω and would exceed the safe leakage current limit. As a result, any PDN using TPS65917/919 PMICs must implement the revised power sequencing as shown in DM version D or later. The specific sequence changes are:
