AM65x/DRA80xM Processors **Silicon Revision 2.0, 1.0**

This document describes the known exceptions to the functional specifications (advisories). This document may also contain usage notes. Usage notes describe situations where the device's behavior may not match presumed or documented behavior. This may include behaviors that affect device performance or functional correctness.

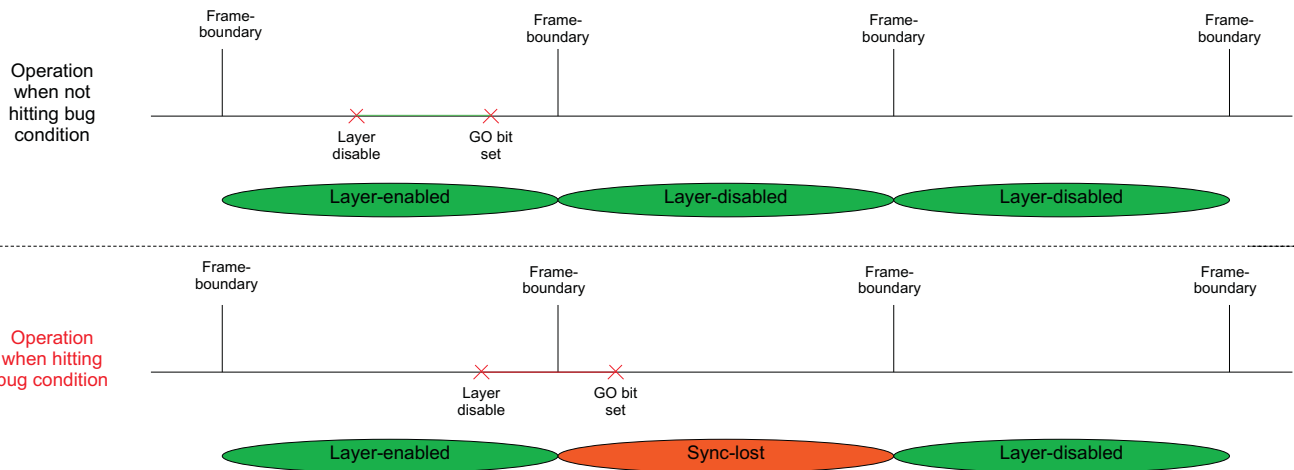
Figure 2. Bug Condition

Details: Disabling a layer (for example VID1) connected to an OVR (that is toggling DSS_VID_ATTRIBUTESx[0] ENABLE from 1 to 0) may result in synclost during the next frame. The synclost may result in a corrupted or blank frame (all pixel data sent out of DSS during the frame is 0x0). The occurrence of synclost is dependent on the timing of setting the GO bit (that is DSS_VP_CONTROL[5] GOBIT to 1) vis-à-vis the disabling of the layer. If the “disable layer” MMR write operation and “set GO bit” MMR write operation happens within the same frame boundary, no synclost occurs. If the operations happen across the frame boundary, then synclost occurs (for one frame). The design automatically recovers and returns to normal operation from the next frame after GO bit is set, see [Figure 2](#).

Workaround(s): A simple software workaround exists. In the workaround, prior to disabling a layer on the OVR, it is moved to the “non-visible” area of the OVR (for example: DSS_OVR_ATTRIBUTES_x[17-6] POSX = max_value_of_posx or DSS_OVR_ATTRIBUTES_x[30-19] POSY = max_value_of_posy). This avoids the

A sample software workaround pseudo-code is shown on [Figure 3](#). In this case, the regular “disable layer” MMR write operation and “set GO bit set” MMR write operation are replaced with macros which implement the software workaround.
