Errata

AM64x/AM243x Processor Silicon Revision 1.0, 2.0

This document describes the known exceptions to the functional specifications (advisories). This document may also contain usage notes. Usage notes describe situations where the device's behavior may not match presumed or documented behavior. This may include behaviors that affect device performance or functional correctness.

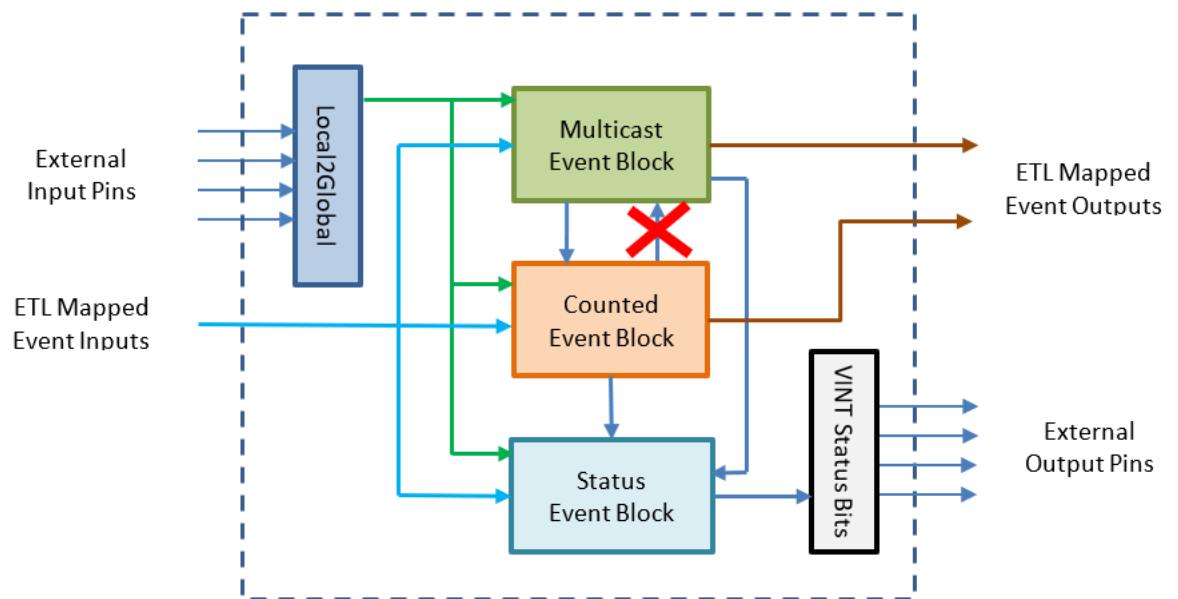
Figure 2-1. Interrupt Aggregator Version 1.0

An issue was found after design that could cause the IA to deadlock. The issue occurs when event “loops” occur between these three processing blocks. It is possible to create a situation where a processing block can not output an event because the path is blocked, and since it can not output an event, it can not take any new input events. This inability to take input events prevents the output path from being able to unwind, and thus both paths remain blocked.

Workaround(s): Figure 2-1 shows the conceptual block diagram of IA 1.0. Potential loops are avoided by adopting the policy of not allowing the counted event block to send events to the multicast block. This method was chosen because it is more common to split an event first, and then count one while sending the other elsewhere. With this path blocked by convention, it is not possible for a single event to visit any block more than once and thus not possible for paths to become blocked so long as the outputs remain unblocked.

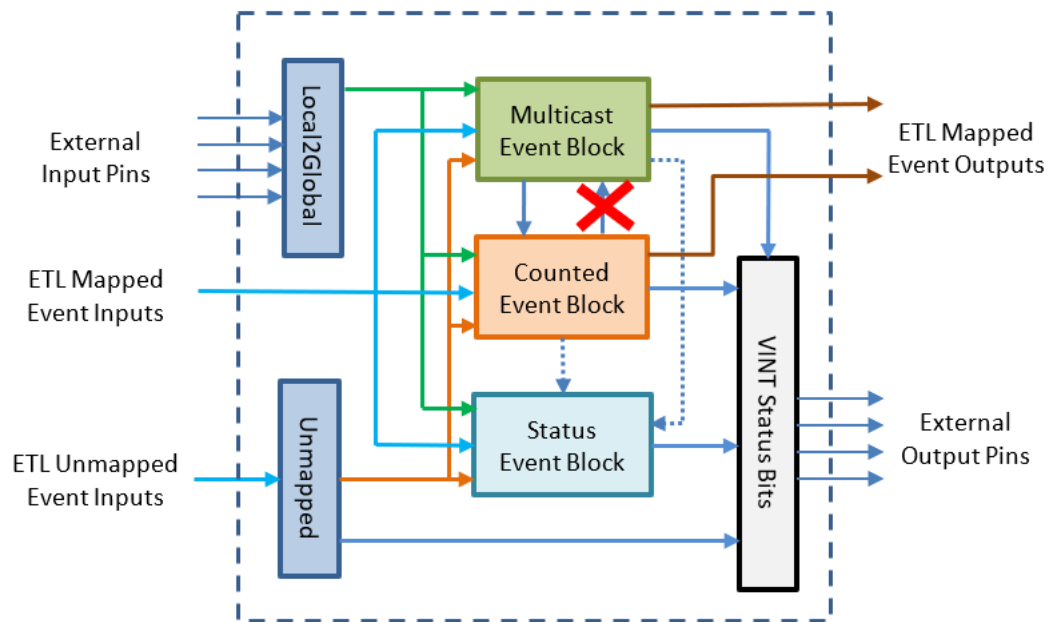
Figure 2-2. Interrupt Aggregator Version 1.1

Figure 2-2 shows the diagram of IA 1.1. Note that the same policy applies to avoid deadlock. In addition, the paths shown as dotted lines (sending ETL events from the multicast or counted blocks to the status event block) is now discouraged. These paths still function as before for backward compatibility, but are rendered obsolete as all blocks are now able to directly set status event bits.

By following the conventions outlined here, the system is safe from looping hazards that can create a deadlock scenario.
