TMS320F2838x Real-Time MCUs Silicon Errata

Silicon Revisions A, 0

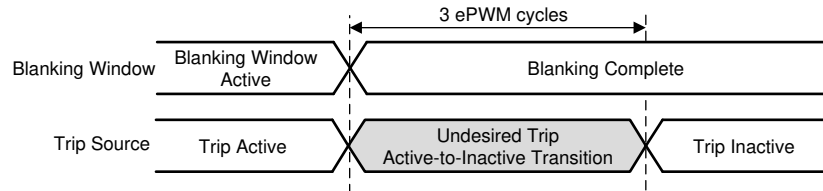
Figure 3-1. Undesired Trip Event and Blanking Window Expiration

Details The blanking window is typically used to mask any PWM trip events during transitions which would be false trips to the system. If an ePWM trip event remains active for less than three ePWM clocks after the end of the blanking window cycles, there can be an undesired glitch at the ePWM output.

Figure 3-1 illustrates the time period which could result in an undesired ePWM output.

Workaround(s) Extend or reduce the blanking window to avoid any undesired trip action.
