# TMS320F28003x Real-Time MCUs Silicon Errata

## Silicon Revision 0

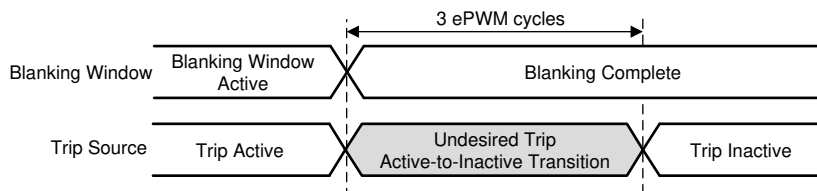
**Figure 3-1. Undesired Trip Event and Blanking Window Expiration**

**Details** The blanking window is typically used to mask any PWM trip events during transitions which would be false trips to the system. If an ePWM trip event remains active for less than three ePWM clocks after the end of the blanking window cycles, there can be an undesired glitch at the ePWM output.

Figure 3-1 illustrates the time period which could result in an undesired ePWM output.

**Workaround** Extend or reduce the blanking window to avoid any undesired trip action.
