# TMS320F280013x Real-Time MCUs Silicon Errata

## Silicon Revisions C, B, A, 0

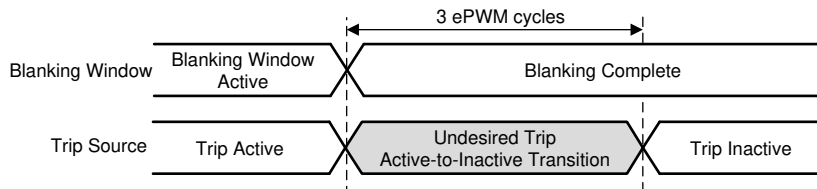
**Figure 3-1. Undesired Trip Event and Blanking Window Expiration**

**Details** The blanking window is typically used to mask any PWM trip events during transitions which would be false trips to the system. If an ePWM trip event remains active for less than three ePWM clocks after the end of the blanking window cycles, there can be an undesired glitch at the ePWM output.

Figure 3-1 illustrates the time period which could result in an undesired ePWM output.

**Workaround** Extend or reduce the blanking window to avoid any undesired trip action.
