Errata

J784S4, TDA4AP, TDA4VP, TDA4AH, TDA4VH, AM69A Processors Silicon Revision 1.0

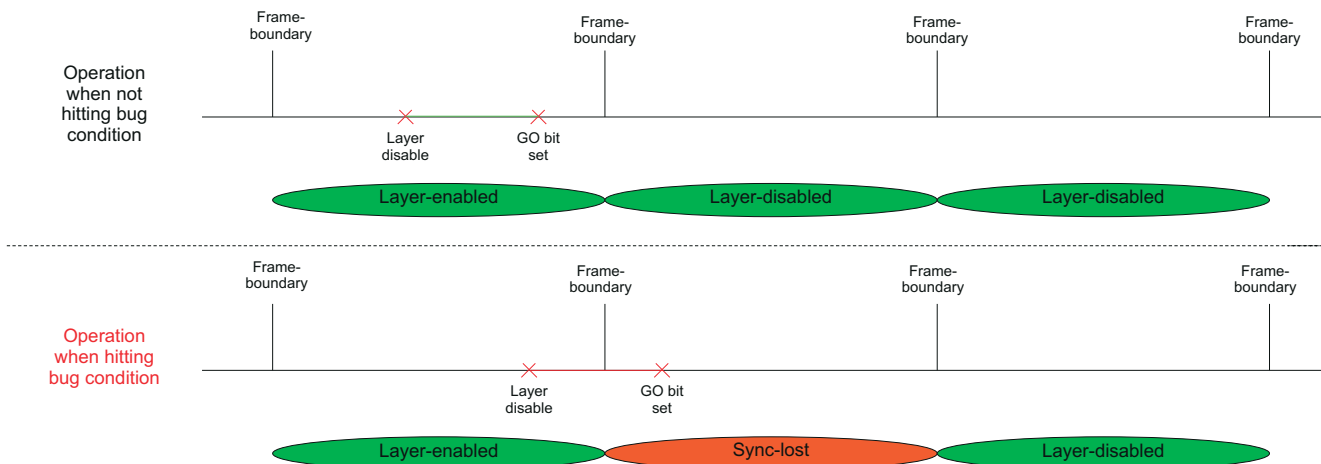
Figure 3-1. Bug Condition

i2097 DSS: Disabling a Layer Connected to Overlay May Result in Synclost During the Next Frame

Details: Disabling a layer (for example VID1) connected to an OVR (that is toggling DSS_VID_ATTRIBUTESx[0] ENABLE from 1 to 0) may result in synclost during the next frame. The synclost may result in a corrupted or blank frame (all pixel data sent out of DSS during the frame is 0x0). The occurrence of synclost is dependent on the timing of setting the GO bit (that is DSS_VP_CONTROL[5] GOBIT to 1) vis-à-vis the disabling of the layer. If the “disable layer” MMR write operation and “set GO bit” MMR write operation happens within the same frame boundary, no synclost occurs. If the operations happen across the frame boundary, then synclost occurs (for one frame). The design automatically recovers and returns to normal operation from the next frame after GO bit is set, see [Figure 3-1](#).

Workaround(s): A simple software workaround exists. In the workaround, prior to disabling a layer on the OVR, it is moved to the “non-visible” area of the OVR (for example: DSS_OVR_ATTRIBUTES_x[17-6] POSX = max_value_of_posx or DSS_OVR_ATTRIBUTES_x[30-19] POSY = max_value_of_posy). This avoids the synclost when the layer is disabled.
