AM273x Sitara Microcontrollers Silicon Revision 1.0 and 1.1

ABSTRACT

This document describes the known exceptions to the functional specifications (advisories) of the AM273x microcontroller. This document may also contain usage notes. Usage notes describe situations where the device's behavior may not match presumed or documented behavior. This may include behaviors that affect device performance or functional correctness.

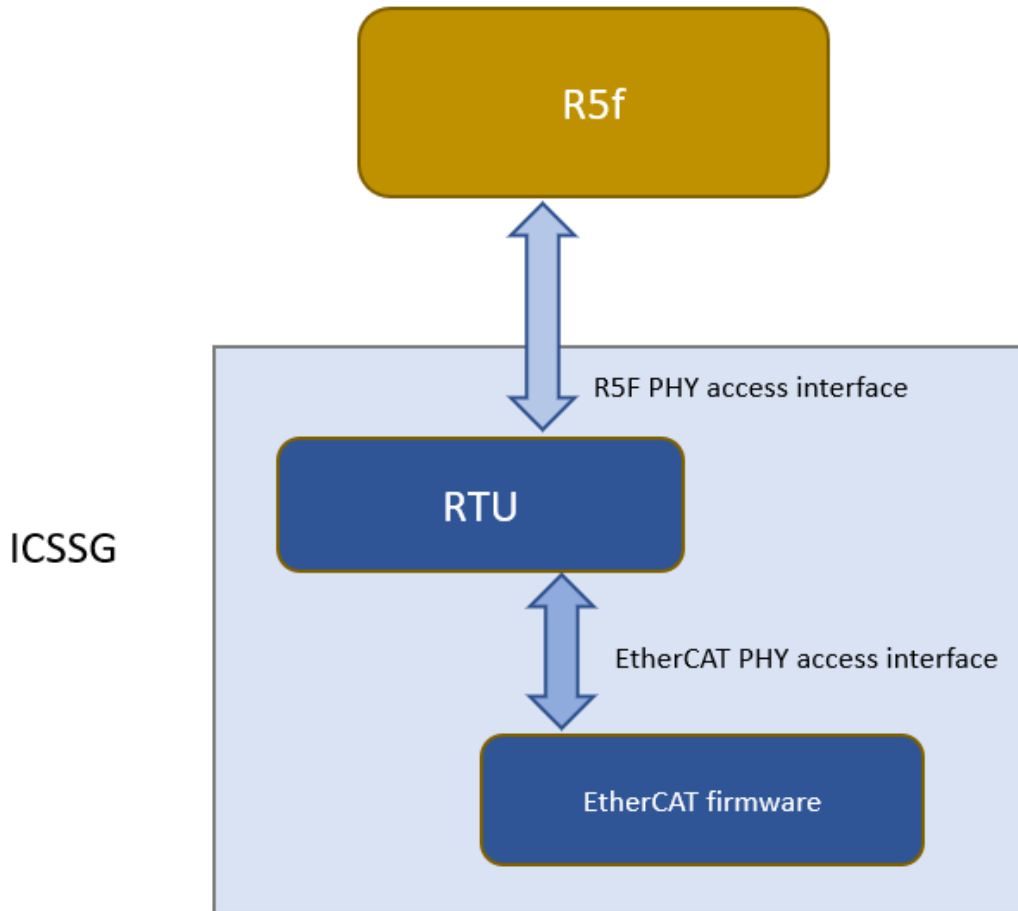
Figure 2-1. MDIO Emulation via Manual Mode using PRU Core

i2329 ***MDIO: MDIO interface corruption (CPSW and PRU-ICSS)***

Details: It is possible that the MDIO interface of all instances of CPSW and PRU-ICSS peripherals (if present) returns corrupt read data on MDIO reads (e.g. returning stale or previous data), or sends incorrect data on MDIO writes. It is also possible that the MDIO interface becomes unavailable until the next peripheral reset (either by LPSC reset or global device reset with reset isolation disabled in case of CPSW).

Possible system level manifestations of this issue could be (1) erroneous ethernet PHY link down status (2) inability to properly configure an ethernet PHY over MDIO (3) incorrect PHY detection (e.g. wrong address) (4) read or write timeouts when attempting to configure PHY over MDIO.

Workaround(s): On affected devices, following workaround should be used:

MDIO manual mode: applicable for PRU-ICSS and for CPSW.

MDIO protocol can be emulated by reading and writing to the appropriate bits within the MDIO_MANUAL_IF_REG register of the MDIO peripheral to directly manipulate the MDIO clock and data pins. Refer to TRM for full details of manual mode register bits and their function.

In this case the device pin multiplexing should be configured to allow the IO to be controlled by the CPSW or PRU-ICSS peripherals (same as in normal intended operation), but the MDIO state machine must be disabled by ensuring MDIO_CONTROL_REG.ENABLE bit is 0 in the MDIO_CONTROL_REG and enable manual mode by setting MDIO_POLL_REG.MANUALMODE bit to 1.

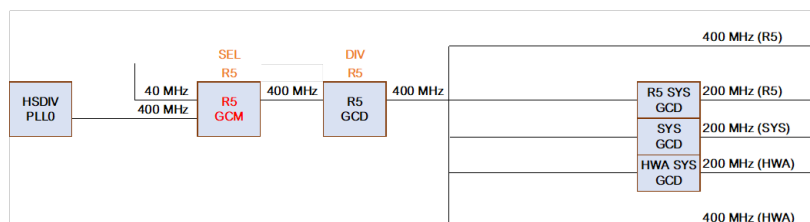
Figure 2-2. PLL

i2387 *PLL: GCM circuit glitch during clock source switch*
Details:

GCM circuit [highlighted] is susceptible to glitch when switching the clock source from Crystal to the PLL Clock, causing the phase misalignment between SYS clocks resulting in random behaviors like aborts or hangs or access failures. Reference below for HSDIV0 feeding clock to R5F and SYS Clocks.

Workaround(s):
