TMS320DM6467
Digital Media System-on-Chip (DMSoC)
Silicon Revisions 3.0, 1.1, and 1.0

Silicon Errata

Literature Number: SPRZ251G
September 2007–Revised October 2010

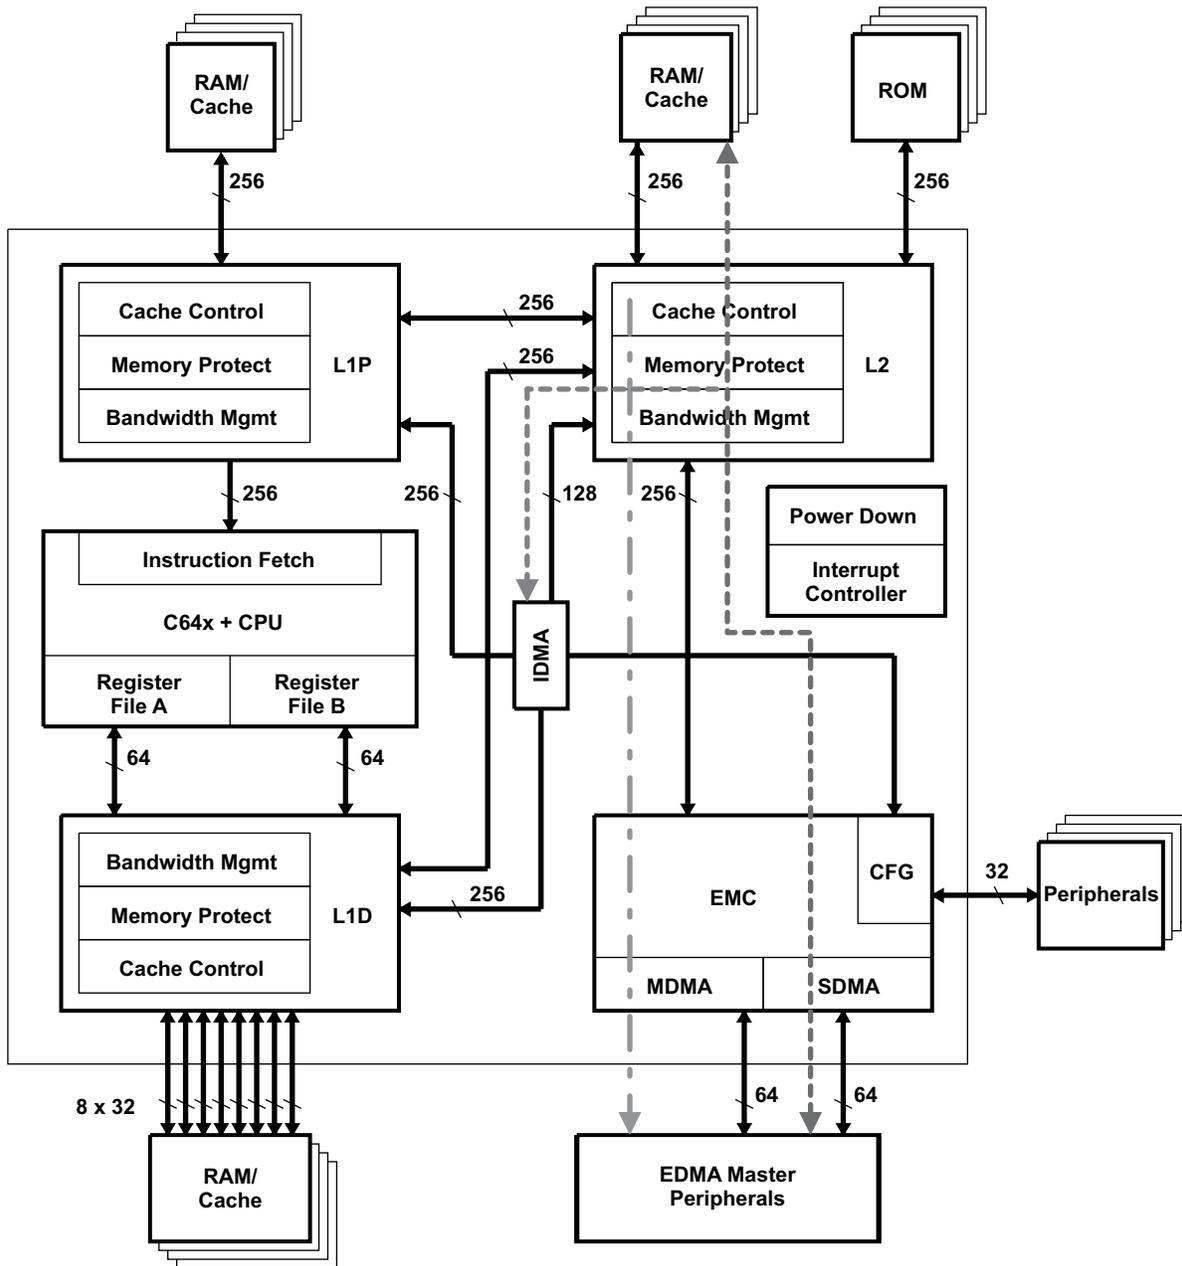
Figure 2. IDMA, SDMA, MDMA Paths

Ideally, the MDMA (dashed-dotted line in [Figure 2](#)) and SDMA/IDMA paths (dashed lines in [Figure 2](#)) operate independently with minimal interference. Normally MDMA accesses may stall for extended periods of time due to expected system level delays (e.g., bandwidth limitations, DDR2 memory refreshes). However, when using L2 as RAM, SDMA and IDMA accesses to L2/L1/HDVICP RAM/Buffers (through DSP SDMA port) may experience unexpected stalling in addition to the normal stalls seen by the MDMA interface. For latency-sensitive traffic, the SDMA stall can result in missing real-time deadlines. In a more severe case, the SDMA stall can produce a deadlock condition in the SoC. An IDMA stall cannot produce a deadlock condition.

2. Various combinations of L1 and L2 cache activity:
 - (a) L1D read miss generating victim traffic to L2 (Cache or SRAM) or external memory. The SDMA/IDMA may be stalled while servicing the read miss and the victim. If the read miss also misses L2 cache, the SDMA/IDMA may be stalled until data is fetched from external memory to service the read miss. If the read access is to non-cacheable memory there will still potentially be an L1D victim generated even though the read data will not replace the line in the L1D cache.

- (b) L1D read request missing L2 (going external) while another L1D request is pending. The SDMA/IDMA may be stalled until the external memory access is complete.

Use the following procedure to determine if SDMA/IDMA stalling is the cause of real-time deadline misses for existing applications. Situations where real-time deadlines may be missed include loss of McASP samples and low peripheral throughput.

1. Determine if the transfer missing the real-time deadline is accessing L2, HDVICP0/1 RAM/Buffers through DSP SDMA port or L1D memory. If not, then SDMA/IDMA stalling is **not** the source of the real-time deadline miss.

- (c) If 'a.' and 'b.' are not possible, move the transfer with the real-time deadline to EMAC CPPI RAM. If the EMAC CPPI RAM is not big enough, a two-step mechanism can be used to page a small working buffer defined in EMAC CPPI RAM into a bigger buffer in L2 SRAM. The EDMA module can be setup to automate this double buffering scheme without CPU intervention for moving data from EMAC CPPI RAM. Some throughput degradation is expected when the buffers are moved to EMAC CPPI RAM.

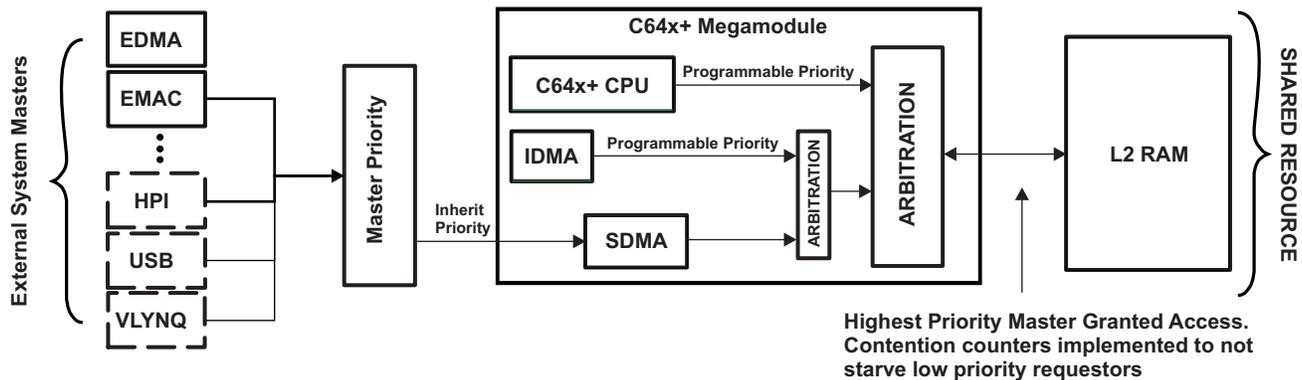
Figure 3. Priority Arbitration Scheme for L2 RAM

The C64x+ Megamodule uses a bandwidth management (BWM) system to arbitrate between the DMA and CPU requests issued to L2 RAM. For more information on the BWM feature, see the *TMS320C64x+ DSP Megamodule Reference Guide* (Literature Number: [SPRU871](#)). The BWM arbitration grants L2 bandwidth based on programmable priorities and contention-cycle-counters. The contention-cycle-counters count the number of cycles for which the associated L2 requests are blocked by higher-priority requests. When the contention-cycle-counter reaches a programmed threshold (MAXWAIT), the associated L2 request is granted a slice of L2 bandwidth. This prevents indefinite blocking of lower-priority requests when faced with the continuous presence of higher-priority requests.

Ideally, the BWM arbitration will grant equal L2 bandwidth between equal priority DMA and CPU requests. Instead, when requests arrive at the BWM such that the CPU priority is *lower than or equal to* the DMA priority, the bandwidth is always granted in favor of the CPU over the DMA. In the case of successive CPU requests, it is possible for the CPU to block all DMA requests until the CPU traffic subsides. [Figure 3](#) shows a high-level diagram of the arbitration scheme used for L2 RAM requests.

When the SDMA has finished sending all of its commands to the L2 controller, the C64x+ Megamodule drops the effective transfer priority to seven. The L2 Controller uses this effective priority to arbitrate the SDMA command with the CPU.

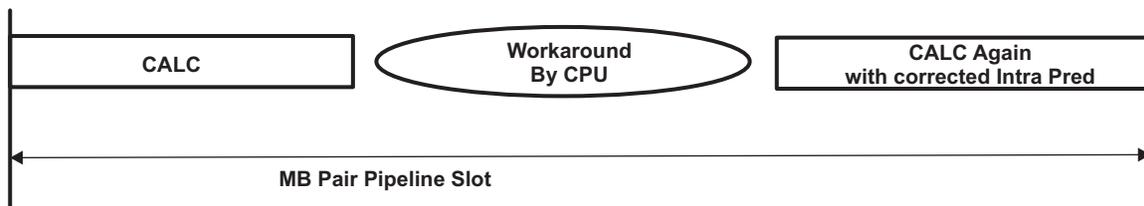
Figure 4. MB Pair Pipeline Slot Example

- In Encode, an incorrect (but legal) bitstream will be generated, and a mismatch will happen between the Encoder and Decoder resulting in significant quality degradation.
- In Decode, the reconstructed macroblock will be incorrect.
- If the following MBs are intra referring to this MB, the error is propagated spatially within the picture.
- If the following pictures refer to this MB, the error is propagated temporally to the following pictures.

During a MB pipeline slot, a CALC is done, a workaround by CPU, and CALC again with corrected intra prediction macroblock (see [Figure 4](#)).

If the MB is of intra 16x16 plane mode, perform the following steps:

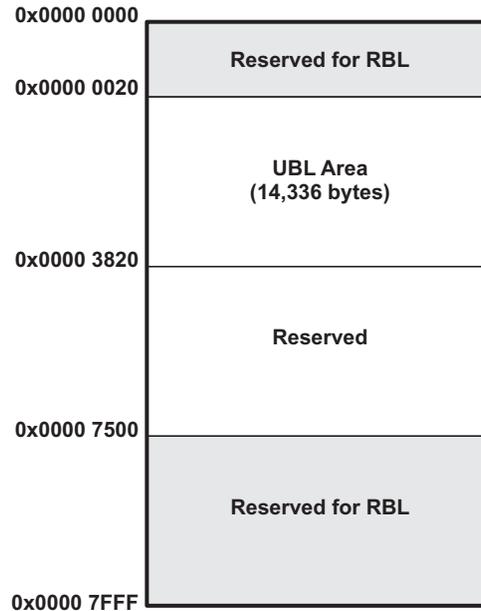
Figure 5. ROM Boot Loader and User Boot Loader Memory Map

Details: The ARM ROM Boot Loader (RBL) is using only 16KB of internal RAM instead of 32KB for UART boot. With this limitation, the UART boot *does not* work if the UBL size is greater than 14KB (2KB out of 16KB is reserved for RBL). [Figure 5](#), shows what a memory map with this limitation looks like:

The starting address of the UBL (User Boot Loader) is at 0x0020 and can be loaded between 0x0020 and 0x381F.

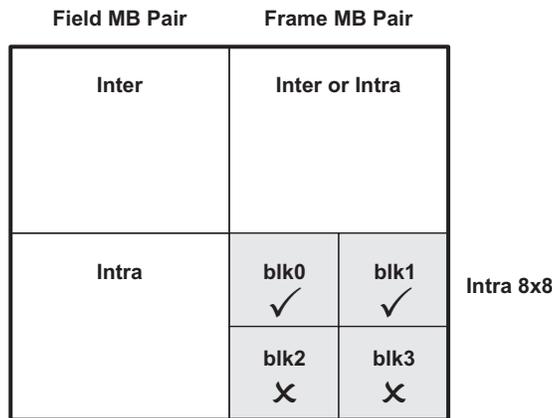
Figure 6. Conditions for the Advisory to Surface Example

- H.264 Universal Decode
- High Profile
- MBAFF
- Constrained_intra_pred_flag = 1*
- A frame MB pair has a field MB pair as its left neighbor (see Figure 6).
- The top MB of the left neighbor is "Inter" and the bottom MB is "Intra"
- The bottom MB of the Frame pair is Intra 8x8 (shown as the shaded area in Figure 6)
- The Block 2 of the Intra 8x8 is coded with one of the following modes:
 - Intra_8x8_Vertical
 - Intra_8x8_DC
 - Intra_8x8_Diagonal_Down_Left
 - Intra_8x8_Vertical_Left
- In this case, the intra-prediction of "blk 2" is incorrect, and this may cause the intra-prediction of "blk 3" to also be incorrect. The error of this MB can propagate to the following MBs of the current and future pictures.

The * constrained_intra_pred_flag equal to 1 specifies that the constrained intra prediction mode. For this case, the prediction of macroblocks coded using Intra macroblock prediction modes only uses residual data and decoded samples from I or SI macroblock types. (For more details, see Section 7.4.2.2, *Picture Parameter Set RBSP Semantics* of the H.264 standard document [Advanced Video Coding for Generic Audiovisual Services, Series H: AUDIOVISUAL AND MULTIMEDIA SYSTEMS, Infrastructure of Audiovisual Services – Coding of Moving Video, ITU-T H.264 (03/2005)]).

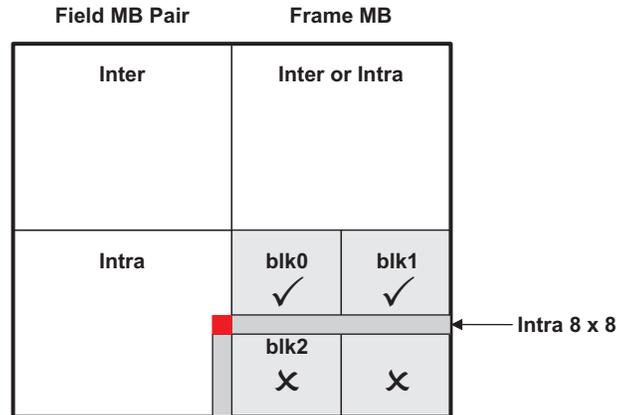
Figure 7. Availability of the Neighbor Pixels Example

The Calc module makes a mistake regarding the availability – it assumes that availability of the upper left pixel, which is NOT available, is the same as the left pixels.

As a result, the sample filtering before calculating the intra 8x8 prediction for block2 is wrong (For more details, see Section 8.3.2.2.1, *Reference Sample Filtering Process for Intra_8x8 Sample Prediction* of the H.264 standard document).
