# **TMS320C6474**

## **Digital Signal Processor**

### **Silicon Revisions 2.1, 1.3, 1.2**

## **Silicon Errata**

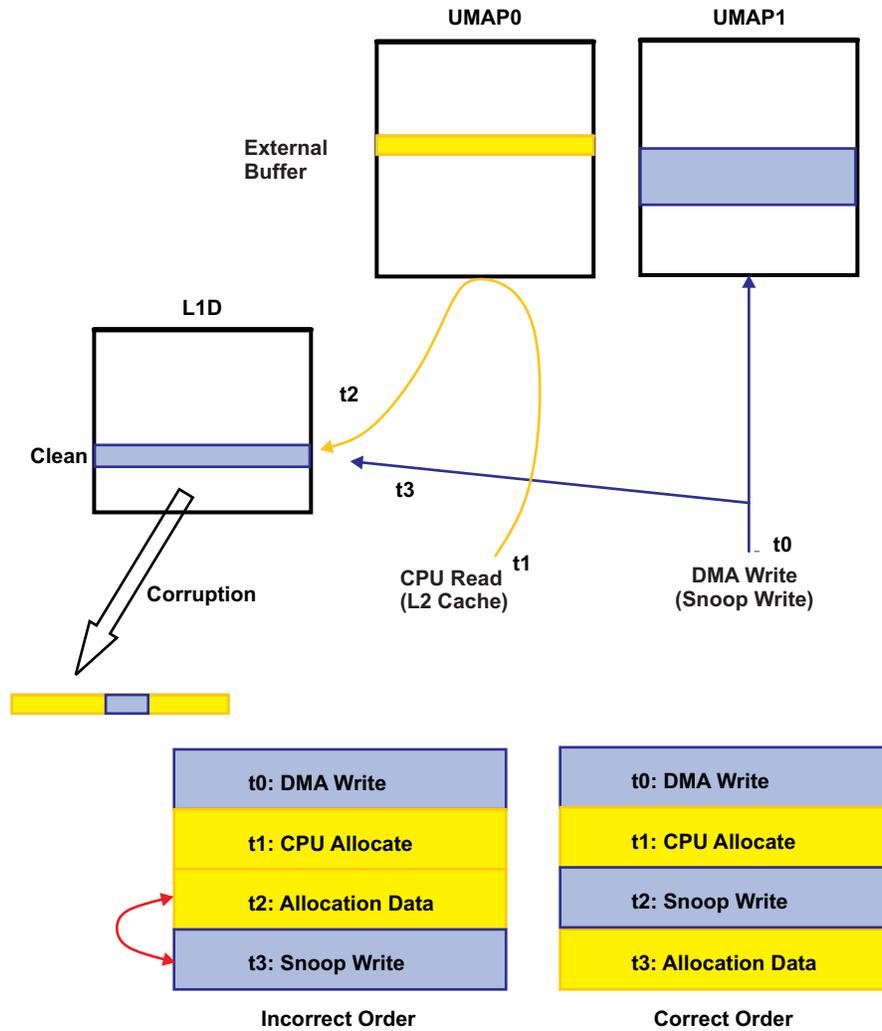
Figure 4. Cache Line Operations Flow

One can identify this issue unambiguously by examining the corrupted memory range in CCStudio using the cache tag viewer. The corrupted data shows up in the include L1D view in a memory window, but not in the exclude L1D view. The cache tag viewer should indicate that the line is also "clean" and the corrupt data should also be visible in its intended destination, which must be in UMAP1 and map to the same L1D set as the corrupted line.

Figure 4 shows the flow of these operations, the incorrect order that causes the issue, and the correct order. The blue line is Cache Line A and the yellow line is Cache line B.

In the issue described above, all of the conditions must be true for the issue to occur. The workarounds focus on picking one of the conditions and removing it so that you do not need to worry about the other conditions.

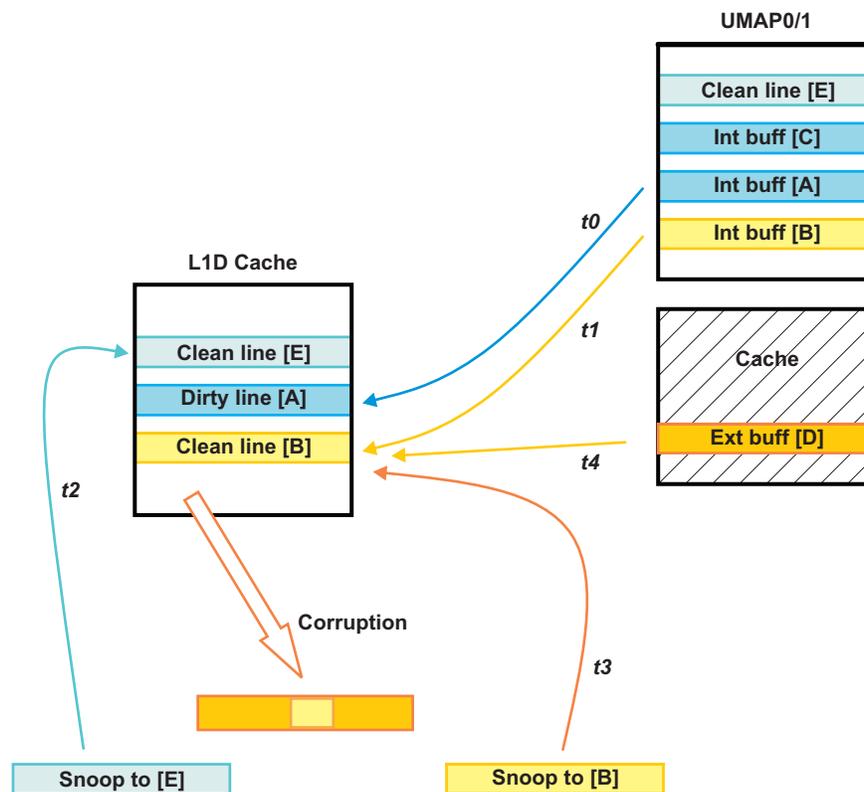
**Figure 6. Sequence of Events**

Under a specific set of circumstances listed below, a snoop-write results in data corruption of L1D\$. The issue occurs when there is a DMA to L2 for one of the allocated (clean) lines that is also in the process of being replaced by an allocation from external, cacheable memory (implying there was a set match between the two); this is along with another allocation and a DMA to the other allocated (clean) line. L2 sends the DMA requests as snoop-writes to the L1D cache. When the error occurs, the line the second snoop-write was destined for has already been replaced by the allocation from external, cacheable memory. The logic to kill the snoop-write did not get sensitized and the snoop-write ends up corrupting the line that was allocated. Subsequent writes to the corrupted line cause this to get committed to lower levels of memory.

- (A) The snoop-write to Cache Line E, from Step 1 above, is now in process and blocking the snoop-write to Cache Line B from Step 2.
- (B) While Step A is going on, Cache Line A has either now been evicted and/or replaced by Cache Line C from Step 4 above and Cache Line B (the intended target of the delayed snoop-write) is now replaced with Cache Line D from Step 3 above.
- (C) Once the first snoop-write from operation C1 completes, the second (delayed) snoop-write mentioned in Step A to Cache Line B should be killed since Cache Line B was replaced in the operation in Step B. Instead, it is not killed and the line cached (which is now actually Cache Line D) is now updated incorrectly.

1. Cache Line D now holds data that was corrupted by the operation in Step C above (as a result of Step 2 above).
  - A subsequent read of this data returns a corrupted value.
  - Subsequent writes to this cache line also cause the corrupted values to be committed to lower levels of memory.

Figure 6 shows the sequence of events.

A compiler flag (`--c64p_dma_l1d_workaround`) has been added to the latest Code Generation Tools to resolve this potential issue. This flag can be utilized for all code in the system or used on particular files/functions that may be susceptible to the conditions listed in this advisory.

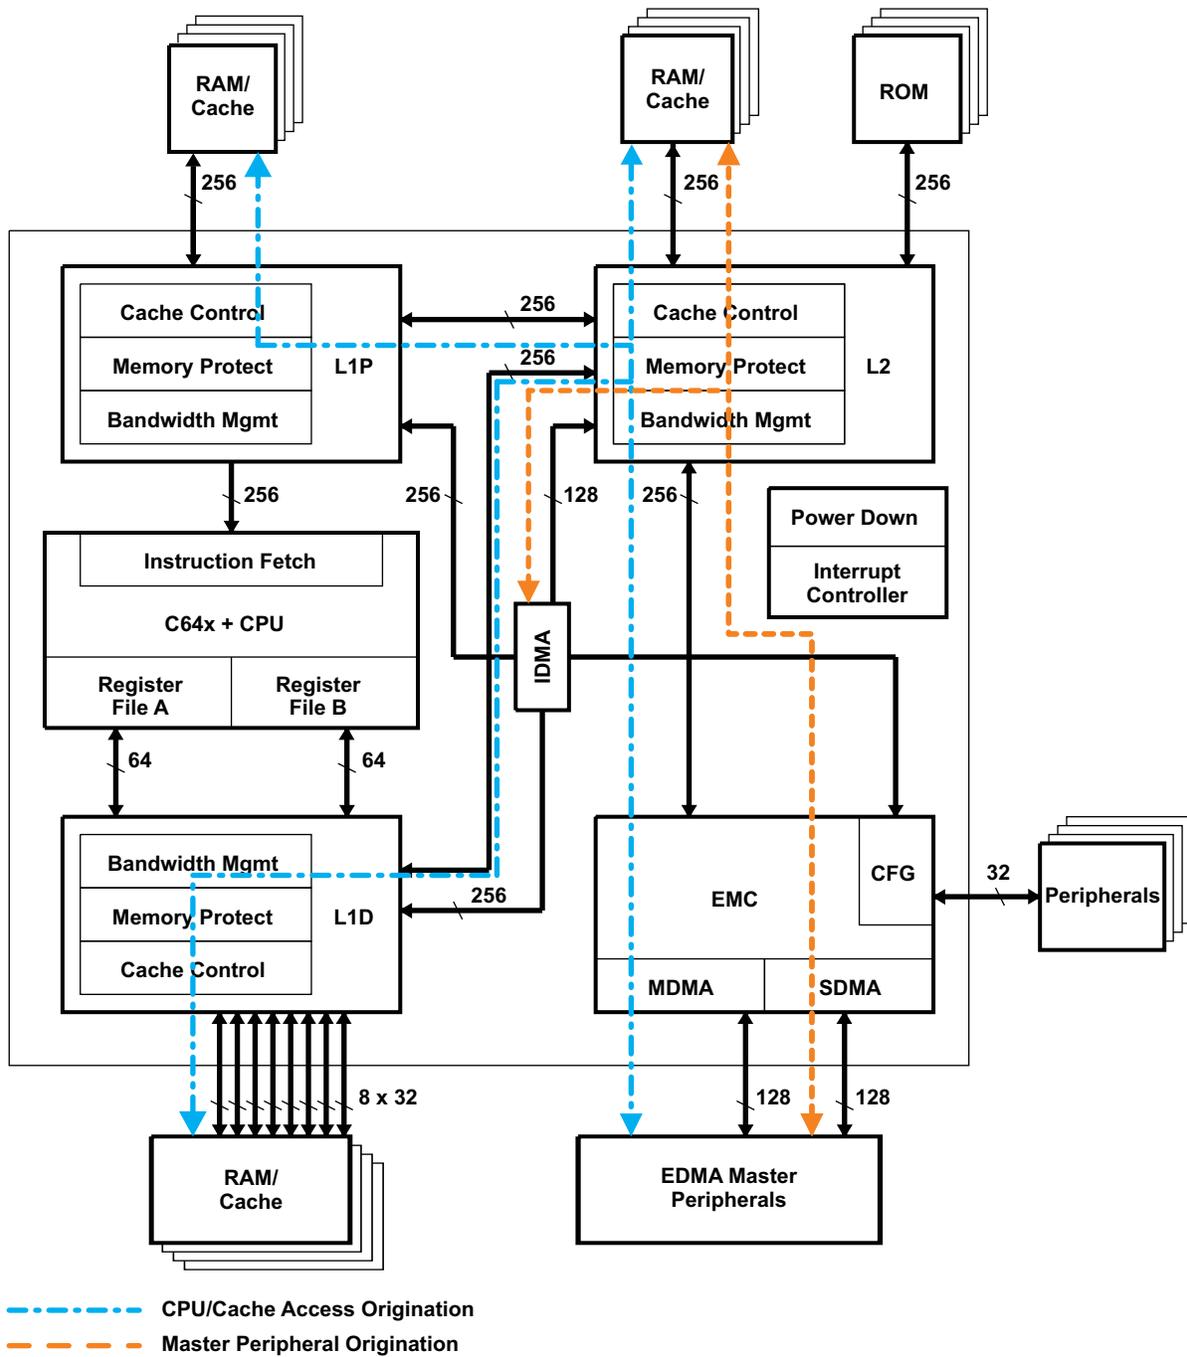
Figure 8. IDMA, SDMA, and MDMA Paths

Ideally, the MDMA (the blue lines in [Figure 8](#)) and SDMA/IDMA paths (the orange lines in [Figure 8](#)) operate independently with minimal interference. Normally, MDMA accesses may stall for extended periods of time (clock cycles) due to expected system level delays (e.g., bandwidth limitations, DDR2 memory refreshes). However, when using L2 as RAM, SDMA and/or IDMA accesses to L2/L1 may experience unexpected stalling in addition to the normal stalls seen by the MDMA interface. For latency-sensitive traffic, the SDMA stall can result in missing real-time deadlines.

[Figure 8](#) is a simplified view for illustrative purposes only. The IDMA/SDMA path (orange lines) can also go to L1D/L1P memories and IDMA can go to the DSP CFG peripherals. MDMA transactions (blue lines) can also originate from L1P or L1D through the L2 controller or directly from the DSP.

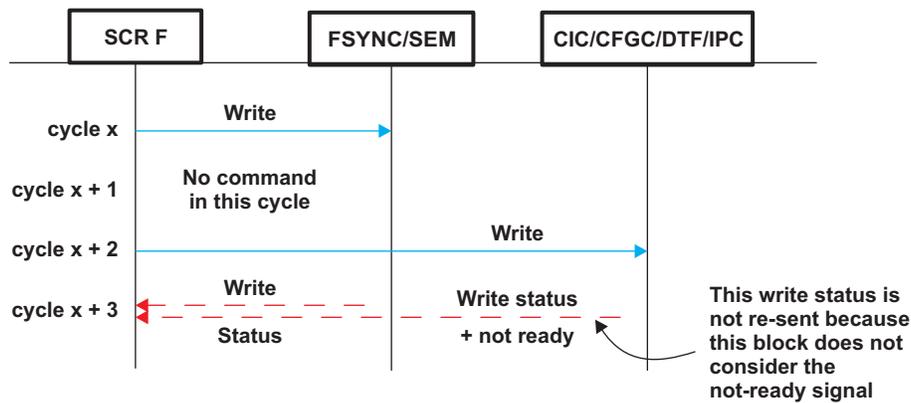
Figure 9. SCR F Write Requests/Write Status

By studying the write status behavior of each of the modules on SCR F, we have found that as long as there are no writes to the FSYNC or SEM, it is safe to write to any of the other modules on SCR F. All modules, except the FSYNC and SEM, respond back with write status on the cycle following the write. On SCR F, since there is only a single master port, all writes are forced to be back to back. Therefore, all write status responses are back to back as well. The FSYNC and SEM blocks respond back three cycles after a write. For this reason, writing to these blocks poses potential write status conflicts.

Figure 9 shows the SCR F write requests to and write status from the modules. The following describes the actions shown in the figure:

- On cycle x, there is a write request from SCR F to FSYNC/SEM. Its write status is expected to come after three cycles.
- On cycle x + 1, no command is issued in this cycle.
- On cycle x + 2, there is one write request from SCR F to CIC/CFG/DTF/IPC. The SCR F sends a not-ready signal to the CIC/CFG/DTF/IPC, but the CIC/CFG/DTF/IPC sends write status irrespective of the not-ready signal, assuming that it responded to the write request and SCR F received it properly.
- The SCR F accepts the write status from the FSYNC/SEM and the write status from the CIC/CFG/DTF/IPC is lost.
