Errata AM263Px Sitara™ Microcontroller Silicon Revision 1.0

ABSTRACT

This document describes the known exceptions to the functional specifications (advisories). This document may also contain usage notes. Usage notes describe situations where the device's behavior may not match presumed or documented behavior. This may include behaviors that affect device performance or functional correctness.

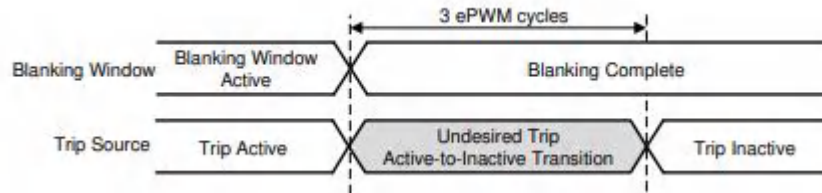
CONTROLSS-ePWM: An ePWM Glitch can Occur if a Trip Remains Active at the End of the Blanking Window

The blanking window is typically used to mask any PWM trip events during transitions which would be false trips to the system. If an ePWM trip event remains active for less than three ePWM clocks after the end of the blanking window cycles, there can be an undesired glitch at the ePWM output.

The following picture illustrates the time period which could result in an undesired ePWM output.

Avoid configuration of blanking window such that the trip input would fall in this range (1 cycle before and 3 cycles after the blanking window closure).

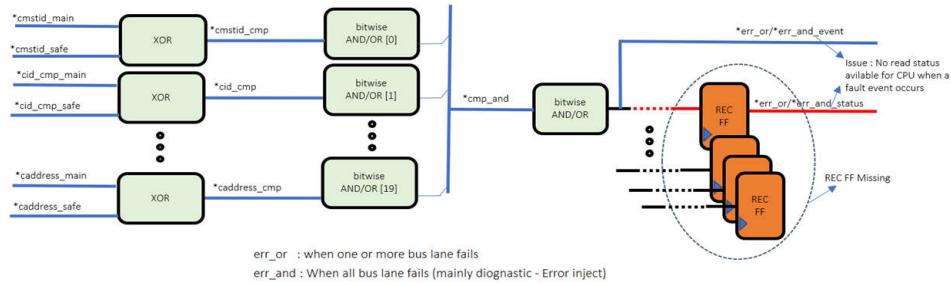
Figure 2-1.

Granular error status not logged in BUS_SAFETY_ERR registers for the detected faults

Granular error status not logged correctly for detected faults in COMP_CHECK and COMP_ERR fields of MSS_CTRL:*_BUS_SAFETY_ERR registers.

The error signal err_comp and err_comp_signals are used to detect any faults on the diagnostic circuit. The AND'ed output of these two signals are used to report the fault. However they are sampled at different edges of the clocks resulting in loss of the error signal getting generated. and hence is not getting logged in the MSS_CTRL MMRs.

Case 2: Log Registers have all zeros

Here the granular logs are not captured correctly and possible entities affected are R5F and L2 memory.

As Granular Error Status is not logged, the bus safety fault is detected only as an aggregated error event and the Granularity of diagnostics information will not be captured correctly.

Case 1: In the case where the logs are captured correctly the log results can be used to take appropriate action.

Case 2: In the case where the logs are not captured correctly then for a) diagnostics no action needed and b) in case of actual failure in the application WarmResethn should be used.

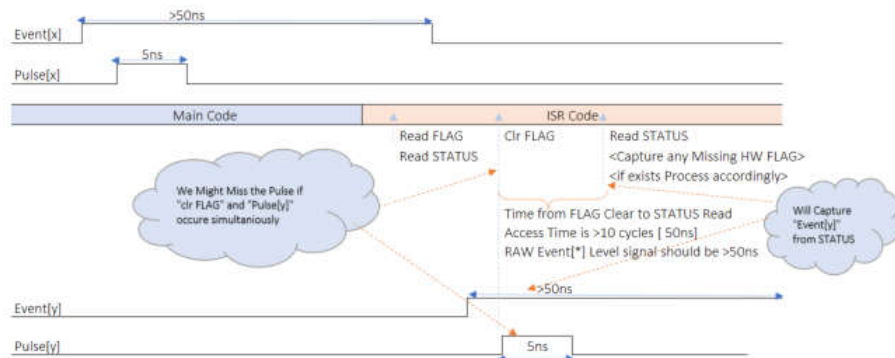
CONTROLSS: Race condition OUTPUT_XBAR and PWM_XBAR resulting in event miss

Potential race condition in capture registers resulting in events getting lost while other events in the same register are being cleared by writing to the register. Following registers are impacted by this issue:

Capture any missing HW event FLAG

If exists, process accordingly

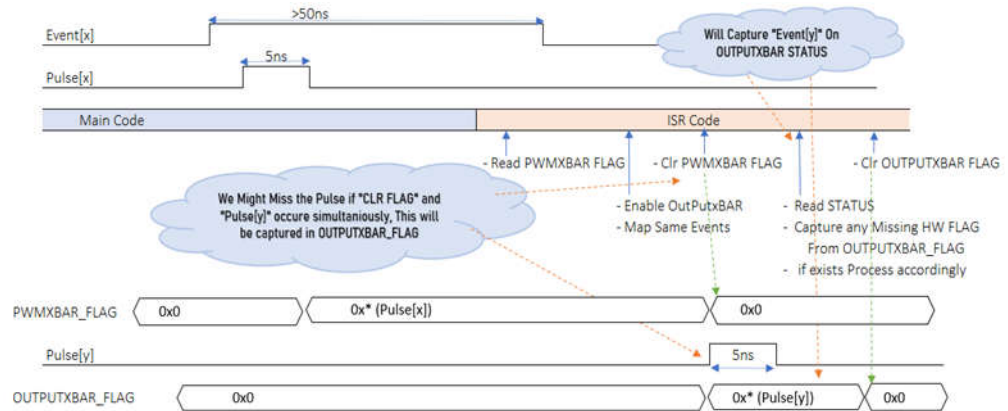
CONTROLSS: Race condition OUTPUT_XBAR and PWM_XBAR resulting in event miss

- Clr FLAG, Event[y] OutputXBAR

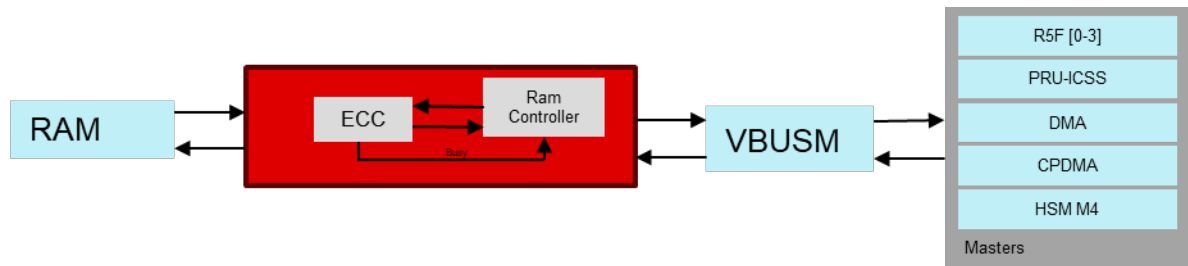
- When a single-bit error is detected during a burst read, the ECC module inserts a BUSY cycle in between.
- In this BUSY cycle, the next read from memory is halted and a corrected write back is performed to fix the error in RAM.
- The BUSY signal generated during this process is improperly handled by the Bus Protocol logic.
- Upon resuming the burst read, the data pipeline becomes misaligned.

- Incorrect data is returned to the master for reads following error correction.
- May cause program execution failures and abort exceptions.

This issue affects only L2 and MBOX RAM read operations.

The physical RAM contents remain properly corrected (no memory corruption) and write operations function normally. Below is the high level block diagram.

Based on system requirements and safety needs, consider the following solutions:
