Errata

# AM62Px Sitara™ Processors Silicon Errata, Silicon Revision 1.0, 1.1, 1.2

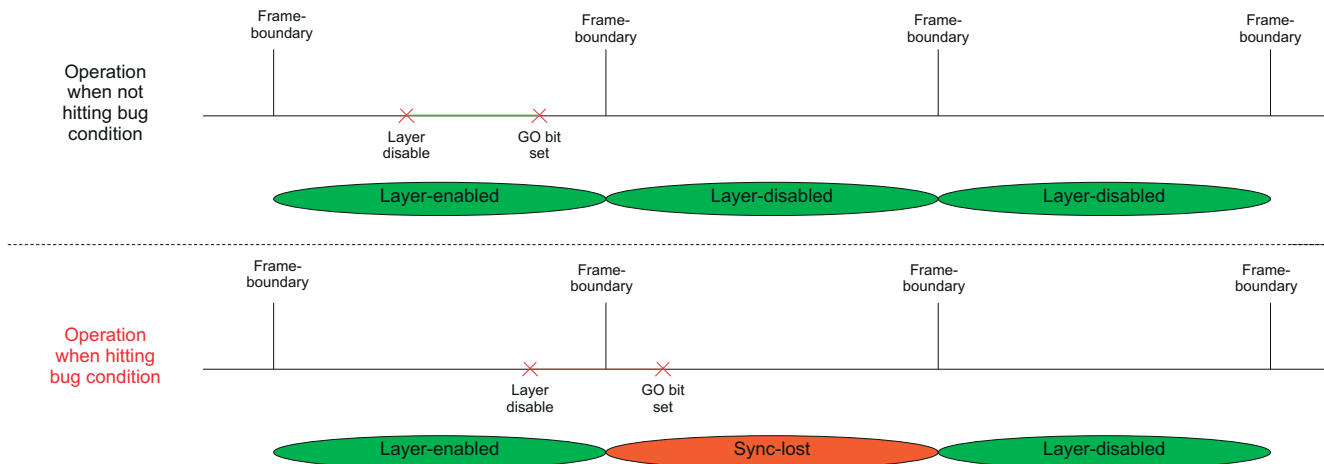
**Figure 2-1. Bug Condition**

Disabling a layer (for example VID1) connected to an OVR (that is toggling DSS\_VID\_ATTRIBUTESx[0] ENABLE from 1 to 0) may result in synclost during the next frame. The synclost may result in a corrupted or blank frame (all pixel data sent out of DSS during the frame is 0x0). The occurrence of synclost is dependent on the timing of setting the GO bit (that is DSS\_VP\_CONTROL[5] GOBIT to 1) vis-à-vis the disabling of the layer. If the “disable layer” MMR write operation and “set GO bit” MMR write operation happens within the same frame boundary, no synclost occurs. If the operations happen across the frame boundary, then synclost occurs (for one frame). The design automatically recovers and returns to normal operation from the next frame after GO bit is set, see [Figure 2-1](#).

A simple software workaround exists. In the workaround, prior to disabling a layer on the OVR, it is moved to the “non-visible” area of the OVR (for example: DSS\_OVR\_ATTRIBUTES\_x[17-6] POSX = max\_value\_of\_posx or DSS\_OVR\_ATTRIBUTES\_x[30-19] POSY = max\_value\_of\_posy). This avoids the synclost when the layer is disabled.

A sample software workaround pseudo-code is shown on [Figure 2-2](#). In this case, the regular “disable layer” MMR write operation and “set GO bit set” MMR write operation are replaced with macros which implement the software workaround.
