Errata

MSP432E4 SimpleLink™ 微控制器

## 1 MSP432E4 SimpleLink™ 微控制器

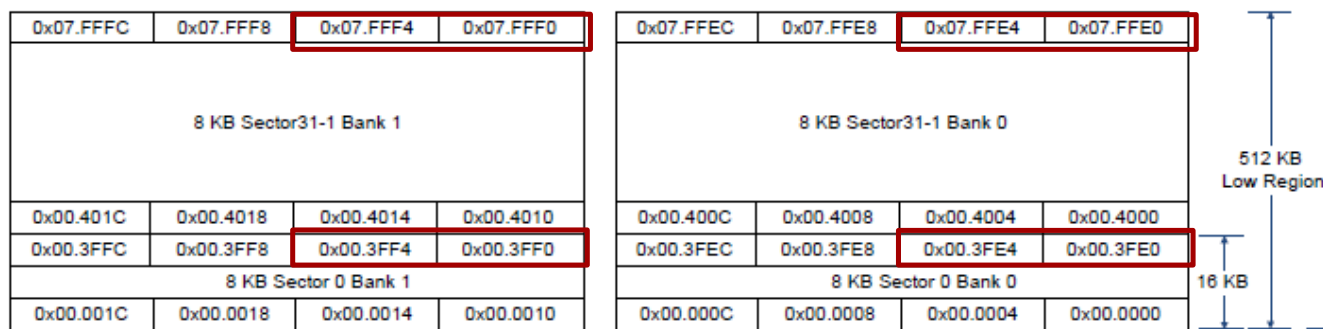
## MEM#15 (续)

如果只对组中一个扇区最后一行的前两个字中的一个或两个字进行编程, 则擦除整个扇区、批量擦除器件或切换批量擦除不会将闪存擦除回全 1。下图显示了下部 512KB 闪存扇区 0 和扇区 31 中受影响的字。

对扇区组中的任何其他字进行编程以允许扇区擦除功能工作。

切换批量擦除，或批量擦除仍将不起作用。
