Errata

AM62Ax Sitara™ Processors Silicon Errata, Silicon Revision 1.0

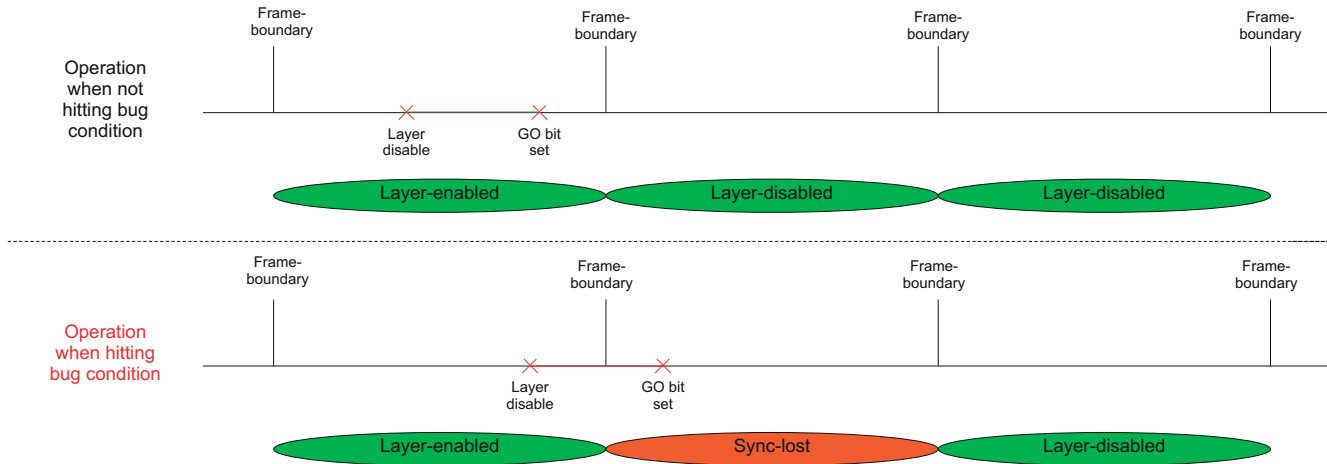
Figure 2-1. Bug Condition

Disabling a layer (for example VID1) connected to an OVR (that is toggling DSS_VID_ATTRIBUTESx[0] ENABLE from 1 to 0) may result in synclost during the next frame. The synclost may result in a corrupted or blank frame (all pixel data sent out of DSS during the frame is 0x0). The occurrence of synclost is dependent on the timing of setting the GO bit (that is DSS_VP_CONTROL[5] GOBIT to 1) vis-à-vis the disabling

of the layer. If the “disable layer” MMR write operation and “set GO bit” MMR write operation happens within the same frame boundary, no synclost occurs. If the operations happen across the frame boundary, then synclost occurs (for one frame). The design automatically recovers and returns to normal operation from the next frame after GO bit is set, see Figure 2-1.

A simple software workaround exists. In the workaround, prior to disabling a layer on the OVR, it is moved to the “non-visible” area of the OVR (for example: DSS_OVR_ATTRIBUTES_x[17-6] POSX = max_value_of_posx or DSS_OVR_ATTRIBUTES_x[30-19] POSY = max_value_of_posy). This avoids the synclost when the layer is disabled.

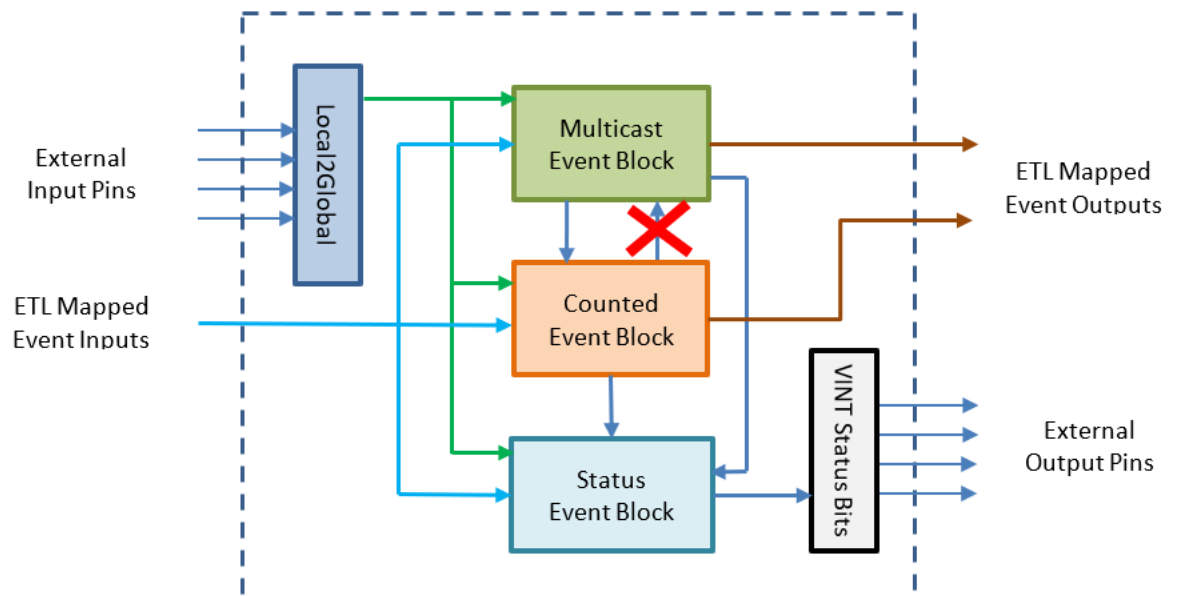
Figure 2-3. Interrupt Aggregator Version 1.0

An issue was found after design that could cause the IA to deadlock. The issue occurs when event “loops” occur between these three processing blocks. It is possible to create a situation where a processing block can not output an event because the path is blocked, and since it can not output an event, it can not take any new input events. This inability to take input events prevents the output path from being able to unwind, and thus both paths remain blocked.

Figure 2-3 shows the conceptual block diagram of IA 1.0. Potential loops are avoided by adopting the policy of not allowing the counted event block to send events to the multicast block. This method was chosen because it is more common to split an event first, and then count one while sending the other elsewhere. With this path blocked by convention, it is not possible for a single event to visit any block more than once and thus not possible for paths to become blocked so long as the outputs remain unblocked.

By following the conventions outlined here, the system is safe from looping hazards that can create a deadlock scenario.
