# TMS320F28004x Real-Time MCUs Silicon Errata

## Silicon Revisions D, B, A, 0

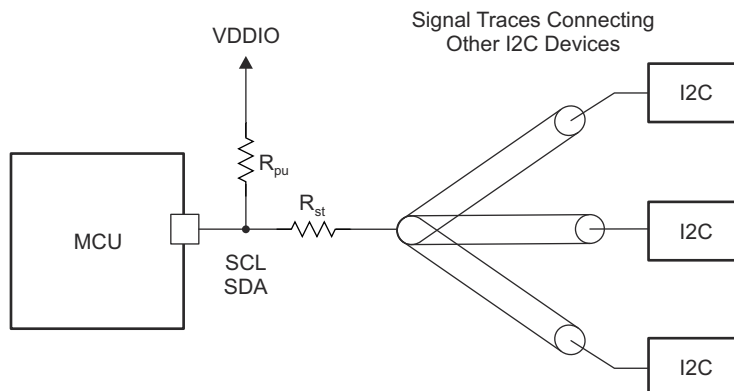
**Figure 3-4. Placement of Series Termination Resistor and Pullup Resistor**

The SDA and SCL outputs are implemented with push-pull 3-state output buffers rather than open-drain output buffers as required by I2C. While it is possible for the push-pull 3-state output buffers to behave as open-drain outputs, an internal timing skew issue causes the outputs to drive a logic-high for a duration of 0–5 ns before the outputs are disabled. The unexpected high-level pulse will only occur when the SCL or SDA outputs transition from a driven low state to a high-impedance state and there is sufficient internal timing skew on the respective I2C output.

This short high-level pulse injects energy in the I2C signals traces, which causes the I2C signals to sustain a period of ringing as a result of multiple transmission line reflections. This ringing should not cause an issue on the SDA signal because it only occurs at times when SDA is expected to be changing logic levels and the ringing will have time to damp before data is latched by the receiving device. The ringing may have enough amplitude to cross the SCL input buffer switching threshold several times during the first few nanoseconds of this ringing period, which may cause clock glitches. This ringing should not cause a problem if the amplitude is damped within the first 50 ns because I2C devices are required to filter their SCL inputs to remove clock glitches. Therefore, it is important to design the PCB signal traces to limit the duration of the ringing to less than 50 ns. One possible solution is to insert series termination resistors near the SCL and SDA terminals to attenuate transmission line reflections.

This issue may also cause the SDA output to be in contention with the slave SDA output for the duration of the unexpected high-level pulse when the slave begins its ACK cycle. This occurs because the slave may already be driving SDA low before the unexpected high-level pulse occurs. The glitch that occurs on SDA as a result of this short period of contention does not cause any I2C protocol issue but the peak current applies unwanted stress to both I2C devices and potentially increases power supply noise. Therefore, a series termination resistor located near the respective SDA terminal is required to limit the current during the short period of contention.

A similar contention problem can occur on SCL when connected to I2C slave devices that support clock stretching. This occurs because the slave is driving SCL low before the unexpected high-level pulse occurs. The glitch that occurs on SCL as a result of this short period of contention does not cause any I2C protocol issue because I2C devices are required to apply a glitch filter to their SCL inputs. However, the peak current applies unwanted stress to both I2C devices and potentially increases power supply noise. Therefore, a series termination resistor located near the respective SCL terminal is required to limit the current during the short period of contention.

Insert series termination resistors on the SCL and SDA signals and locate them near the SCL and SDA terminals. The SCL and SDA pullup resistors should also be located near the SCL and SDA terminals. The placement of the series termination resistor and pullup resistor should be connected as shown in [Figure 3-4](#).
