## Errata

# ***F29H85x, F29P58x, and F29P32x Real-Time MCUs Silicon Errata (Silicon Revisions C, B, A, 0)***

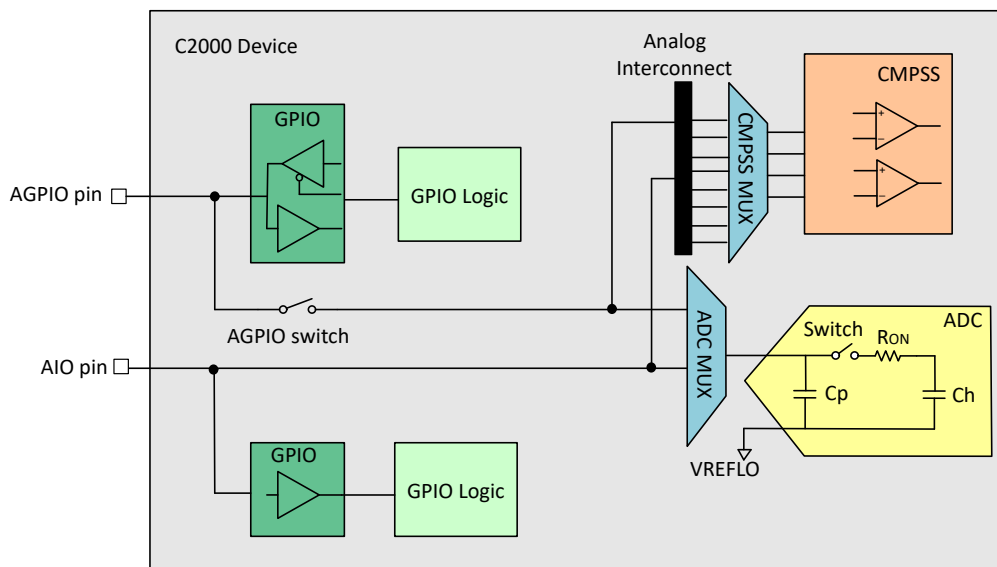
The AGPIO analog pin path contains an extra series switch of 53Ω. This creates a low-capacitance isolated node shared by the ADC and CMPSS comparator, as shown in [Figure 3-1](#). This node can be disturbed when the ADC samples the channel (depending on the prior voltage stored on the ADC sample-and-hold capacitor), and this disturbance can cause a false CMPSS event of up to 50ns. To accommodate this potential disturbance, the workarounds below can be implemented.

**Figure 3-1. Analog Subsystem Diagram with AGPIO and AIO Analog Pin Types**
**Workarounds**

1. Use a different pin (that is AIO pin type) for analog channels that need both ADC and CMPSS together.
2. Use the CMPSS Digital Filter with a setting of 50ns or greater, which will filter the temporary disturbance.
3. Precondition the sample-and-hold capacitor of the ADC so that the disturbance will not cause a false trip. For example, perform a dummy read of a 3.3V connection from a different channel on the ADC immediately before the impacted channel is read,

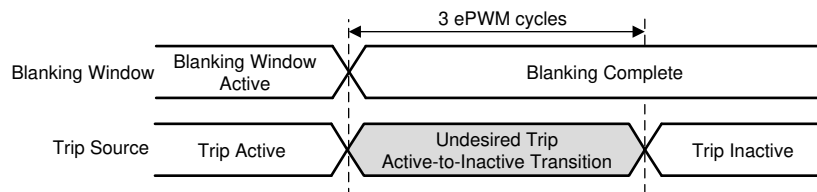
The blanking window is typically used to mask any PWM trip events during transitions which would be false trips to the system. If an ePWM trip event remains active for less than three ePWM clocks after the end of the blanking window cycles, there can be an undesired glitch at the ePWM output.

Figure 3-2 illustrates the time period which could result in an undesired ePWM output.

**Figure 3-2. Undesired Trip Event and Blanking Window Expiration**

Extend or reduce the blanking window to avoid any undesired trip action.

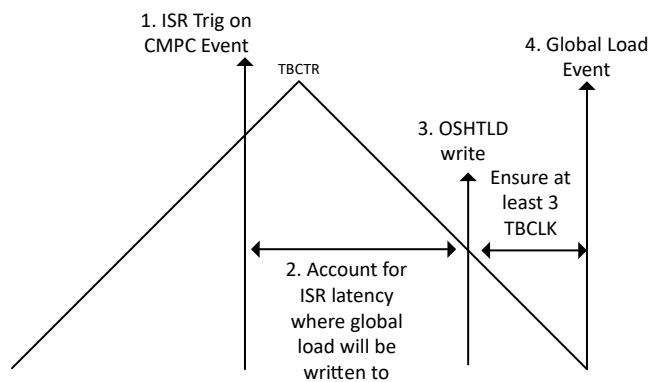
**Figure 3-4. Example of Synchronous ISR Loading Method**

**Workaround 1** (Recommended): Synchronous ISR to PWMs

1. Generate an ISR on a known Event Trigger Interrupt event (that is, CMPC, CMPD event, and so forth).
2. Ensure a minimum of 3 TBCTR cycles are kept between the global load event and when the ISR writes to GLDCTL2.OSHTLD.
  - a. When writing to the OSHTLD bit, ensure this is non-interruptible code by disabling the interrupts.

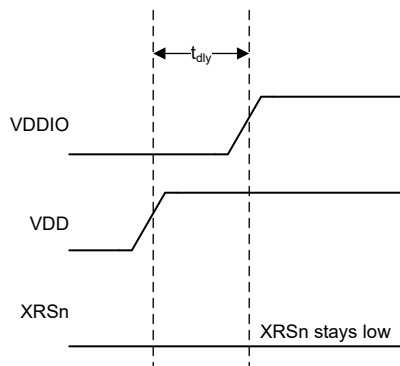
The device XRSn reset signal can remain in a low (reset asserted) state when the VDD supply voltage is ramped up before or simultaneously with the VDDIO supply. As a result, the device fails to boot.

**Figure 3-5. Incorrect Power-up Sequence Leading to Stuck Reset**

Ensure the VDDIO supply is fully ramped before ramping up the VDD supply voltage. See Power Management Module Operating Conditions for  $V_{DD33} - V_{DD12}$  Delay parameter

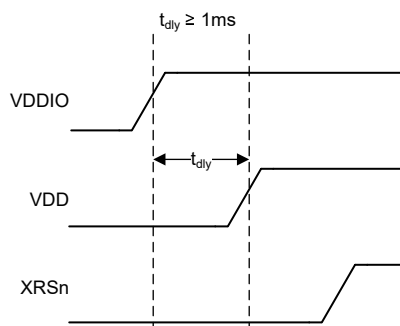
**Figure 3-6. Correct Power-up Sequence With Reset Release**
