OMAP5910
Dual-Core Processor
Silicon Errata

SPRZ016F
August 2002 – Revised February 2006

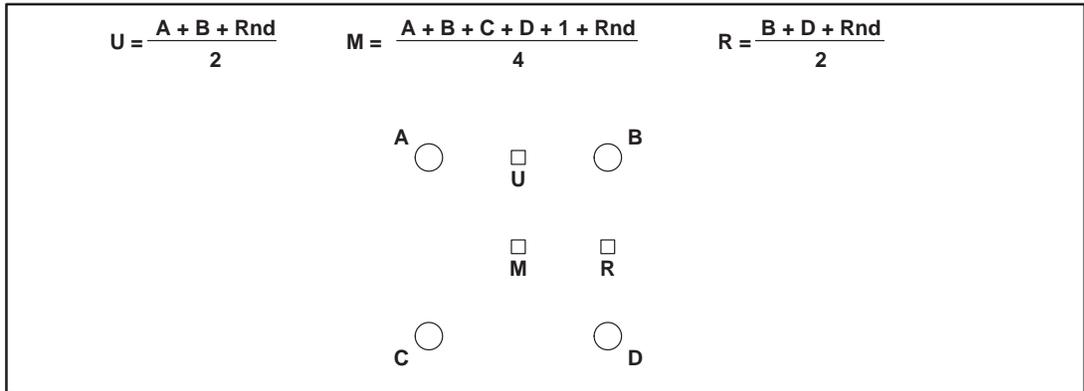
Details: The pixel interpolation computation is wrong by one pixel unit in “Decoder” mode, when “Rounding Mode” is set to zero and when half-pixel interpolation is performed in the middle of four full-resolution pixels (i.e., in the middle of two rows of pixels). In “Decoder” mode, the Pixel Interpolator data path is configured to deliver two interpolated pixels per cycle. Each section of the data path implements the computations shown below, normalized according to video decoding standards:

U and R results are interpolated from lines and columns, respectively. M is computed from two following full-resolution pixels lines. Two U, R, or M results are computed during each cycle by the data path, according to the instruction being executed by the accelerator for the M results set (the results are denoted as M0 and M1). When “Rounding Mode” (Rnd in the above picture) is set to 1, the faulty data path section is implemented, $M0 = (A+B+C+D+2)/4$, which is the correct result; but when “Rounding Mode” is set to 0, the data path section implements $M0=(A+B+C+D)/4$. This is not correct and generates a bit exactness issue. The M1 result is always correct, regardless of the “Rounding Mode” state.

Workaround: Do not use the PI data path in the “Decoder” software when computing M type points and when software-rounding is needed. Instead, use a routine consisting of regular C55x instruction combinations. This routine must be called from the point where the one using PI HWA instructions is and should take the same parameters and data organization. Hence, the new routine should perform following steps:

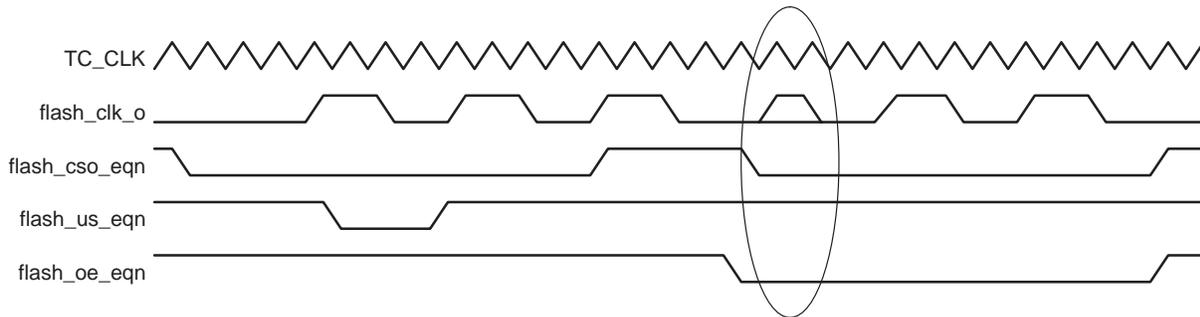
Figure 3. Flash Clock Glitch With FDIV = 4

Details: Whenever EMIFS is configured to FDIV= 4 or 6 in synchronous RDMODE, an extra clock is generated during an access. This extra clock cycle is generated for the transaction between write to write operations and the first read operation after any write operation. Since normally flash memories ignore flash clock during write operations, this isn't a problem. However, an extra flash clock cycle may corrupt memory contents during reads.

Figure 3 shows the problem in detail. It can be observed from the waveform that the first read immediately after the write operation has an extra clock pulse of width 1 TC clock cycle using FDVI = 4. For FDIV = 6, the pulse width is 2 TC clock cycles.

Workaround: In order to avoid data corruption, software needs to insert a dummy read/write to a asynchronous chip select.

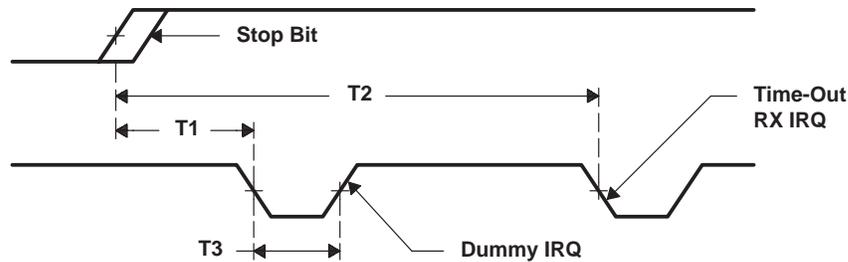
Details: The UART1, 2, 3 peripherals generate an interrupt without corresponding status when a receive time-out occurs. This time-out is generated when received data is present in the FIFO and is not read (MPU or DMA) during a defined time. See Figure 5.

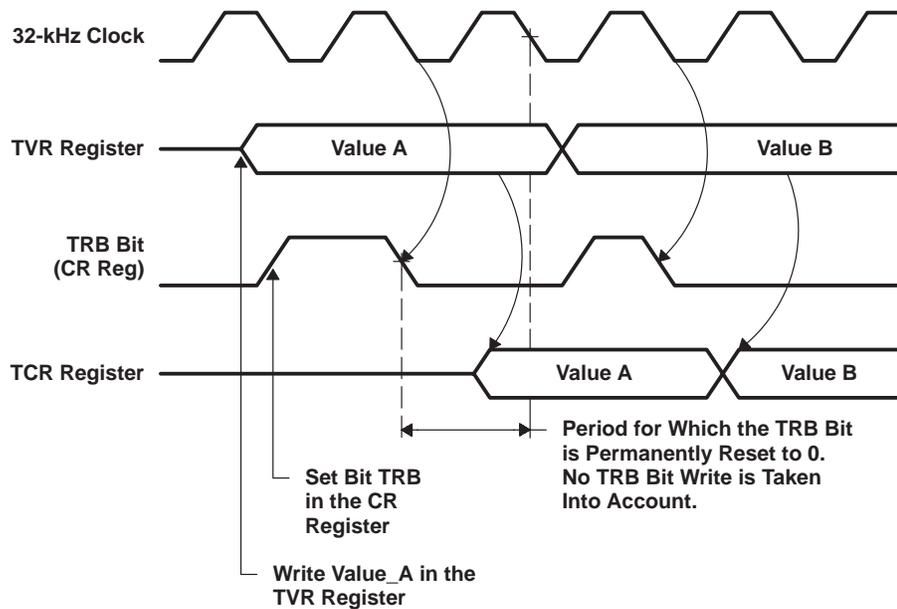
Figure 6. TRB Timing Diagram

Details: The Timer32K Reload bit (TRB) is used to load the TCR register with the value contained in the TVR register. Once the TCR is loaded, the TRB bit should be automatically reset to '0'. The user should be able to use the TRB bit (by polling) to know when to load a new value in the TVR.

However (see Figure 6), the TRB bit is reset to zero by the falling edge of the 32-kHz clock only after a maximum of 1.5 x 32-kHz clock period (or minimum 0.5 x 32-kHz clock period) after the TRB bit is set. The TCR register is loaded after a maximum of two 32-kHz clock periods (or minimum of 1 x 32-kHz clock periods) on the rising edge of the 32-kHz clock. After the TRB is reset, there is one 32-kHz clock period where a new TRB setting will not be taken into account by the module. If the user programs the TVR and updates the TRB bit within this 32-kHz clock period, the new TVR will not be loaded correctly into the TCR.

Workaround: To load a new value into the TCR, poll the TRB bit. When the TRB is equal to '0' (signaling that the previous value has been loaded), the user has to wait for an additional one 32-kHz clock period, before loading a new value in the TVR and setting the TRB bit to '1'.
