# TMS320F28003x Real-Time MCUs Silicon Errata

## Silicon Revision 0

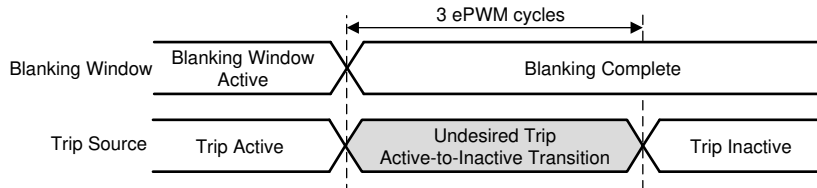
**Figure 3-1. Undesired Trip Event and Blanking Window Expiration**

The blanking window is typically used to mask any PWM trip events during transitions which would be false trips to the system. If an ePWM trip event remains active for less than three ePWM clocks after the end of the blanking window cycles, there can be an undesired glitch at the ePWM output.

Figure 3-1 illustrates the time period which could result in an undesired ePWM output.
