## ABSTRACT

This document describes the known exceptions to the functional specifications (advisories).

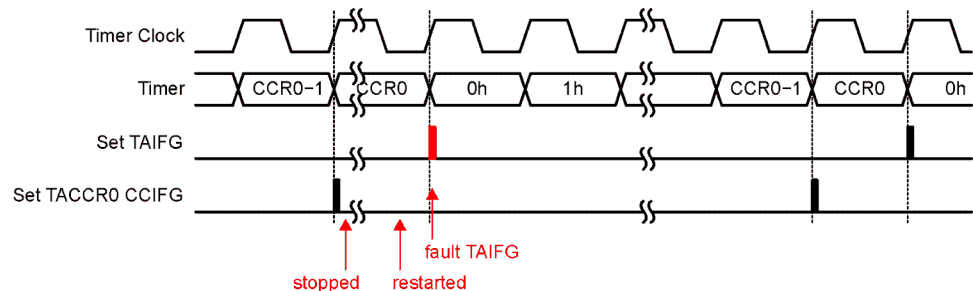
**Function** TAIFG Flag is erroneously set after Timer A restarts in Up Mode

**Description** In Up Mode, the TAIFG flag should only be set when the timer counts from TACCR0 to zero. However, if the Timer A is stopped at  $TAR = TACCR0$ , then cleared ( $TAR=0$ ) by setting the TACLRL bit, and finally restarted in Up Mode, the next rising edge of the TACLK will erroneously set the TAIFG flag.

**Workaround** None.

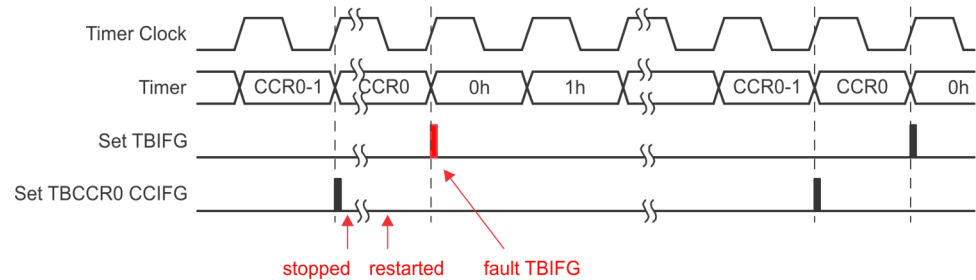
<b>Workaround</b>	None
<b>TB24</b>	<b><i>TB Module</i></b>
<b>Category</b>	Functional
<b>Function</b>	TBIFG Flag is erroneously set after Timer B restarts in Up Mode
<b>Description</b>	In Up Mode, the TBIFG flag should only be set when the timer resets from TBCCR0 to zero. However, if the Timer B is stopped at TBR = TBCCR0, then cleared (TBR=0) by setting the TBCLR bit, and finally restarted in Up Mode, the next rising edge of the TBCLK will erroneously set the TBIFG flag.

**Workaround** None.
