CC2340R5-Q1 SimpleLink™ Wireless MCU Device Revision B

ABSTRACT

This document describes the known exceptions to functional specifications (advisories) to the CC2340R5-Q1 and CC2340R53-Q1 SimpleLink™ devices.

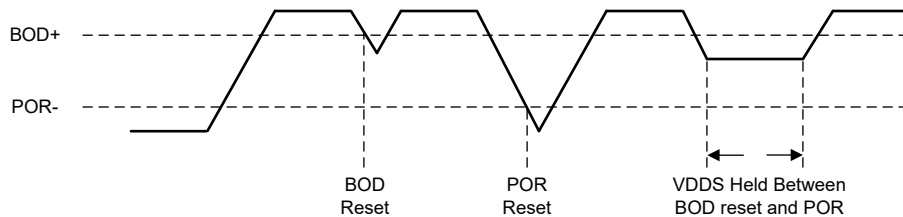
Figure 3-1. Diagram showing occurrence

If the VDD5 supply voltage is held in the BOD threshold region (approximately 1.68V), the device might, on rare occasions, enter a lock-up state. In this state, the device draws approximately 2.25mA of current and will not recover even if the VDD5 supply voltage is subsequently increased above the BOD threshold. Recovery from this state requires either a pin reset or reducing the VDD5 supply voltage below the power-on reset (POR) threshold (1.0V), thereby triggering a POR reset.

The lock-up state is triggered if a brown-out-detect (BOD) event occurs during specific stages of boot code execution. There are two critical narrow time windows, each of approximately 10 ns duration, and both of these time windows occur within 100 μs to 1 ms after the reset event that initiates the boot code. The issue typically arises when the supply voltage ramps slowly across the BOD threshold. In such cases, supply resistance in combination with device startup current may cause the VDD5 voltage to repeatedly dip below the BOD threshold as the device resets, increasing the likelihood of entering the lock-up state.

The specified operating supply voltage range for the device is 1.72V to 3.8 V. When using rechargeable batteries, the battery protection system must ensure one of the following:

- The device supply voltage remains at or above the minimum operating supply voltage (1.72V) once powered on, or
- If the device supply is discharged below the minimum operating supply voltage (1.72V), the device must be reset (pin or power-on reset) when the supply is charged above the minimum operating supply voltage (1.72V) again.
