# TMS320F28003x Real-Time MCUs Silicon Errata

## Silicon Revision 0

### ABSTRACT

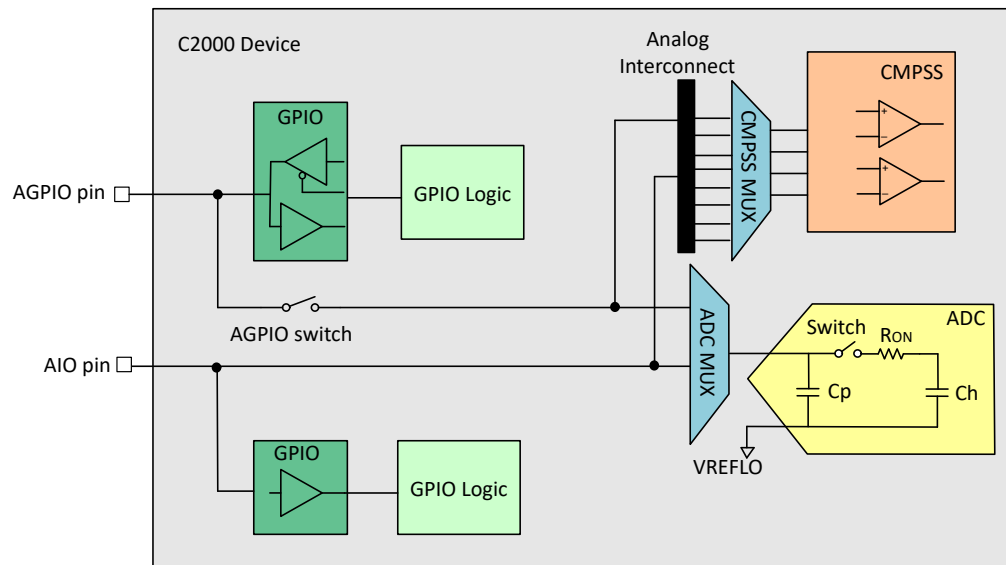
**Figure 3-1. Analog Subsystem Diagram with AGPIO and AIO Analog Pin Types**
**Workarounds**

The AGPIO analog pin path contains an extra series switch of 53Ω. This creates a low-capacitance isolated node shared by the ADC and CMPSS comparator, as shown in [Figure 3-1](#). This node can be disturbed when the ADC samples the channel (depending on the prior voltage stored on the ADC sample-and-hold capacitor), and this disturbance can cause a false CMPSS event of up to 50ns. To accommodate this potential disturbance, the workarounds below can be implemented.

1. Use a different pin (that is AIO pin type) for analog channels that need both ADC and CMPSS together.
2. Use the CMPSS Digital Filter with a setting of 50ns or greater, which will filter the temporary disturbance.
3. Precondition the sample-and-hold capacitor of the ADC so that the disturbance will not cause a false trip. For example, perform a dummy read of a 3.3V connection from a different channel on the ADC immediately before the impacted channel is read,
