TMS320VC5509A
Digital Signal Processor
Silicon Revision 1.0 and 1.1

Silicon Errata

Literature Number: SPRZ200F
June 2003–Revised September 2010

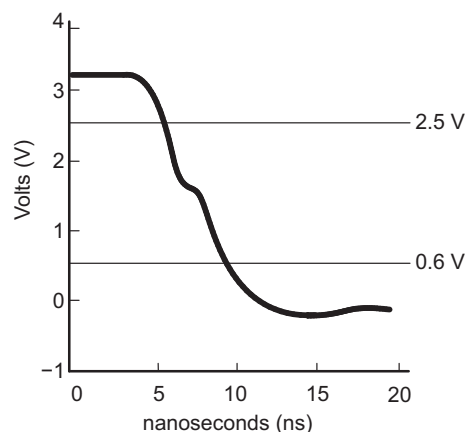
Figure 3. Bad TCK Transition

This phenomenon is observed when an erroneous clock edge is generated from the TCK signal inside the C55x™ DSP. This can be caused by several factors, acting independently or cumulatively:

A TCK edge that can cause this problem might look similar to the one shown in [Figure 3](#). A TCK edge that does not cause the problem will look similar to the one shown in [Figure 4](#). The key difference between the two figures is that [Figure 4](#) has a clean and sharp transition whereas [Figure 3](#) has a “knee” in the transition zone. Problematic TCK signals may not have a knee that is as pronounced as the one in [Figure 3](#). Due to the TCK signal amplification inside the chip, any perturbation of the signal can create erroneous clock edges.

When examining a TCK signal for this issue, either in board simulation or on an actual board, it is very important to probe the TCK line as close to the DSP input pin as possible. In simulation, it should not be difficult to probe right at the DSP input. For most physical boards, this means using the via for the TCK pad on the back side of the board. Similarly, ground for the probe should come from one of the nearby ground pad vias to minimize EMI noise picked up by the probe.

As the problem may be caused by one or more of the above factors, one or more of the steps outlined below may be necessary to fix it:

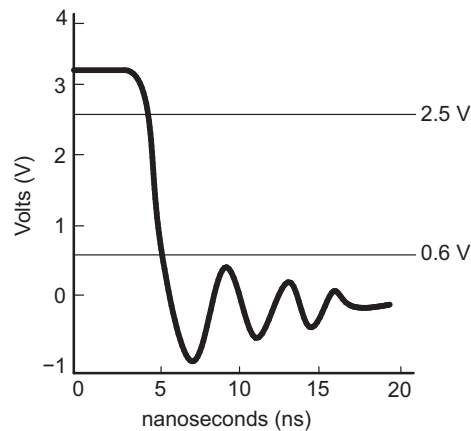
Figure 4. Good TCK Transition

As a result of the faster edge transition, there is increased ringing in [Figure 4](#). As long as the ringing does not cross logic input thresholds (0.6 V for falling edges, and 2.5 V for rising edges), this ringing is acceptable.

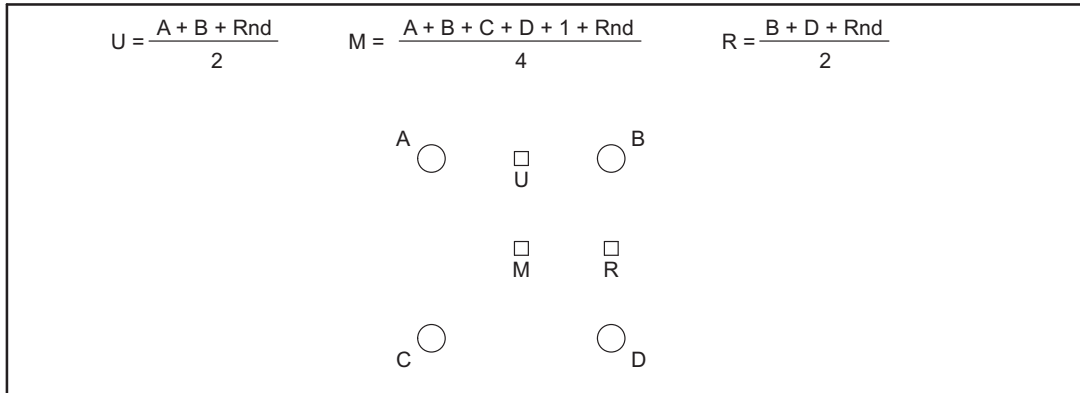
The pixel interpolation computation is wrong by one pixel unit in “Decoder” mode, when “Rounding Mode” is set to zero and when half-pixel interpolation is performed in the middle of four full-resolution pixels (i.e., in the middle of two rows of pixels).

In “Decoder” mode, the Pixel Interpolator data path is configured to deliver two interpolated pixels per cycle. Each section of the data path implements the computations shown below, normalized according to video decoding standards:

U and R results are interpolated from lines and columns, respectively. M is computed from two following full-resolution pixels lines. Two U, R, or M results are computed during each cycle by the data path, according to the instruction being executed by the accelerator for the M results set (the results are denoted as M0 and M1). When “Rounding Mode” (Rnd in the above picture) is set to 1, the faulty data path section is implemented, $M0 = (A+B+C+D+2)/4$, which is the correct result; but when “Rounding Mode” is set to 0, the data path section implements $M0=(A+B+C+D)/4$. This is not correct and generates a bit exactness issue. The M1 result is always correct, regardless of the “Rounding Mode” state.
