TDA2Ex
SoC for Advanced Driver Assistance
Systems (ADAS)
23mm (ABC) Package (SR2.0, SR1.0)
17mm (CBD) Package (SR2.1, SR2.0)

Errata

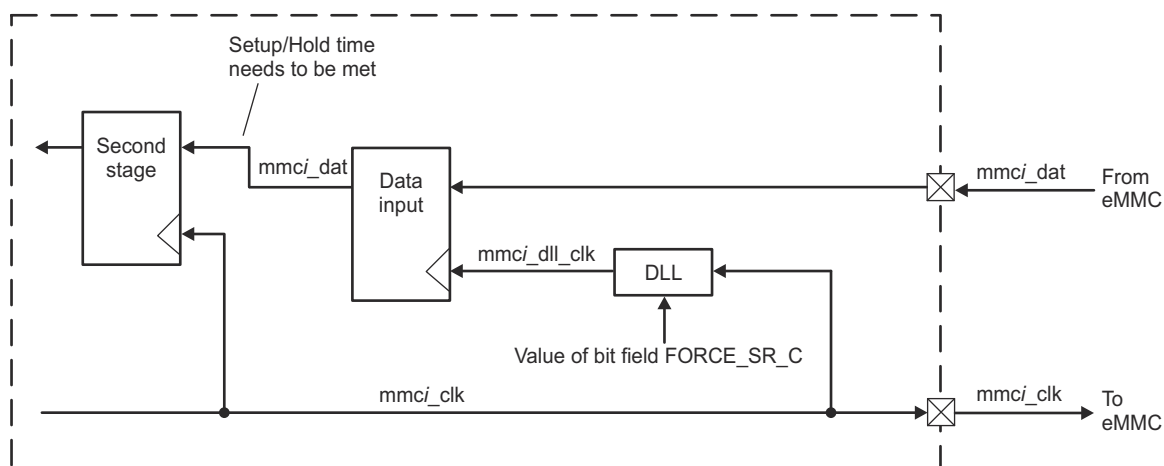
Figure 2-1. Simplified SoC 192-MHz Mode DLL Block Diagram

Internal to the MMC module, a second stage latch is used to recapture data captured by DLL delayed clock, `mmci_dll_clk`. The second stage latch captures with the original transmitting clock, `mmci_clk`.

`mmci_dll_clk` and `mmci_clk` both run at the same clock frequency. This results in a narrow range of tuning ratio elements, where the delayed `mmci_dll_clk` comes in phase with `mmci_clk`. If the clocks are in phase, the data captured by the first clock violates the setup and hold time requirements needed for the second stage latch, resulting in incorrectly read data. This is known as tuning re-timing errors.

A DLL tuning algorithm has been implemented that can avoid the tuning re-timing errors. More details on this can be found in App Note [SPRACA9](#). The following notes summarize the updated algorithm:

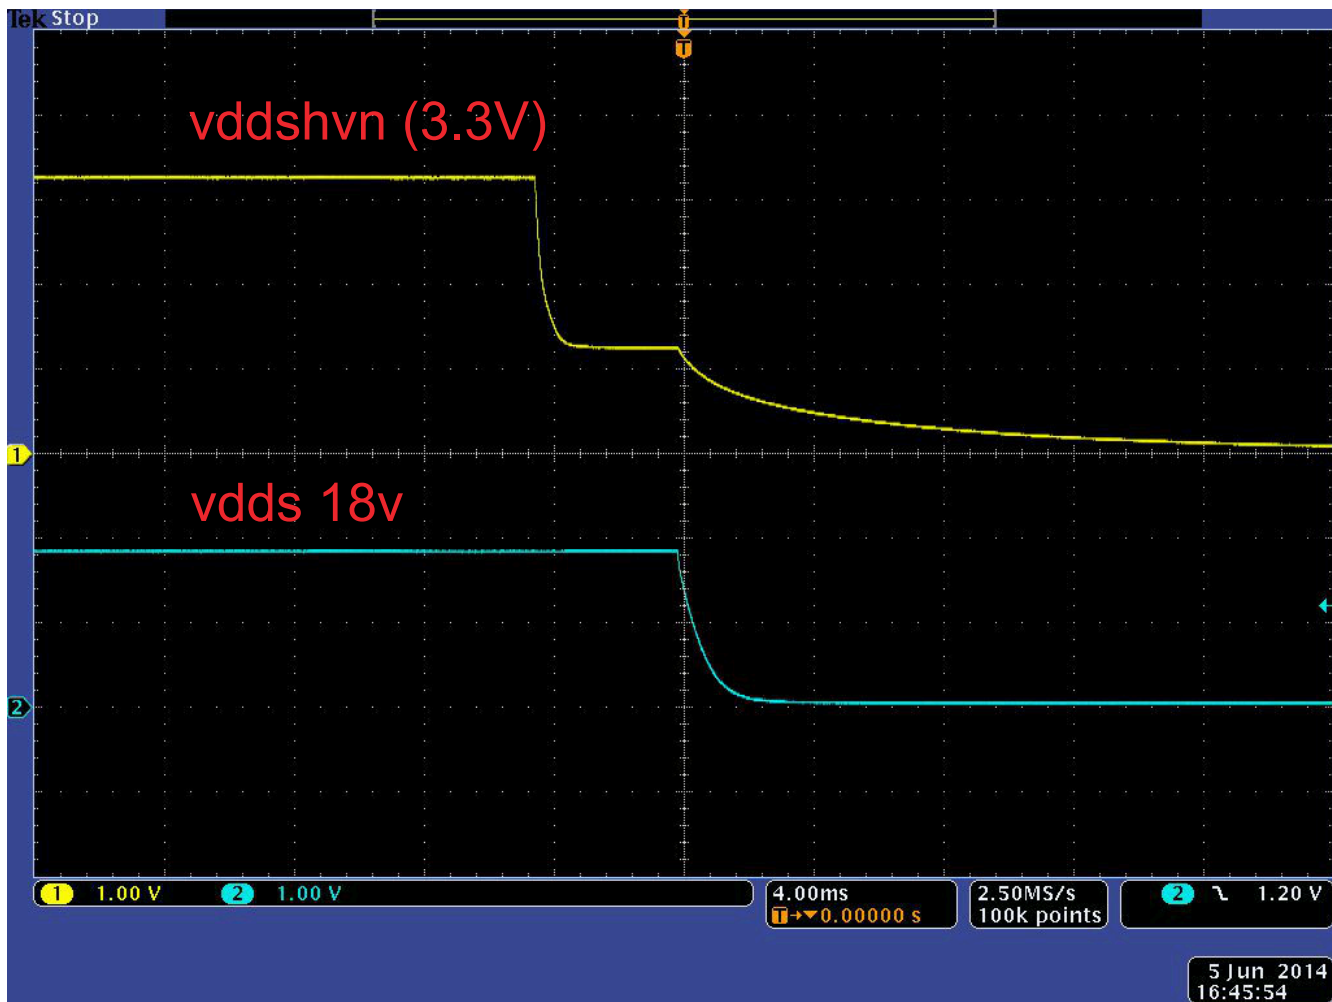
Figure 4-1. PAB_RevA

The Data Manual allows the vddshvn rail (in either 3.3V or 1.8V mode) to power down at the same time or before the vdds18v rail. When the vddshvn rail is powered down before the vdds18v rail, the vddshvn rail stays at Plateau Level (<1.5V) until the vdds18v rail is disabled, as shown in the waveform below.

A subset of the SOC's LVCMOS IOs (refer to DM for details) have a pull-up resistor that is active by default, including during reset and power-down. The SOC's IOs that have internal or external pull-ups will stay at Plateau Level (<1.5V) during the power-down. If other ICs on the board that are interfaced to the SOC's LVCMOS signals use a separate supply then it's possible that the other IC's signals can be pulled to the Plateau Level while its power supply is off.

The root cause of the plateau is related to the LVCMOS IO buffer Dual Voltage detection circuitry. The LVCMOS Dual Voltage IO includes voltage comparator circuitry to determine

In general, TI recommends using the same supply source for connected components. E.g., a single LDO should drive vddshvn and the related 3.3V external components.

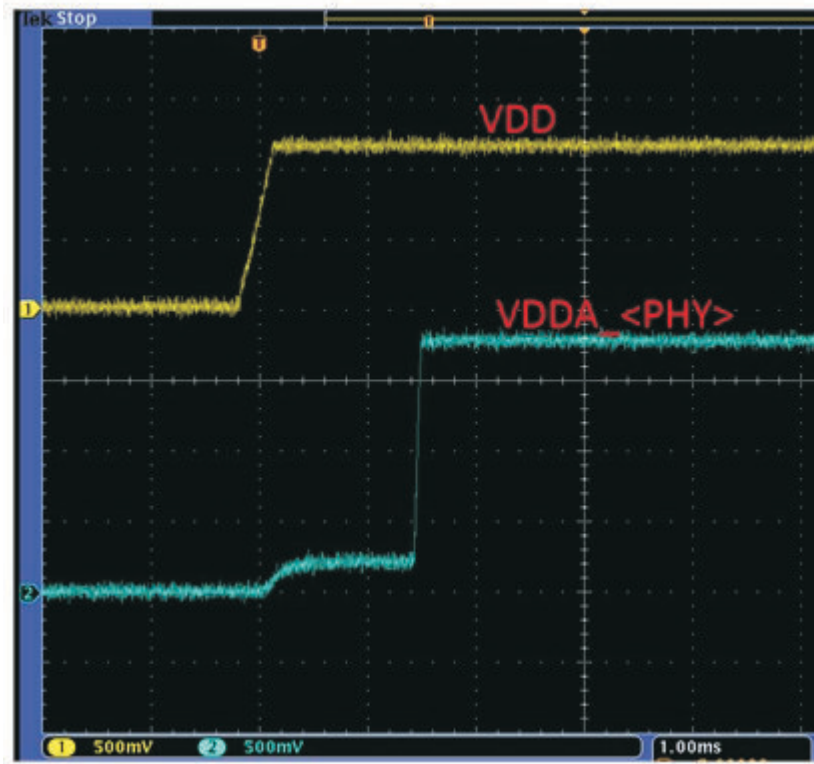
Figure 4-2. Leakage Voltage

The device-specific Data Manual requires Core AVS rail (VDD) to power up before the 1.8 V high speed analog PHY domain(s). When this sequence is followed, the high speed analog PHY domain will have a small step-up to a voltage plateau (< 0.5 V) that aligns to the beginning of the VDD ramp-up, and is maintained until the ramp-up of high speed analog PHY rail, as shown in Figure 4-2. Note the leakage value will differ from system to system, but will be less than 500 mV. The leakage voltage in the provided capture is approximately 250 mV.

A similar condition exist during supply power down sequence. The high speed analog PHY domain(s) are required to be powered down prior to Core AVS rail (VDD), and may cause a small plateau to exist until Core AVS rail (VDD) is ramped down.

The root cause of the voltage plateau during power-up/down sequencing is related to the parasitic diodes in logic blocks which have multiple power sources. This leakage path is not a reliability concern for this device.

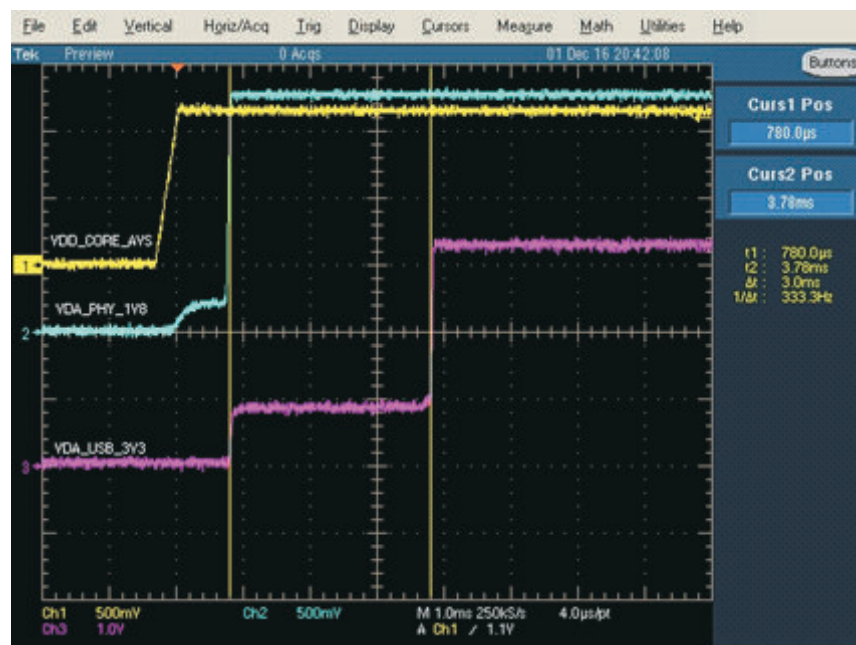
Figure 4-3. Original Power-Up Sequence

An unintended leakage current path between VDDA_PCIE (1.8 V) and VDDA33V_USB1 (3.3 V) due to ESD protection diode connection across the signal to I/O supply pads exists. This path can allow current to flow from VDDA_PCIE to VDDA33V_USB1. The current flows whenever the voltage level on VDDA_PCIE exceeds VDDA33V_USB1 by more than a diode drop during certain power-up and power-down sequences.

This leakage current causes the un-energized VDDA33V_USB1 to rise to a ~1 V plateau (see Figure 4-3) due to the power resource's "off impedance" seen between the VDDA33V_USB1 power rail to ground. When the minimum "off impedance" is $\geq 100 \Omega$, the SoC leakage current is small and sustainable with no SoC reliability impacts.

Note: Figure 4-3 shows in VDA_PHY_1V8 rail a plateau approximately 250 mV documented in i931, VDD to VDDA_"PHY" Current Path.

TI recommended Power Delivery Networks (PDNs) could have multiple different PMIC LDO power resources connected to the VDDA33V_USB1 rail. The LP8733/32 PMICs have a minimum OFF resistance equal to 150Ω so a PDN using these PMICs would not exceed safe leakage current level and could continue to use the original SoC power sequences. However, the TPS65917/919 PMICs have a minimum OFF resistance equal to 30Ω and would exceed the safe leakage current limit. As a result, any PDN using TPS65917/919 PMICs must implement the revised power sequencing as shown in DM version D or later. The specific sequence changes are:
