Preventing ICT-Induced Electrical Overstress on TCA9617 I/O Ports

ABSTRACT

This application note describes a failure mechanism observed on the TCA9617 during In-Circuit Test (ICT) environments. The issue manifests as I/O ports becoming stuck low (particularly on SDAB, SCLB, or both) due to permanent damage of the device.

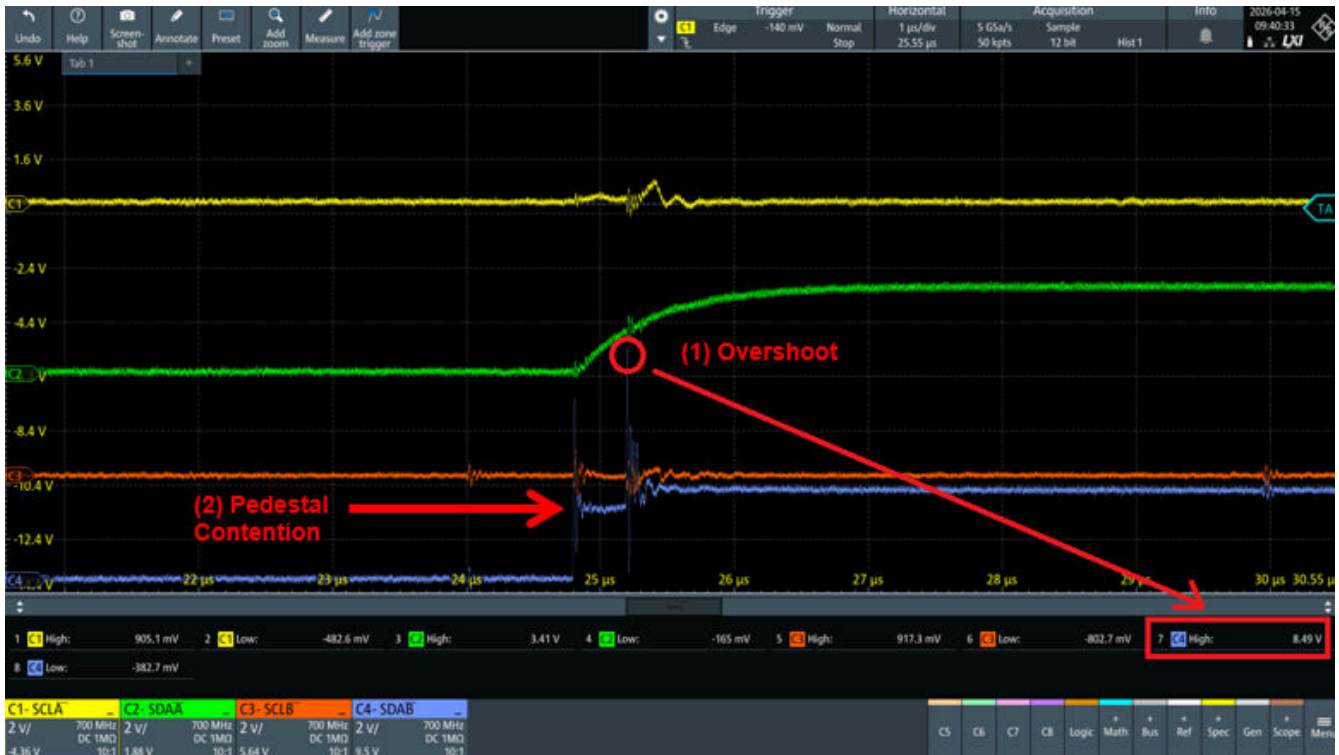
Figure 2-2. Overshoot Spike Test from ICT

Oscilloscope measurements captured significant overshoot and undershoot events during ICT operation. The worst-case overshoot measured 8.62V, while the worst-case undershoot measured -4.28V. These values exceeded the datasheet absolute maximum ratings of 6.5V and -0.5V, respectively for V_{IO} – I²C bus voltage range. The transient spikes therefore subjected the device pins to electrical overstress conditions. See [figure 2-2 note \(1\)](#) of this document for overshoot behavior. See [Figure 2-3](#) of this document for undershoot behavior.

Parameter	Measured Value	Datasheet Limit
Overshoot	8.62V	6.5V
Undershoot	-4.28V	-0.5V

1. Adding approximately 200-Ω series resistance in the ICT signal path to dampen ringing and reduce overshoot/undershoot.
2. Modifying the ICT test pattern to use open-drain drivers rather than push-pull.

In addition to the software changes, hardware changes were made by adding 200Ω series resistors to SCLA, SDAA, SCLB, and SDAB on the ICT test platform. The resistors provided edge-rate reduction, reflection damping, and suppression of LC resonance created by the long ICT interconnect structure. The resistors also limit the current to and from the buffer.

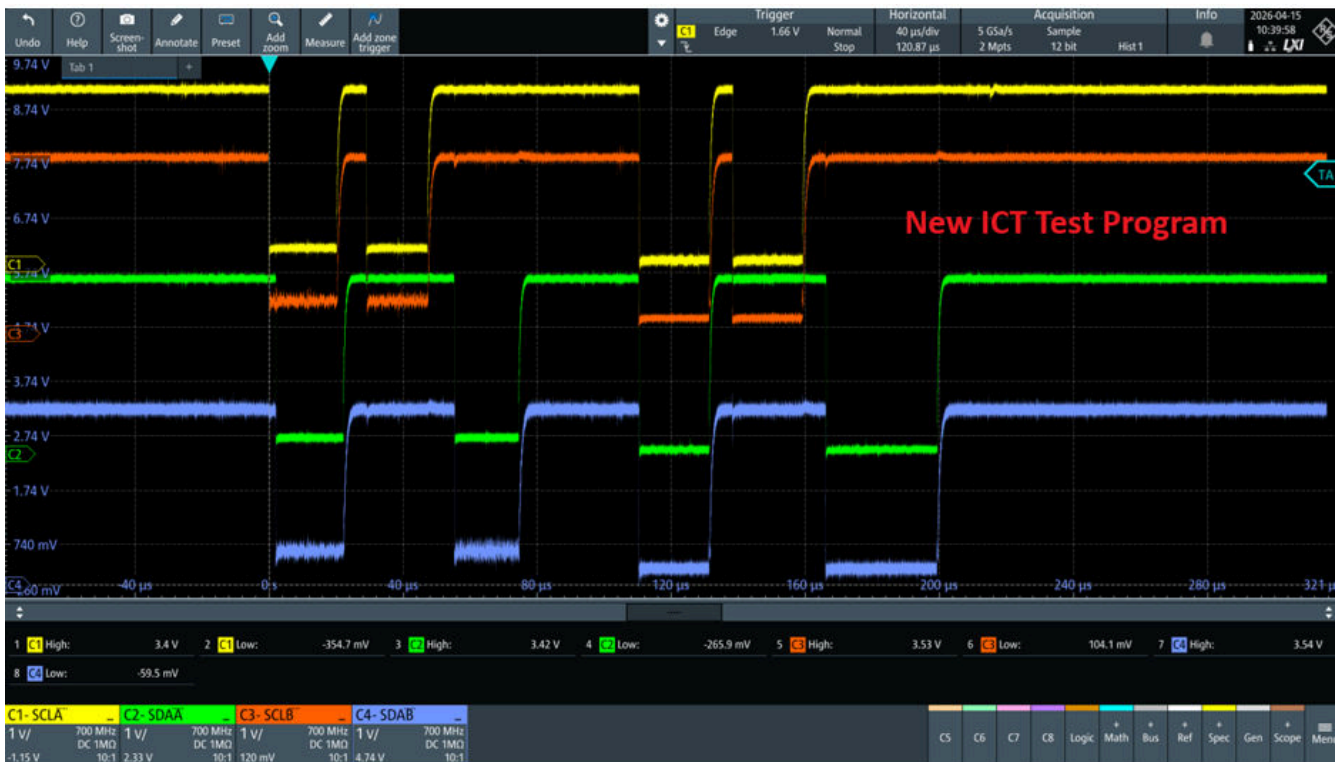
Figure 2-4. New ICT Setup with Software and Hardware Changes Reduces Overshoot/Undershoot Behavior and Resolves B-side Pedestal Contention

where “X” represents a “Don’t Care” state. In this updated approach, the logic-high condition was no longer actively driven by the tester (open-drain driver). Instead, the output was allowed to rise high through the existing pull-up resistors. This significantly reduced edge-rate aggressiveness which minimized overshoot generation during a low-to-high transition. The use of open-drain also resolves any contention with the pedestal voltage from the TCA9617 on B-side.

After implementing the updated ICT setup, waveform integrity improved significantly. The worst-case overshoot decreased from 8.62 V to 3.54 V, while the worst-case undershoot improved from -4.28 V to -0.35 V. All measured voltages were now within the datasheet absolute maximum specifications of the device. There exists no more pedestal contention.

Oscilloscope measurements also confirmed that ringing amplitude and transient spike energy were substantially reduced. Following implementation of the new ICT method and the addition of series resistors, no additional I/O damage or stuck-low conditions were observed during production testing.

Parameter	Measured Value (Before ICT changes)	Measured Value (After ICT changes)	Datasheet Limit
Overshoot	8.62V	3.54V	6.5V
Undershoot	-4.28V	-0.35V	-0.5V
