# Debugging a Current Shunt Monitor circuit – Probe Placement and Soldering

TI Precision Labs – Current Sense Amplifiers

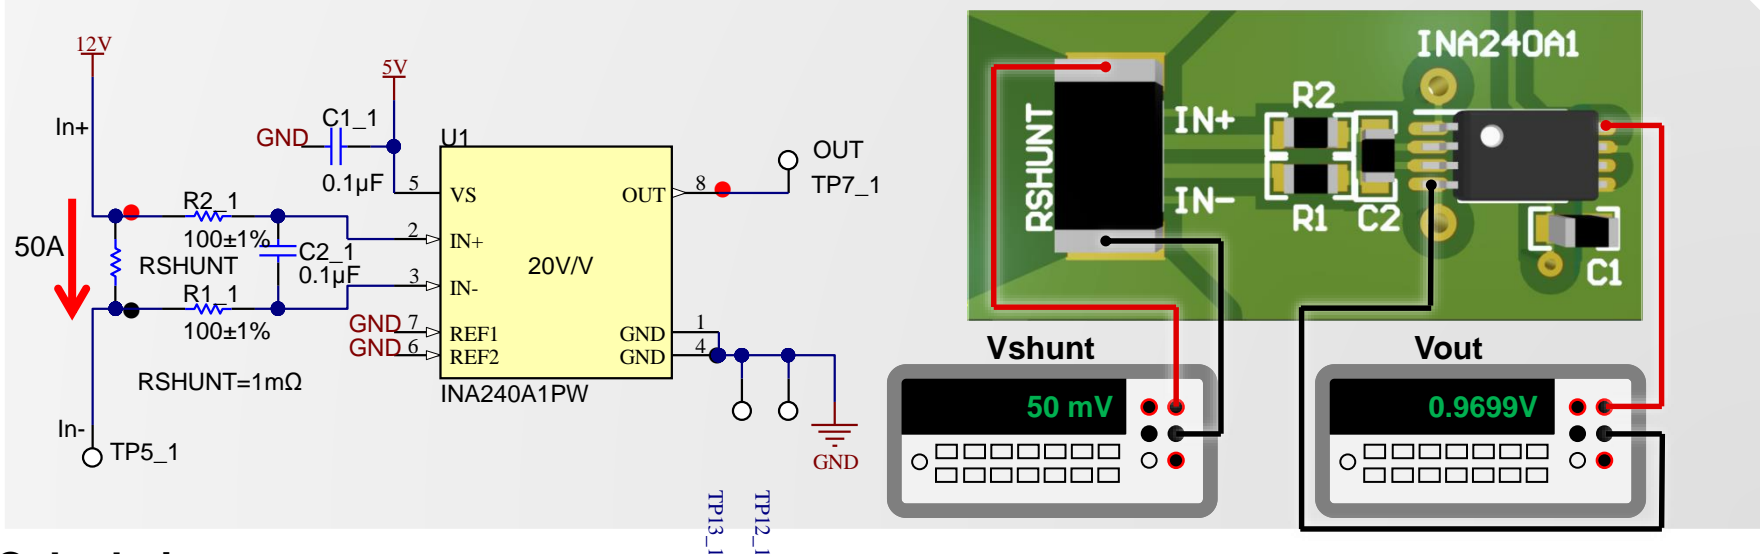
# Probe Placement: Case 2

Now lets consider a different case involving the INA240 with a 20V/V gain. In this instance we are trying to measure a 50A load. Based upon our calculations, we expect the output to be 1V. Yet we measure a value that is 30.1mV lower, suggesting our measured load is 48.495A. The schematic looks fine, and our layout indicates symmetric kelvin connections to the shunt. Obviously, this part is broken! Or is it...?

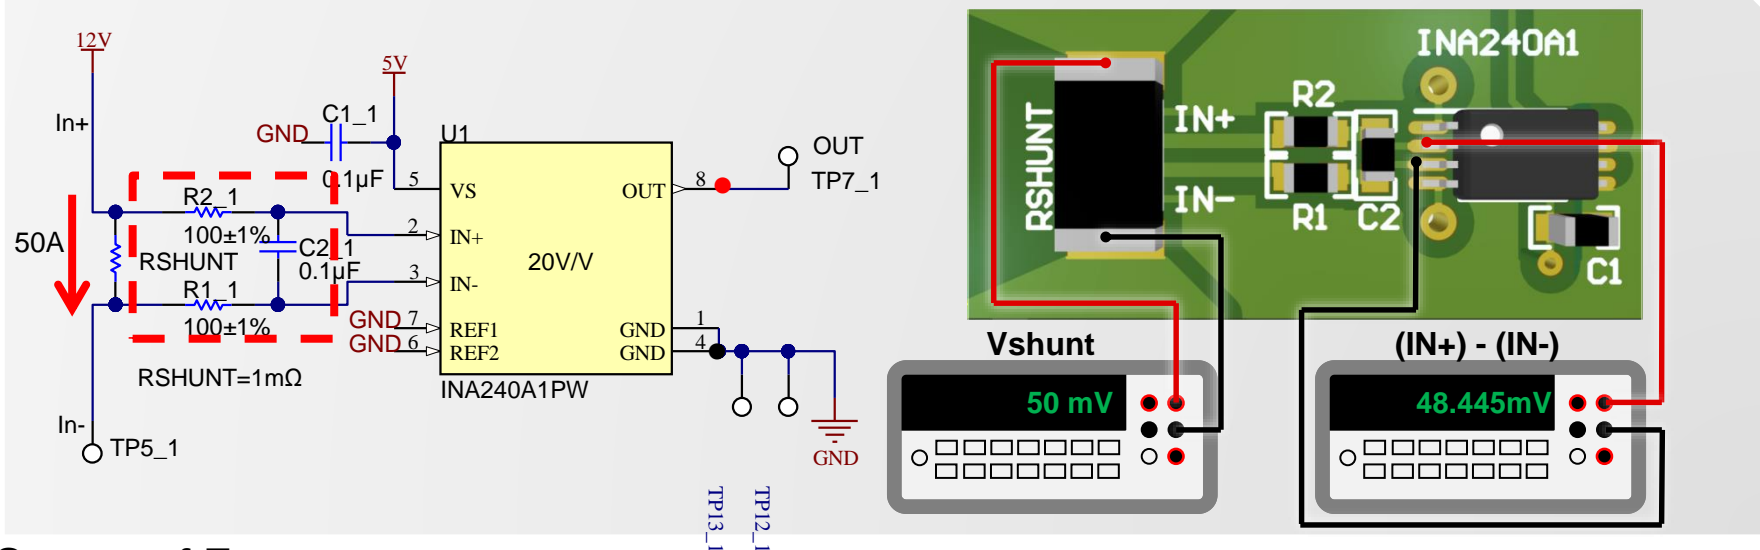
# Probe Placement: Case 2

We decide do some further probing and discover that right at the device input pins we measure a different differential voltage. It turns out that the differential between IN+ and IN- is 48.445mV, a little lower than our ideal 50mV. We now have determined the source of ire to be the filter. But why?

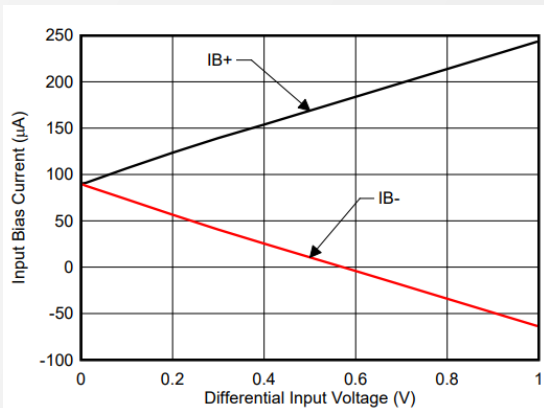
Recalling from our layout video that trace symmetry can influence measurement error due to input bias current, we turn back to the schematic and realize that while our traces are symmetric, the filter resistors may not be. The tolerances are 1% on 100Ω resistors. In the extreme case where the resistors have the greatest difference between them, we find the INA240 output could be offset by as much as 3.6mV from the ideal output. While for precision measurements this is significant, it is still almost 10x smaller than the error we are observing, so what else could be our issue? Well we are actually quite close now. Further digging into the datasheet reveals gain error formulas. After putting our filter resistance values into the formula, we see that our output could be as low as 968mV neglecting all other sources of error. It is because of this gain error issue, we typically recommend all filter resistors be no greater than 10Ω for most of our devices. Aside from using small filter resistors with tight tolerances, the key takeaway from this case and the prior case is to probe at multiple points along your signal path starting at the device input and output pins. By doing so you will be able to determine if the signal is reaching the device and thereby discern if the device is indeed broken or you may be able to discover some solder issues.

Additionally as current shunt monitors have input bias currents and due to their sense inputs not being buffered, resistances between the shunt and input pins will influence the offset and gain error of the device.

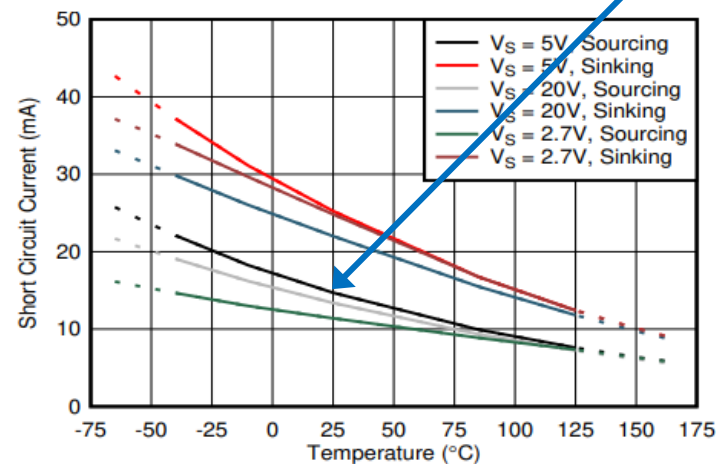
Figure 6-20. Short-Circuit Current vs Temperature

The best answer here is OUT is shorted to GND. While we do not have enough details from the Eload side to determine if there is a connection issue to the input pins, we do have details from the supply that suggest there is a connection issue with the supply. Based on the features section pulled from the datasheet, we should see a quiescent current less 25mA. If VS were shorted directly to GND, we would expect the supply to hit the compliance value set. If the compliance was set even higher, we might expect to hear a pop when the solder bridge shorting VS and GND fused open. As the supply definitely has an issue, the only logical choice left is that OUT is shorted to GND. This actually corresponds to the short circuit graph and claw curves

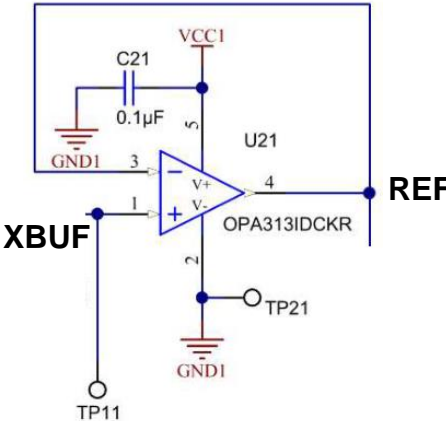
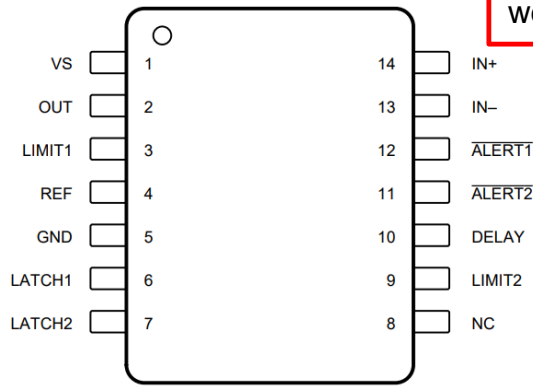
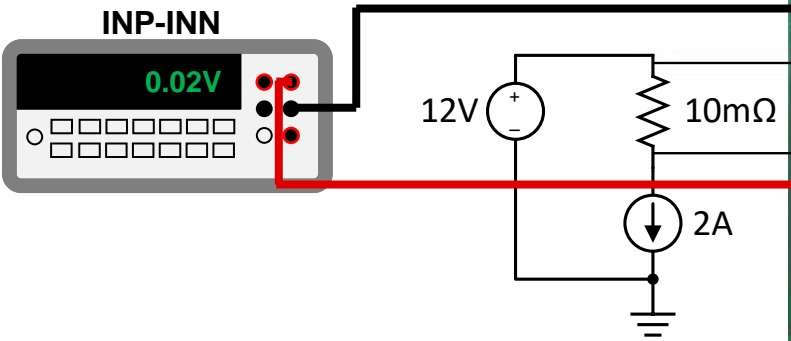
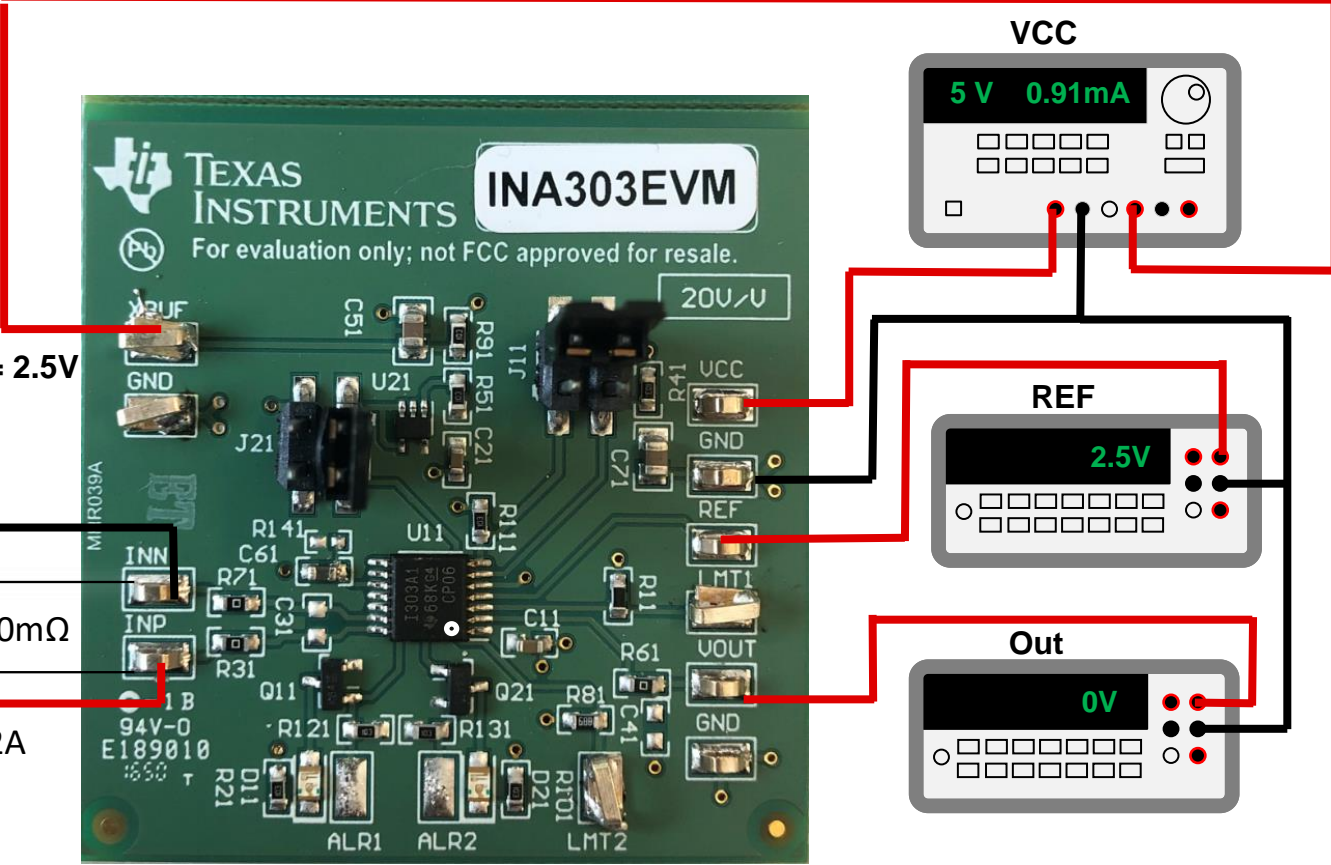
We cannot assume that it is broken just yet. The supply indicates that there is current being pulled and while it is above the device typical value, it is still within specification. The REF meter indicates that there is a good signal path from XBUF to the device reference as the device ref pin is between REF test point and the XBUF output. One thing to note is that for INP, INN, and OUT, we are probing at test points and not at the device pins. While they are more convenient to work with, they may not accurately reflect the potential at the device value as there are resistors between the test points and the device. Its possible that these may not be soldered down as well as we think.

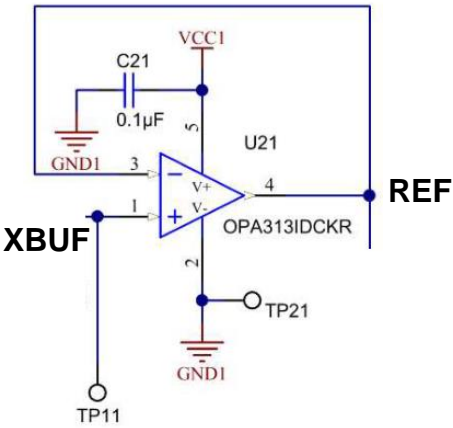
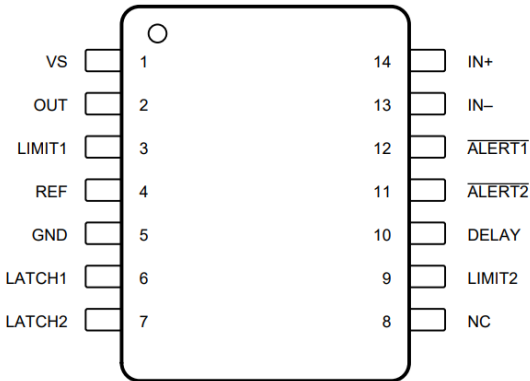
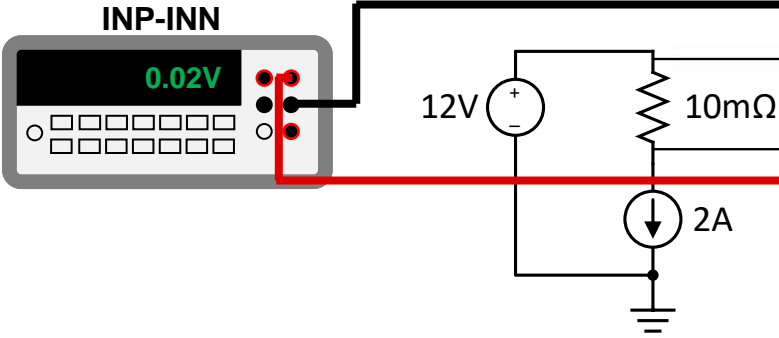
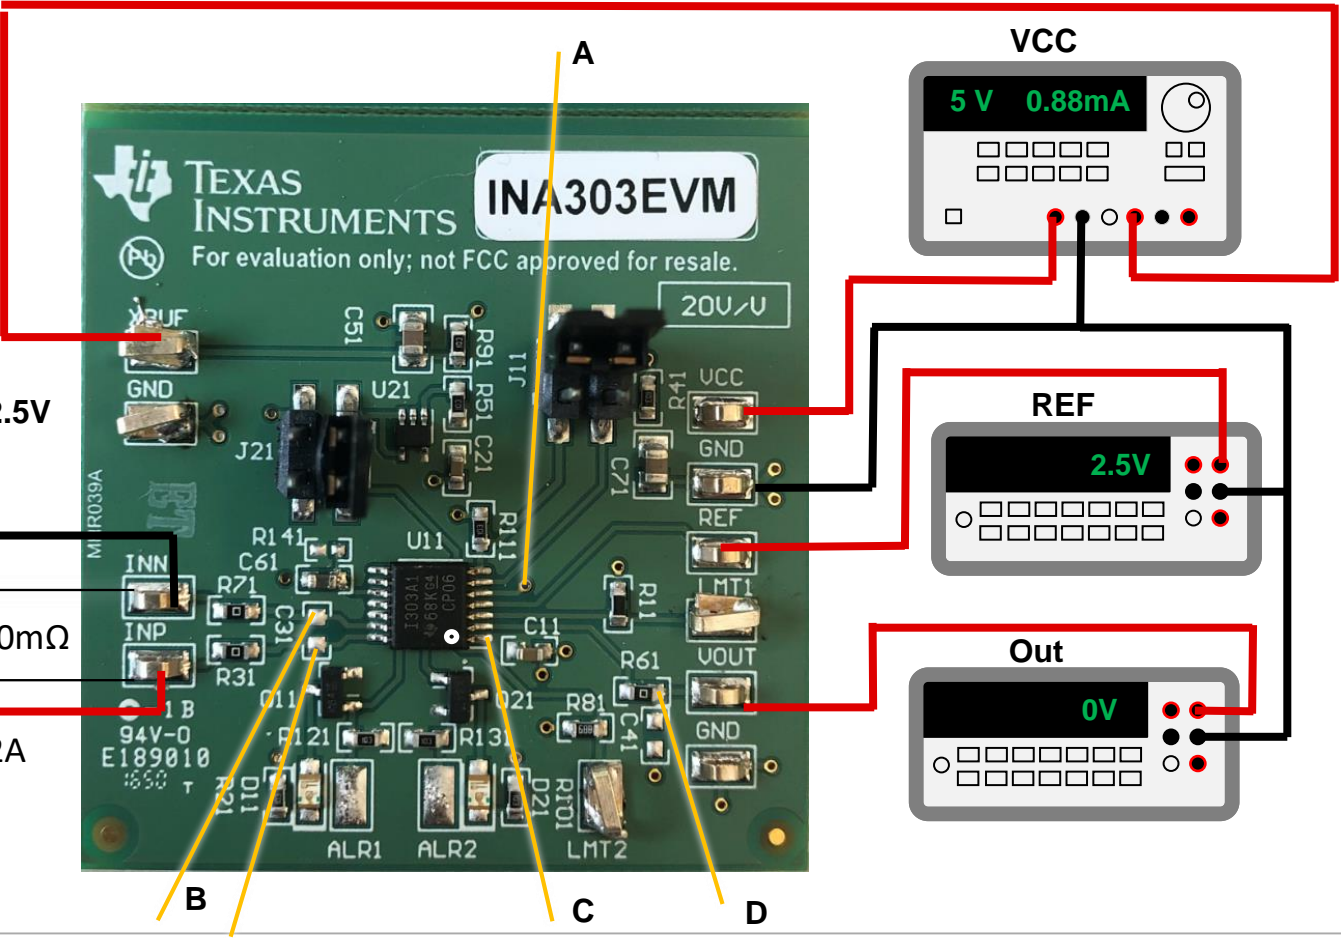
Yet again the quiescent current suggests the device is working properly, which eliminates the need to probe VS (C) and GND (A). While it is possible that the series resistor on the output could be open, option D would be probing on the wrong side of the device to verify that. This leaves only choice B which has us probing the input pins where an optional input filter cap could be placed. While this is not directly at the device pin, there is no device between that could have a bad solder connection other than the INA303.
