*Errata*

# *DRA72x (SR 2.0, 1.0) and DRA71x (SR 2.1, 2.0) SoC for Automotive Infotainment*

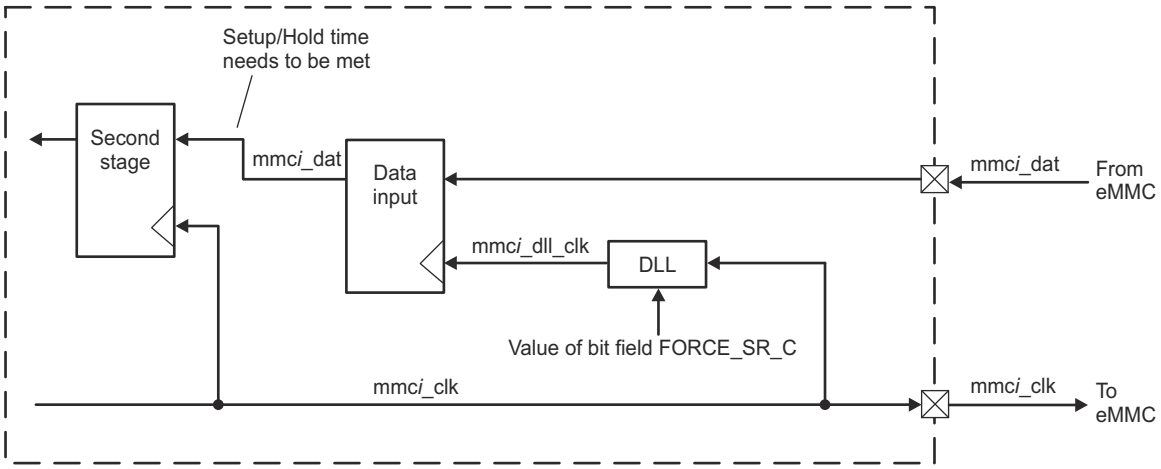
**Figure 2-1. Simplified SoC 192-MHz Mode DLL Block Diagram**

Internal to the MMC module, a second stage latch is used to recapture data captured by DLL delayed clock, mmc*i*_dll_clk. The second stage latch captures with the original transmitting clock, mmc*i*_clk.

mmc*i*_dll_clk and mmc*i*_clk both run at the same clock frequency. This results in a narrow range of tuning ratio elements, where the delayed mmc*i*_dll_clk comes in phase with mmc*i*_clk. If the clocks are in phase, the data captured by the first clock violates the setup and hold time requirements needed for the second stage latch, resulting in incorrectly read data. This is known as tuning re-timing errors.

A DLL tuning algorithm has been implemented that can avoid the tuning re-timing errors. More details on this can be found in App Note SPRACA9. The following notes summarize the updated algorithm:

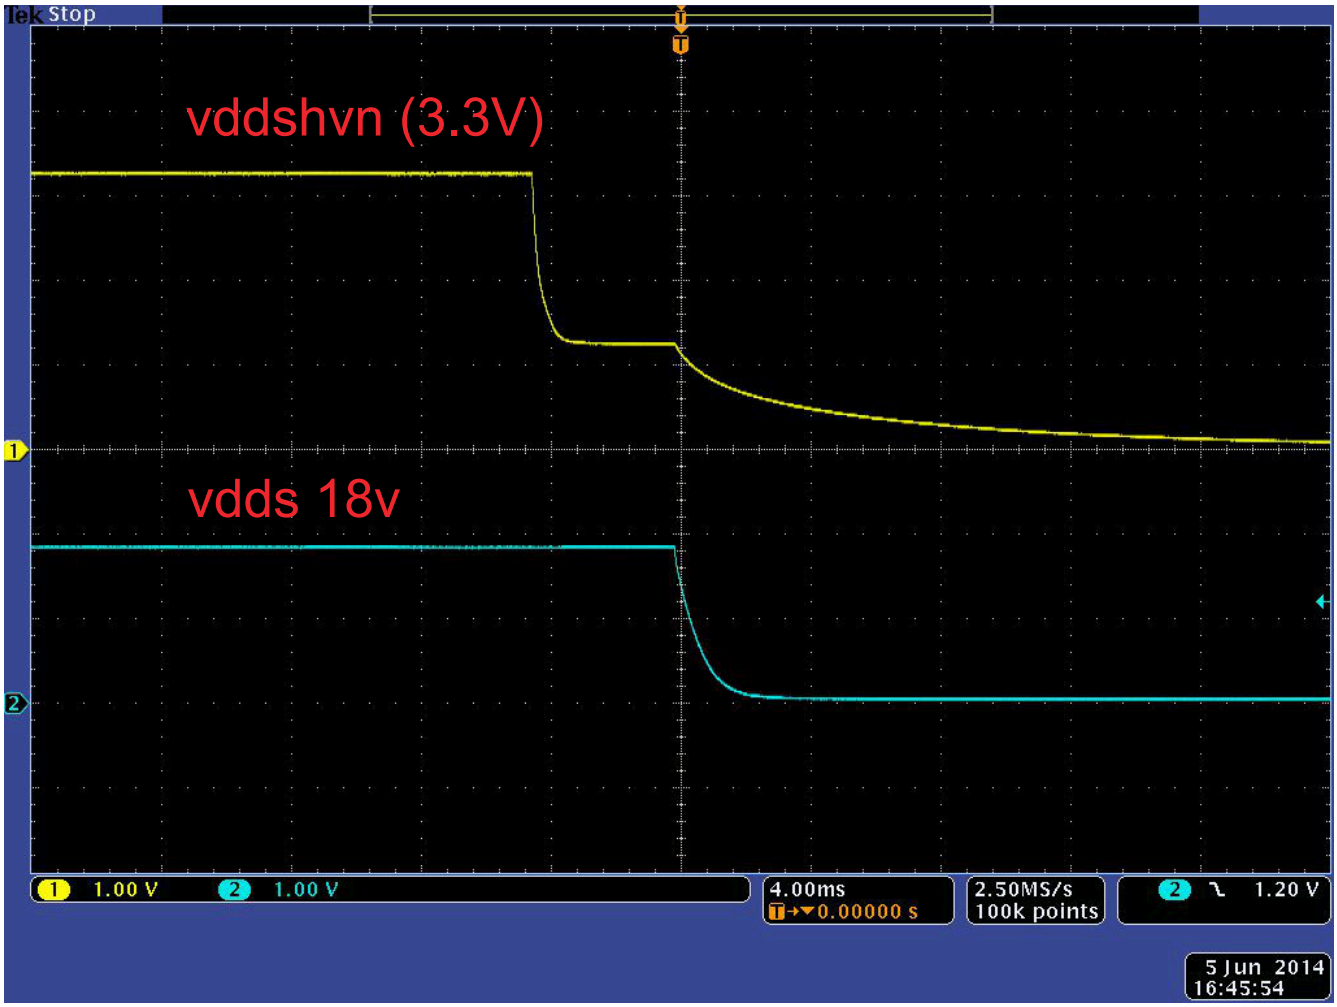
**Figure 4-1. PAB_RevA**

The Data Manual allows the vddshvn rail (in either 3.3V or 1.8V mode) to power down at the same time or before the vdds18v rail. When the vddshvn rail is powered down before the vdds18v rail, the vddshvn rail stays at Plateau Level (<1.5V) until the vdds18v rail is disabled, as shown in the waveform below.

A subset of the SOC's LVCMOS IOs (refer to DM for details) have a pull-up resistor that is active by default, including during reset and power-down. The SOC's IOs that have internal or external pull-ups will stay at Plateau Level (<1.5V) during the power-down. If other ICs on the board that are interfaced to the SOC's LVCMOS signals use a separate supply then it's possible that the other IC's signals can be pulled to the Plateau Level while its power supply is off.

The root cause of the plateau is related to the LVCMOS IO buffer Dual Voltage detection circuitry. The LVCMOS Dual Voltage IO includes voltage comparator circuitry to determine if the IO is in 3.3V mode or 1.8V mode. During powerdown of vddshvn domains, a current path in the internal bias transistors results in the vddshvn rail being held to an

In general, TI recommends using the same supply source for connected components. E.g., a single LDO should drive vddshvn and the related 3.3V external components.

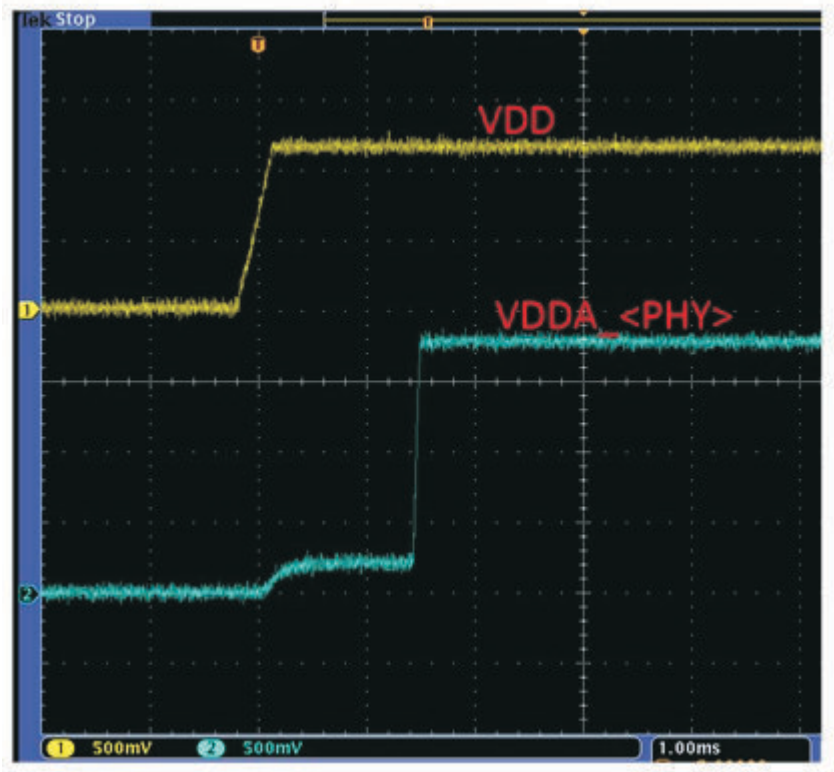
**Figure 4-2. Leakage Voltage**

The device-specific Data Manual requires Core AVS rail (VDD) to power up before the 1.8 V high speed analog PHY domain(s). When this sequence is followed, the high speed analog PHY domain will have a small step-up to a voltage plateau (< 0.5 V) that aligns to the beginning of the VDD ramp-up, and is maintained until the ramp-up of high speed analog PHY rail, as shown in Figure 4-2. Note the leakage value will differ from system to system, but will be less than 500 mV. The leakage voltage in the provided capture is approximately 250 mV.

A similar condition exist during supply power down sequence. The high speed analog PHY domain(s) are required to be powered down prior to Core AVS rail (VDD), and may cause a small plateau to exist until Core AVS rail (VDD) is ramped down.

The root cause of the voltage plateau during power-up/down sequencing is related to the parasitic diodes in logic blocks which have multiple power sources. This leakage path is not a reliability concern for this device.

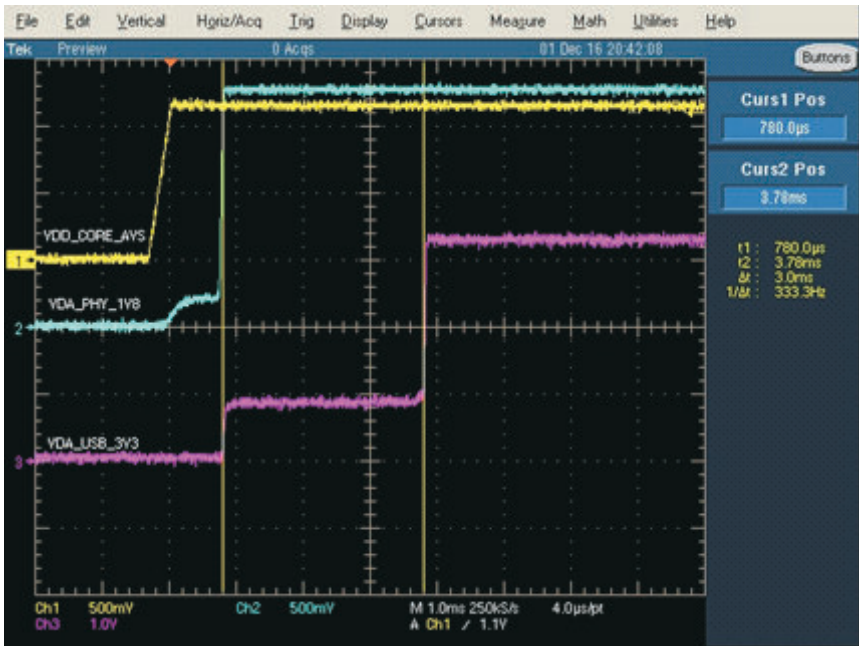
**Figure 4-3. Original Power-Up Sequence**

An unintended leakage current path between VDDA_PCIE (1.8 V) and VDDA33_USB1 (3.3 V) due to ESD protection diode connection across the signal to I/O supply pads exists. This path can allow current to flow from VDDA_PCIE to VDDA33V_USB1. The current flows whenever the voltage level on VDDA_PCIE exceeds VDDA33V_USB by more than a diode drop during certain power-up and power-down sequences.

This leakage current causes the un-energized VDDA33V_USB1 to rise to a ~1 V plateau (see Figure 4-3) due to the power resource's "off impedance" seen between the VDDA33V_USB1 power rail to ground. When the minimum "off impedance" is >= 100 Ω, the SoC leakage current is small and sustainable with no SoC reliability impacts.

Note: Figure 4-3 shows in VDA_PHY_1V8 rail a plateau approximately 250 mV documented in i931, VDD to VDDA_"PHY" Current Path.

TI recommended Power Delivery Networks (PDNs) could have multiple different PMIC LDO power resources connected to the VDDA33V_USB1 rail. The LP8733/32 PMICs have a minimum OFF resistance equal to 150 Ω so a PDN using these PMICs would not exceed safe leakage current level and could continue to use the original SoC power sequences. However, the TPS65917/919 PMICs have a minimum OFF resistance equal to 30 Ω and would exceed the safe leakage current limit. As a result, any PDN using TPS65917/919 PMICs must implement the revised power sequencing as shown in DM version D or later. The specific sequence changes are:

The following PMIC OTP IDs have been aligned to the revised power sequencing to avoid any leakage current:
