AM571x (SR 2.0, 1.0) and AM570x (SR 2.1, 2.0) Sitara™ Processors

Errata

Literature Number: SPRZ436I
OCTOBER 2015 – REVISED OCTOBER 2026

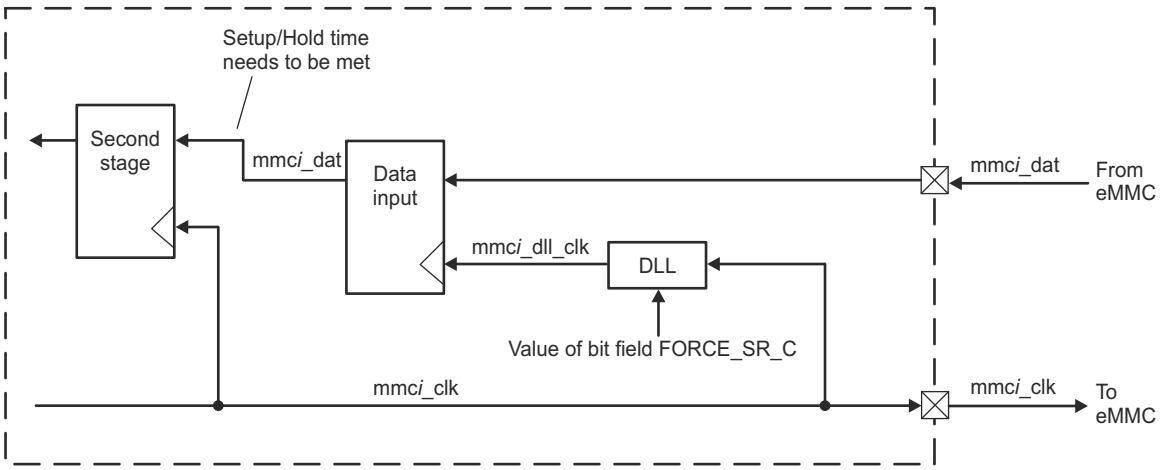
Figure 2-1. Simplified SoC 192-MHz Mode DLL Block Diagram

Internal to the MMC module, a second stage latch is used to recapture data captured by DLL delayed clock, mmc*i*_dll_clk. The second stage latch captures with the original transmitting clock, mmc*i*_clk.

mmc*i*_dll_clk and mmc*i*_clk both run at the same clock frequency. This results in a narrow range of tuning ratio elements, where the delayed mmc*i*_dll_clk comes in phase with mmc*i*_clk. If the clocks are in phase, the data captured by the first clock violates the setup and hold time requirements needed for the second stage latch, resulting in incorrectly read data. This is known as tuning re-timing errors.

A DLL tuning algorithm has been implemented that can avoid the tuning re-timing errors. More details on this can be found in App Note SPRACA9. The following notes summarize the updated algorithm:

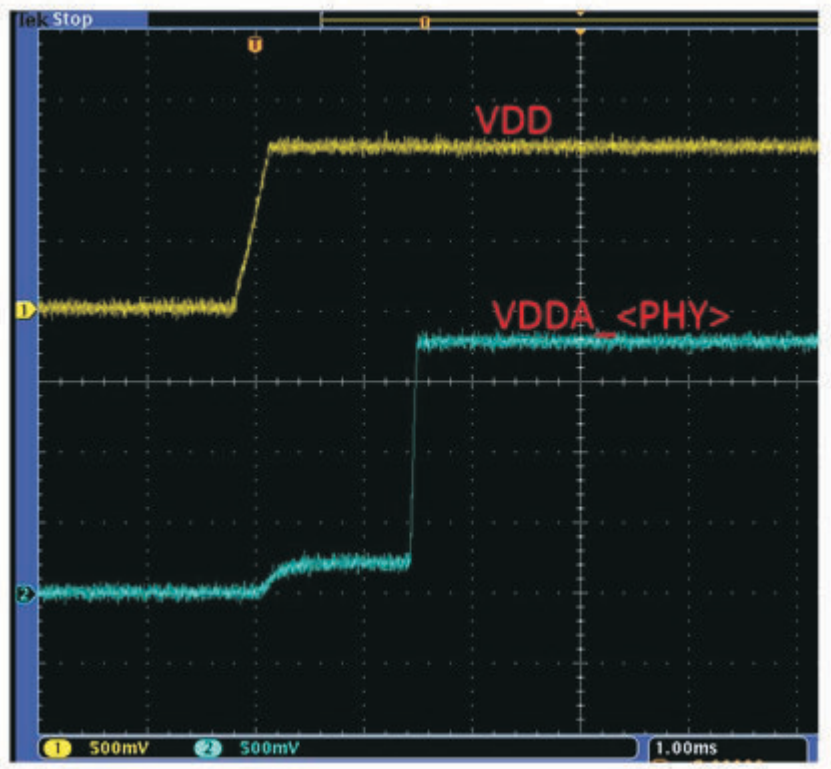
Figure 4-2. Leakage Voltage

The device-specific Data Manual requires Core AVS rail (VDD) to power up before the 1.8 V high speed analog PHY domain(s). When this sequence is followed, the high speed analog PHY domain will have a small step-up to a voltage plateau (< 0.5 V) that aligns to the beginning of the VDD ramp-up, and is maintained until the ramp-up of high speed analog PHY rail, as shown in Figure 4-2. Note the leakage value will differ from system to system, but will be less than 500 mV. The leakage voltage in the provided capture is approximately 250 mV.

A similar condition exist during supply power down sequence. The high speed analog PHY domain(s) are required to be powered down prior to Core AVS rail (VDD), and may cause a small plateau to exist until Core AVS rail (VDD) is ramped down.

The root cause of the voltage plateau during power-up/down sequencing is related to the parasitic diodes in logic blocks which have multiple power sources. This leakage path is not a reliability concern for this device.
