TMS320DM6441

Digital Media System-on-Chip

Silicon Revisions 2.3, 2.1, 1.3, 1.2, and 1.1

Silicon Errata

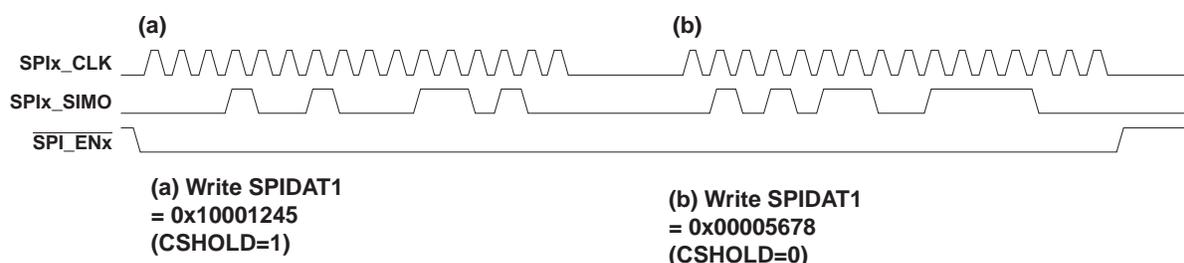
Figure 2. Expected CSHOLD Behavior

According to the SPI specification, the following sequence should produce the expected result as illustrated in Figure 2:

- Write 0x10001234 to SPIDAT1 for transmission of 0x1234 (CSHOLD = 1)
- Write 0x00005678 to SPIDAT1 for transmission of 0x5678 (CSHOLD = 0)

Instead, what actually occurs is that $\overline{\text{SPI_ENx}}$ is momentarily de-asserted at the beginning of the second write, as illustrated in Figure 3.

Both Figure 2 and Figure 3 assume that SPIDAT1 is written using a single 32-bit write instruction. If SPIDAT1 is instead written using an 8-bit or 16-bit instruction to write to the CSHOLD field, followed by a 16-bit write to the transmit shift register field of SPIDAT1, then what actually occurs is illustrated in Figure 4. This is the same case illustrated in Figure 3 except that the de-assertion of $\overline{\text{SPI_ENx}}$ lasts for the duration between writing a '0' to the CSHOLD field and writing new data to the transmit shift register.
