TMS320C6201
Digital Signal Processor
Silicon Errata

SPRZ153
November 2000

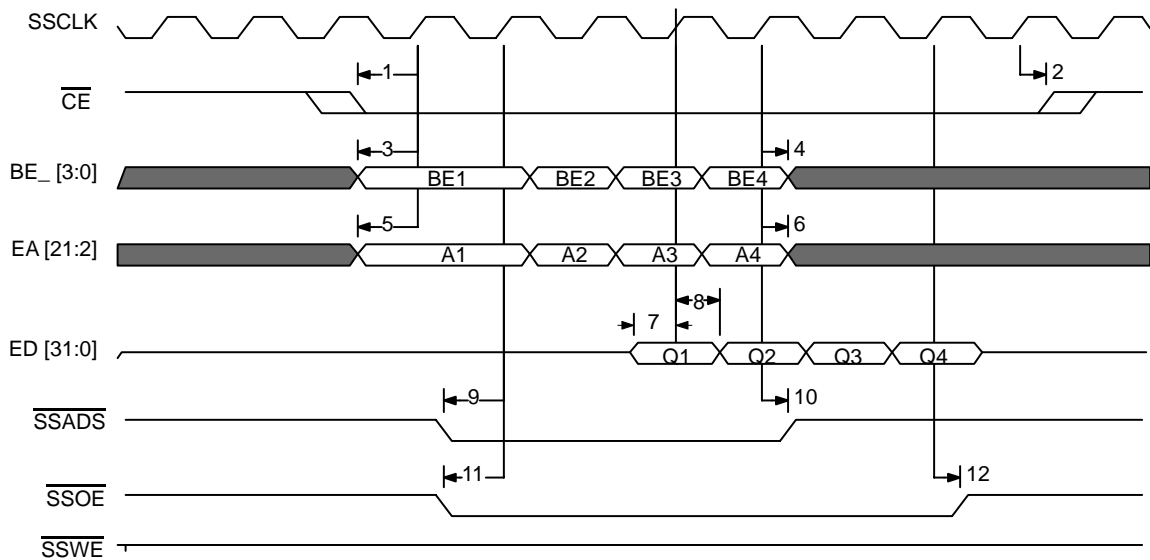
Figure 2. SBSRAM Read Timing (1/2 Rate SSCLK) (See Note)

NOTE: The $\overline{\text{CE}}$ output setup and hold times are specified to be accurate relative to the clock cycle to which they are referenced, since these timings are specified as minimums. However, the $\overline{\text{CE}}$ output setup and hold time may be greater than that shown in the data sheet in multiples of P ns. In other words, for output setup time, the $\overline{\text{CE}}$ transition from high to low may happen P, 2P, ..., or nP ns before the time specified by the data sheet. Similarly, for output hold time, the $\overline{\text{CE}}$ low-to-high transition may happen P, 2P, ..., or nP ns after the time specified by the data sheet. This is indicated by the period of uncertainty for specs 1 and 2 in Figure 2, and Figure 3.

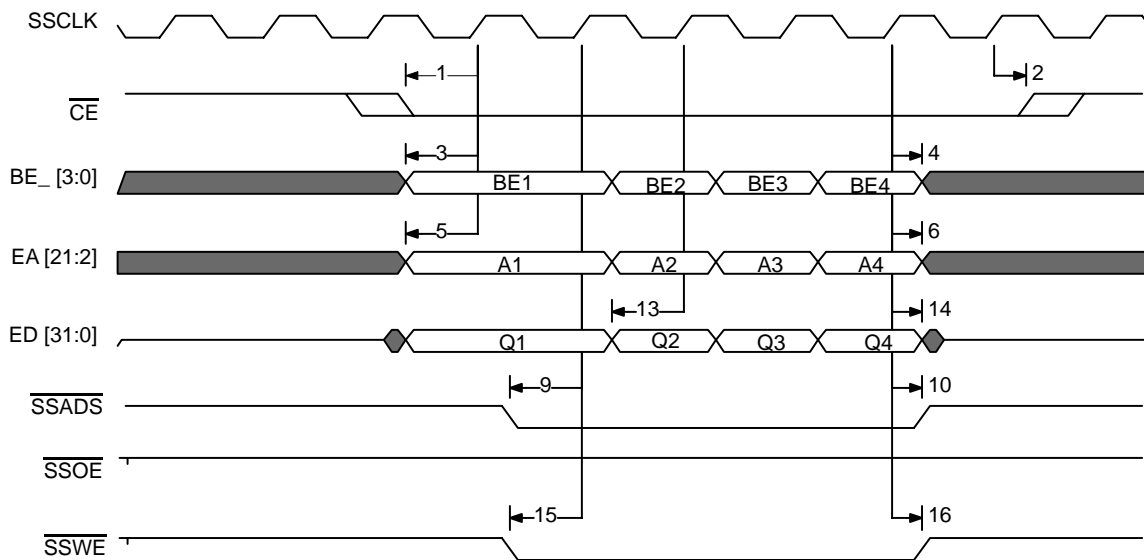
Figure 3. SBSRAM Write Timing (1/2 Rate SSCLK) (See Note)

NOTE: The \overline{CE} output setup and hold times are specified to be accurate relative to the clock cycle to which they are referenced, since these timings are specified as minimums. However, the \overline{CE} output setup and hold time may be greater than that shown in the data sheet in multiples of P ns. In other words, for output setup time, the \overline{CE} transition from high to low may happen P, 2P, ..., or nP ns before the time specified by the data sheet. Similarly, for output hold time, the \overline{CE} low-to-high transition may happen P, 2P, ..., or nP ns after the time specified by the data sheet. This is indicated by the period of uncertainty for specs 1 and 2 in Figure 2, and Figure 3.
