AM1808 ARM Microprocessor Silicon Revisions 2.3, 2.1, 2.0, and 1.1

Silicon Errata

Literature Number: SPRZ313H
March 2010–Revised September 2014

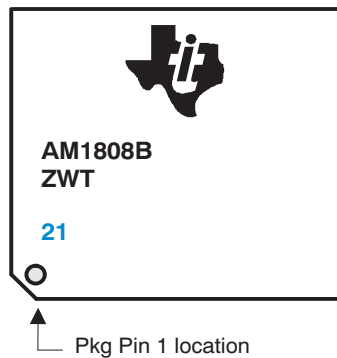
Figure 1. Device Markings

DEVICE REVISION CODE (xx)	SILICON REVISION	COMMENTS
E	2.3	-
B	2.1	Silicon Revision 2.1 can be differentiated from Revision 2.0 by a top side '21' marking on the package. See Figure 1 for details. Additionally the ROM ID code of may be used to distinguish Revision 2.1 from Revision 2.0
B	2.0	-
A	1.1	-

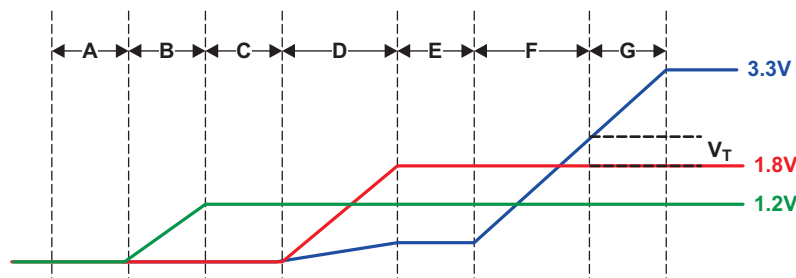
Figure 3. Normal power-supply ramp

Important Note: The 3.3V DVDD3318_x supplies must not be driven to 0V during zones A – E or high current capable of damaging the device may occur. The 3.3V DVDD3318_x supplies should not be driven during this time.

- A. All device supplies are undriven
- B. The 1.2V supplies are ramped to their nominal levels
- C. Potential delay between supply ramps (not required)
- D. The 1.8V supplies (specifically DVDD18) are ramped to their nominal levels. During the DVDD18 ramp there will be some minor drift up in the undriven DVDD3318_x supplies. This is normal and is not a problem.
- E. Potential delay between supply ramps (not required)
- F. DVDD3318_x is ramping but is less than DVDD18 + V_T
- G. DVDD3318_x is ramping but is greater than DVDD18 + V_T

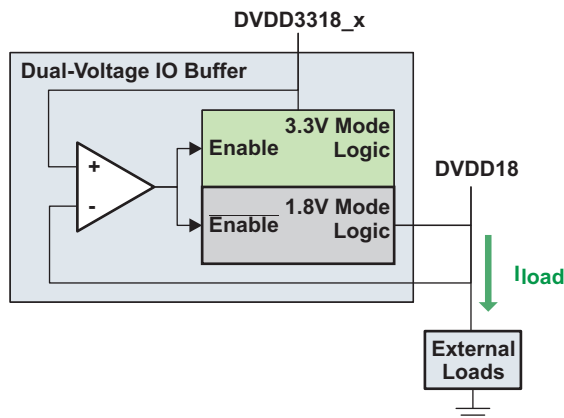
Figure 6. Error State of the IO buffer during Zone G

If DVDD18 continues to rise as DVDD3318_x ramps, the comparator never sees enough difference between the two supplies to switch to 3.3V mode.

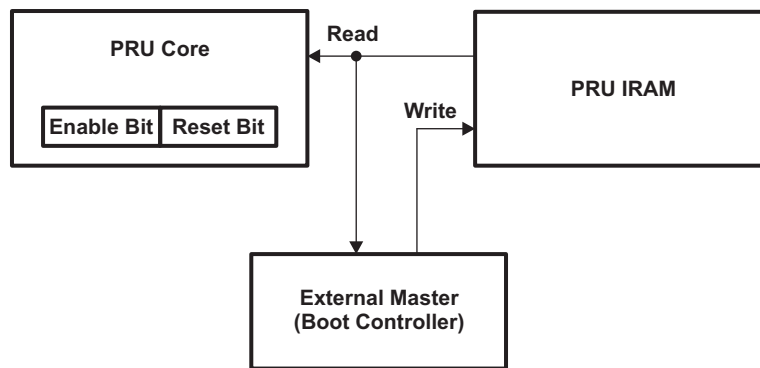
Figure 8. PRU and Boot Controller Block Diagram

The ARM reset vector table is located in the ARM's local RAM, however the ARM local RAM can only be accessed by two bus masters: ARM and PRU0. Therefore, the Boot Controller must program PRU0 to copy the desired reset vector table into the ARM's local RAM.

The PRU instructions are located inside of an instruction RAM (IRAM) which is initialized by the Boot Controller (see Figure 8). After the instructions are stored to IRAM, the PRU is reset and enabled to execute its instructions. In this case, the PRU is instructed to initialize the ARM reset vector table.

When the device is first powered-on, the read bus from the PRU IRAM is not initialized and will contain random values (see Figure 9). Under unpredictable circumstances, the random value on the read bus may resemble a reserved instruction which can be interpreted by the PRU when the core is reset and not enabled.

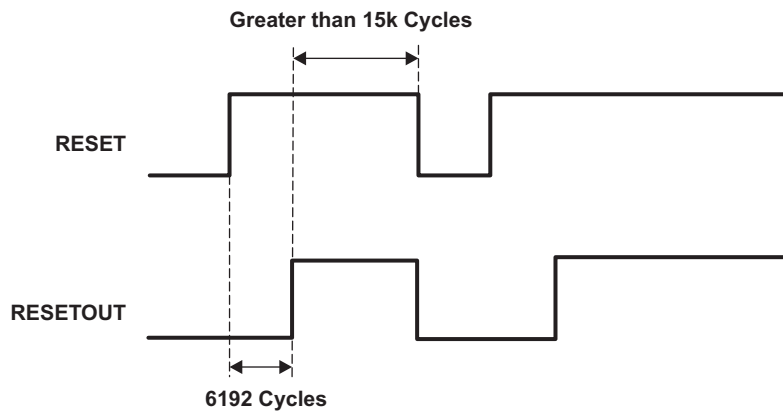
Figure 11. First POR Reset Timing

Note that in order to recover from this fail state with a secondary reset, the Boot Controller must be allowed to execute up to the point where the PRU has fetched a known instruction from the PRU IRAM. The approximate count of 15k clock cycles is sufficient.

The 15k clock cycle count does not include the 6192 clock cycles required to complete a device POR reset (see Figure 11). With a 24MHz crystal, the first RESET signal must be asserted high for at least 883us (or approximately 1ms).

Modify the target board so that the affected device is given a secondary reset on power-up as shown in Figure 11. Two example methods are described in the sections that follow.

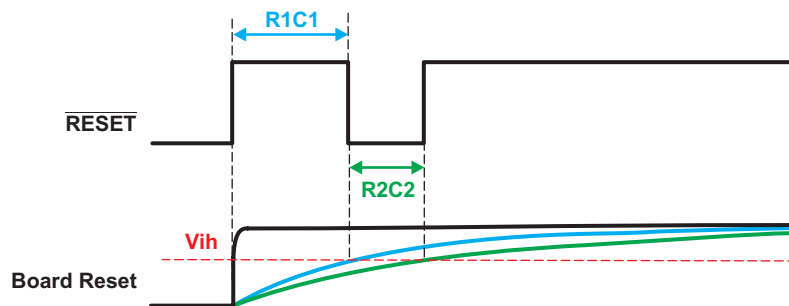
Figure 14. RESET Signal vs Board Reset

This is possible because each RC load connected to the board reset control signal can output a different rising-edge waveform. With increasing RC load, the resulting control signal will reach the Schmitt buffers' V_{ih} level at a later point in time.

[Figure 14](#) shows the relationship between the board reset signal and the RESET signal produced by the circuit. The blue and green lines represent the voltage as seen by the Schmitt buffers. The output voltage of a charging RC circuit is defined as: $V_o = V_i * (1 - e^{-t / RC})$

Given ideal conditions, a 3.3V board reset signal, and an input buffer V_{ih} of 1.4V, the following set of component values would generate an initial RESET high period (R1C1 region) of approximately 2ms and a RESET low period (R2C2 region) of approximately 0.5ms:
